All steamed up

Pressure on the Government to make double-glazing obligatory in new-build has focused attention on the shortcomings of the existing British Standard. Alastair Stewart investigates.

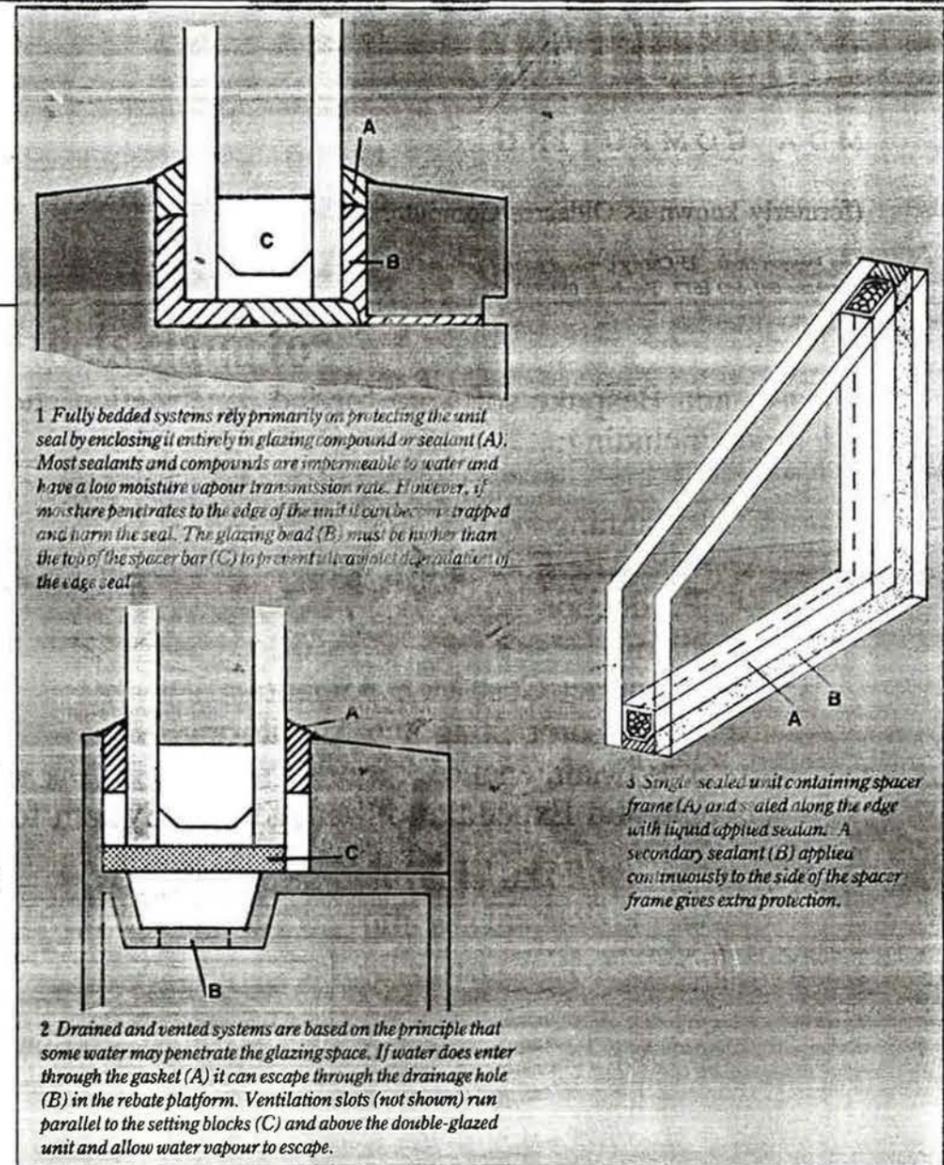
In fully-bedded systems the double-glazed unit is held in place

and protected by a continuous ring of glazing compound or sealant (see diagram 1). Plough and a growing number of consultants are pushing for this method to be banned and for drained and ventilated systems to be made obligatory (see diagram 2).

GGF head of standards John Weir admits the federation is becoming more sympathetic to Plough's way of thinking: "You can do a good job with fully-bedded systems, but they are prone to bad workmanship. It is very difficult to glaze them without forming voids in the bedding where water can gather.

"No matter how good the quality of the sealant, it can't survive prolonged contact with water," says Weir.

He says drained and ventilated frames are the preferable method. "Drain holes in the rebate platform allow any moisture that gets past the glazing material to escape. Ventilation holes allow air to dry out any remaining water."

The problem facing the GGF, says Weir, is that the vast majority of standard wooden frames have insufficient rebate depths and widths to accommodate the more complex drained and vented systems and accompanying wooden beads. A minimum 18 mm depth is required for fully-bedded and 22 mm for drained, he insists. But the average is 13 mm.

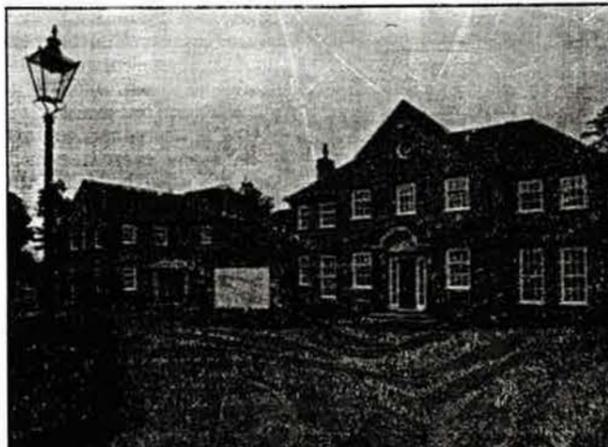
AT Barratt's Dulwich Gate estate, glazing experts that represent the residents claim the double-glazed units are bedded and fronted in a wholly unsuitable material, linseed oil putty. Linseed oil putty was removed from BS 6262 in the 1982 revision because it commonly loses adhesion with the glass, allowing water into the area beneath the glazing unit.

£400 000 houses have been blighted on Barratt's Dulwich Gate estate. An example (right) of the misted windows.

According to the residents, Barratt has offered to strip out the glazed units and fully bed them with metal casement putty. But some of the residents who have issued writs are insisting that all the windows are converted to the drained and ventilated system.

But in order to fit these into the wooden sashes properly, deeper rebates and wider rebate platforms will be required. "Our consultants have told us the rebates are too narrow to even comply with the allegedly poor British Standard," says a resident on the Barratt estate.
