Auditing the All-Electric Multifamily Building

By Vicky Hayes

A rehabbed, all-electric multifamily building can give an auditor one whale of a headache—or the satisfaction of a job well done, if idiosyncrasies are transformed into insights.

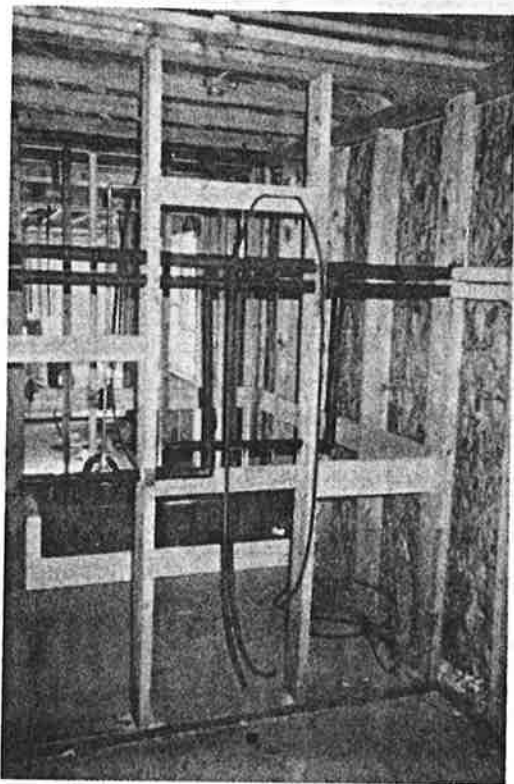
Here, electrical, plumbing, and mechanical systems are being installed before interior walls are finished. Many adaptations of original building plans occur at this point of construction. "As built," plans which have been updated to include actual construction changes, are a valuable resource, allowing the auditor to know what is actually inside the walls.

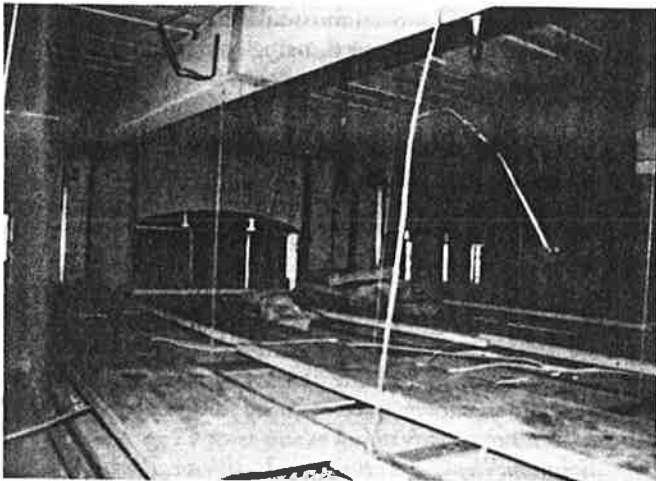
Auditors at the Steinhorst Square complex found the apartments were built as a series of boxes within the frame of the original factory building. Massive gaps created severe convection currents.

November 21, 1991 (Audit day one, field notes): The rehabilitation consisted of building sheetrock "boxes" with aluminum stud walls within the old brick walls of the factory. These boxes would eventually become the apartments.

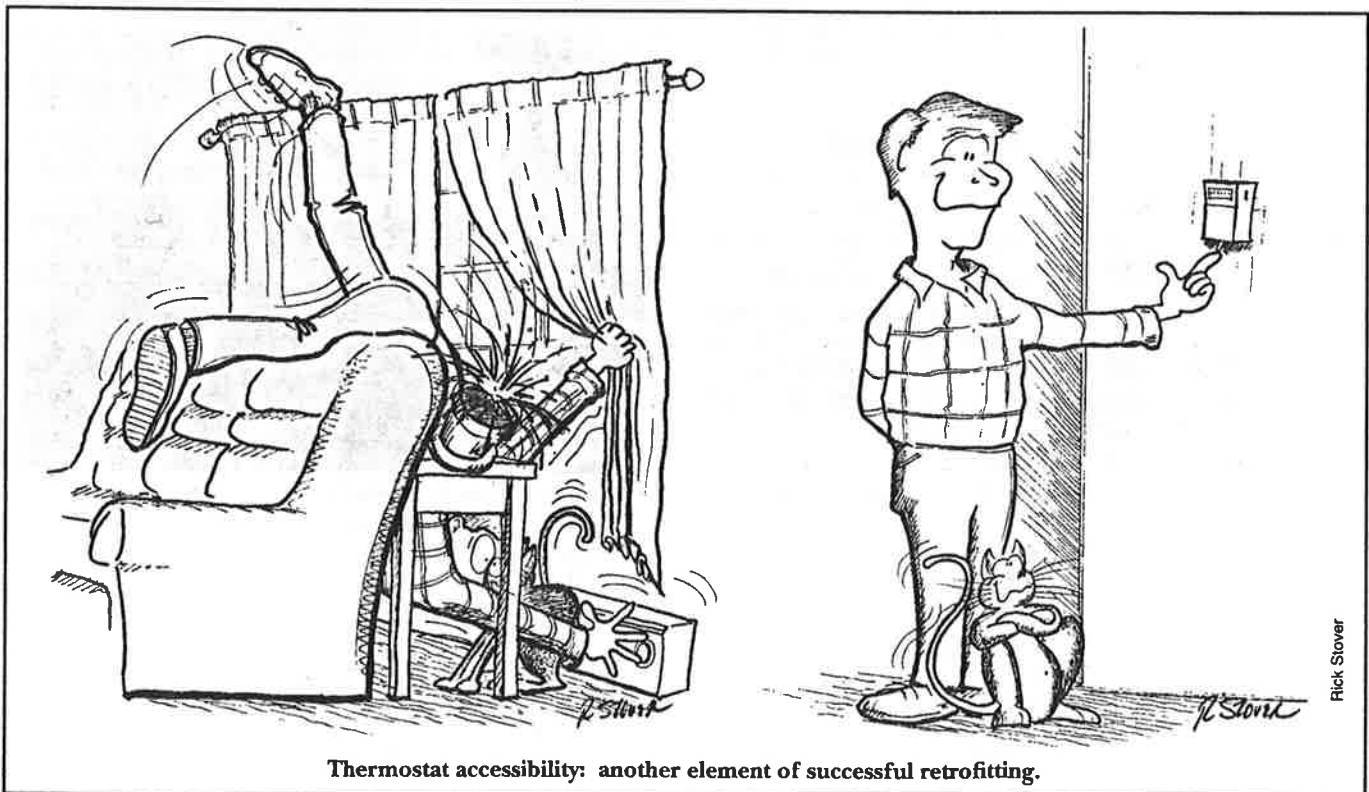
Thermostat accessibility: another element of successful retrofitting.

Problem: Existing thermostatic controls can best be described as useless. Deadband range was impossible to measure due to the non-calibrated thermostat. Tenant attempts to set back thermostats failed, short of turning the thermostat completely off.

Solution: Replace all thermostats with a calibrated thermostat having a 3°F deadband range. Replace living room thermostats with automatic night set-back thermostats.

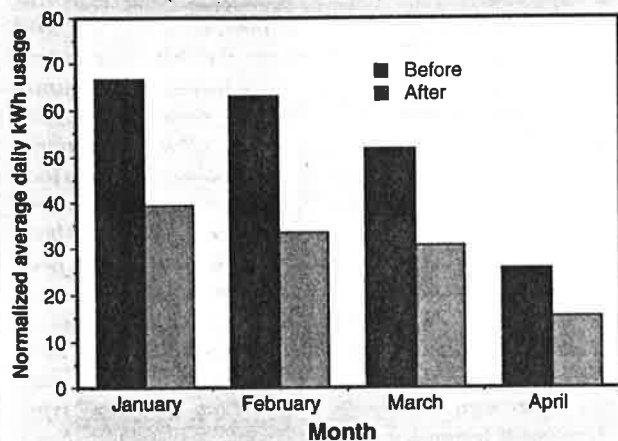
Figure 2. Steinhorst Square Apartment Fuel Use
(Fourth Floor Center Apartment)

October 17, 1991 (Notes on fuel analysis results): The 42 individual fuel histories for common areas and apartments have been weather normalized and disaggregated using PRISM. We profiled the usage by floor and by apartment location to see if we would find anything interesting. We did! Contrary to what we expected, the top floor has the highest electric usage. In addition, looking at the graphs by location, we see corner apartments on all floors are high users.

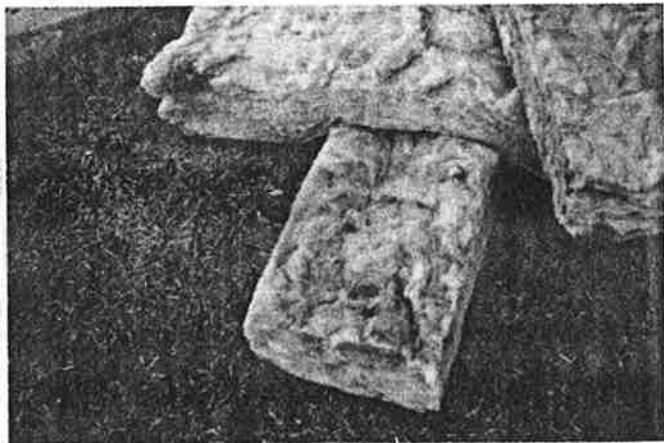
Dirty fiberglass insulation is one sign of air movement within the building cavity. With poorly sealed structures, a large volume of air moves through the insulation, leaving behind smudges of dirt.
