Indoor Air Quality Update[®]

Special Case Study: The DuPage County Courthouse

Introduction

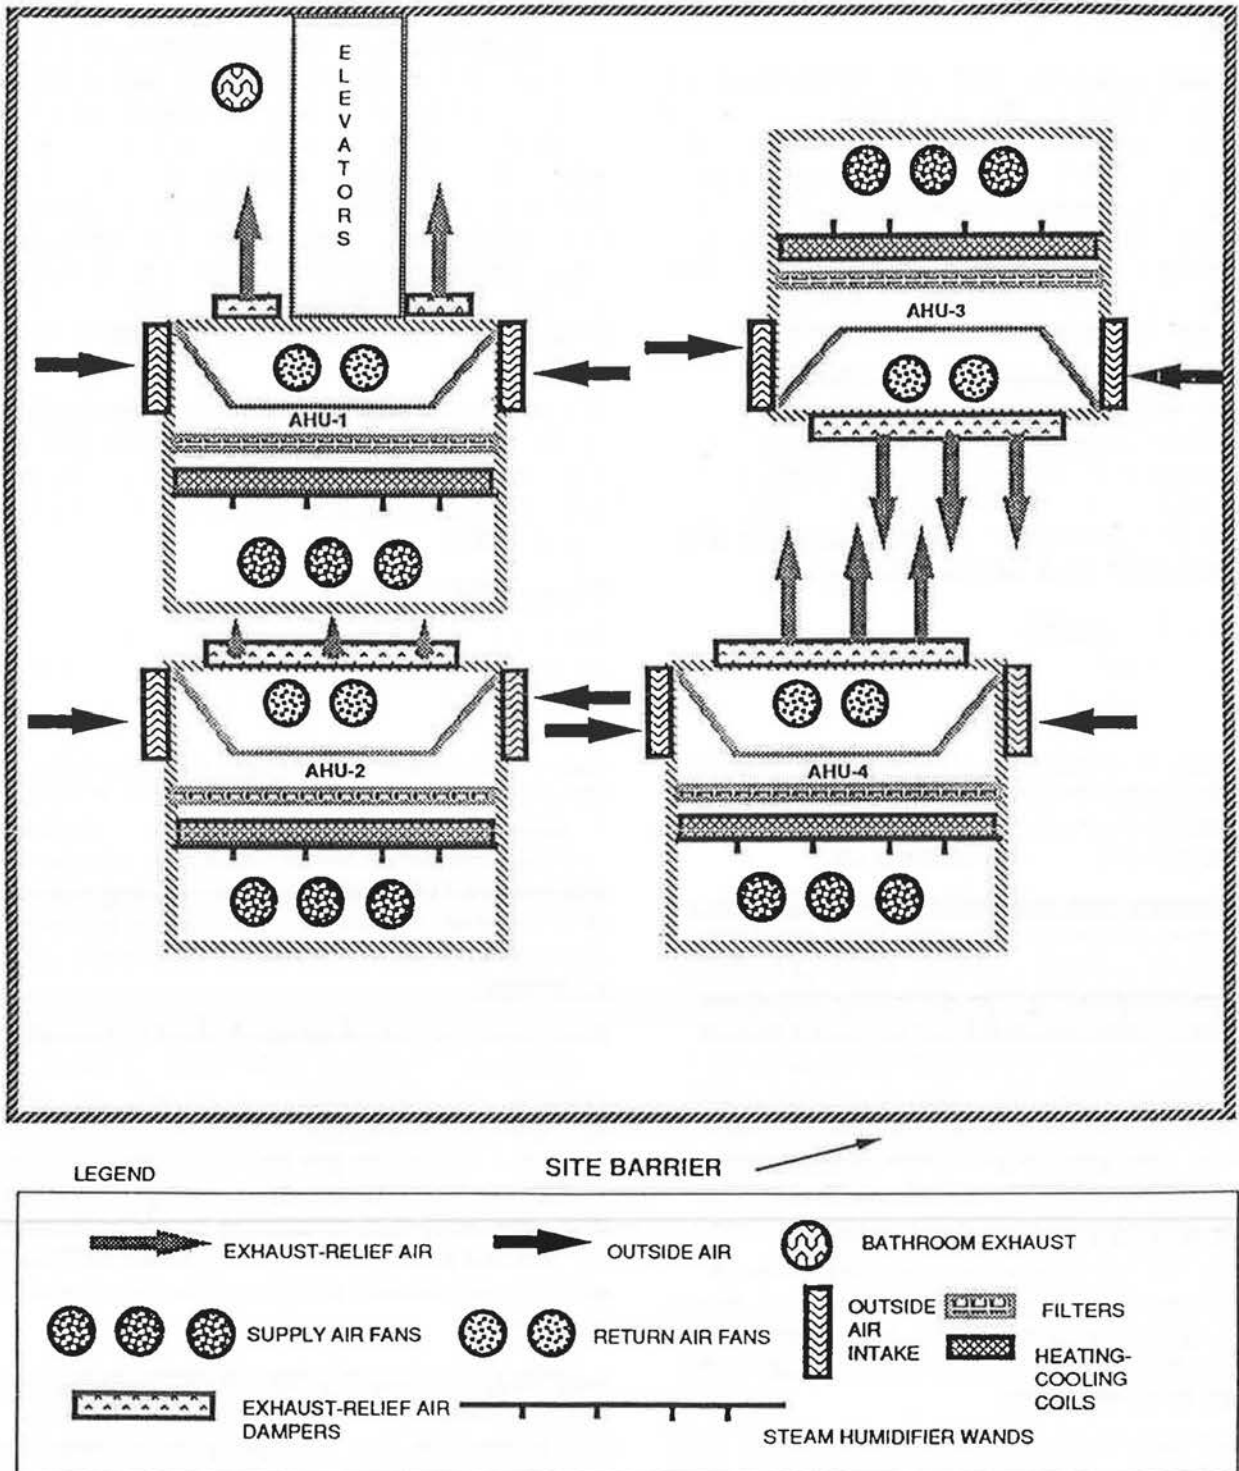
Figure 1 — Roof Air Handlers Layout at JOF

The situation was aggravated by the sight barrier, which prevented the wind from removing the exhaust air and also from diluting it before it was reentrained by the air intake dampers. The barrier also caused fresh air to be drawn across the surface of the roof, where it picked up chemicals being offgassed by construction materials in the roof. Also, the cafeteria exhaust system discharged horizontally across the surface of the roof.
