CASE STUDIES OF VENTILATION RETROFITS DESIGNED TO RESOLVE AIR QUALITY PROBLEMS IN PUBLIC BUILDINGS

E.M. Sterling C.W. Collett B. Mueller J. Meredith T. Blomfield

IAQ 87

Practical Control of Indoor Air Problems

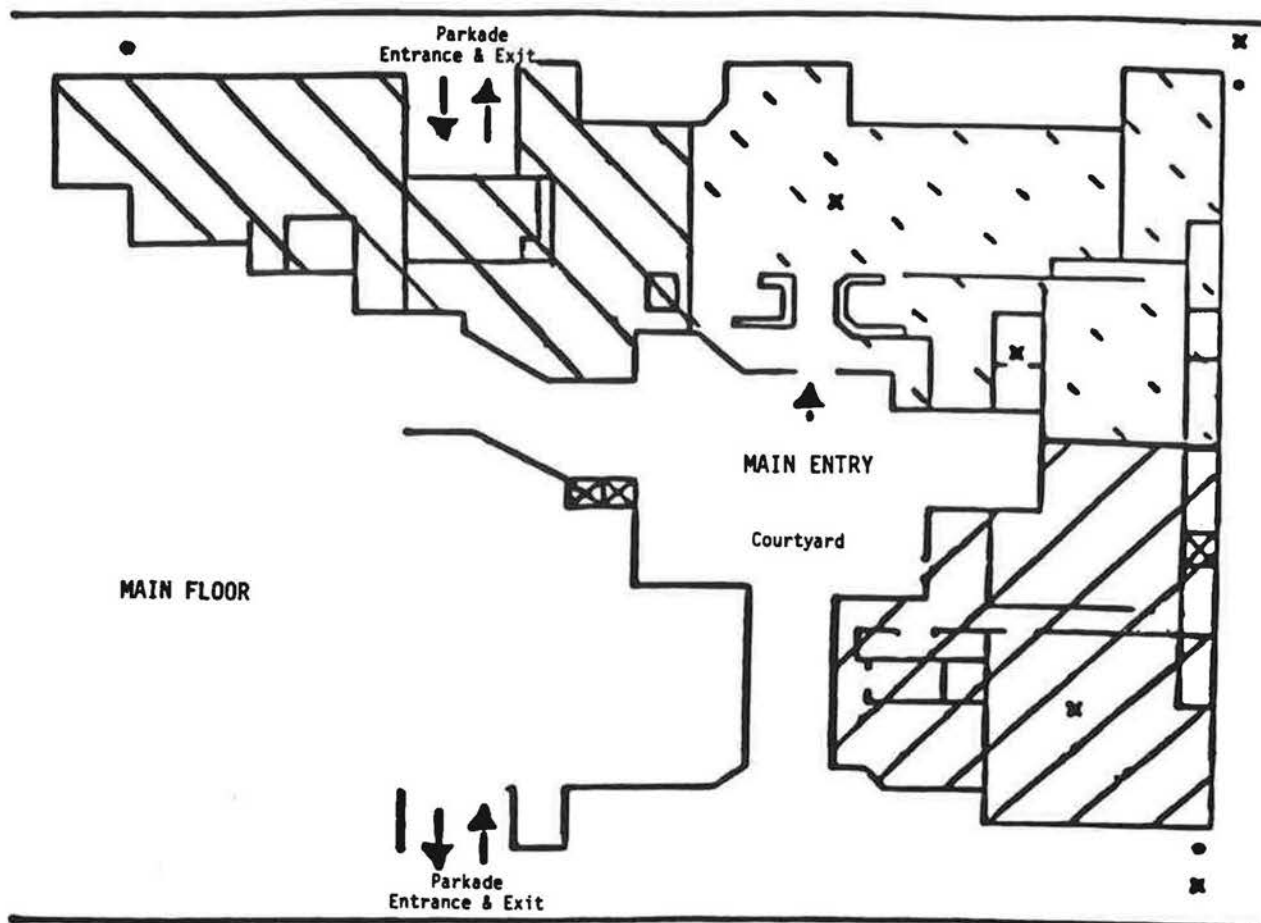
Figure 1. Floor plan of the public library

The library is located on the main floor of a four-story office complex. A three level parking garage is located beneath the offices. The mechanical system is a constant volume, dual duct multizone system with terminal boxes controlled by zone thermostats. The library is divided into three ventilation zones, which are shown in Figure 1.

Measurements and observations taken prior to the installation of the activated carbon filter indicated that the majority of occupant complaints about restaurant and traffic odors were concentrated in the northwest ventilation zone. CO concentrations were higher in this zone than in the other two zones (approximately 5 ppm). Indoor CO concentrations appeared to be strongly influenced by the outdoor CO concentrations measured in the vicinity of the outside air intake. There did not appear to be a relationship between CO concentrations measured in the library and in the parking garage.

Inspection of the outside air intake for the northwest zone confirmed its location at street level on a busy downtown street. The intake was also located adjacent to a commercial loading zone and a restaurant. After installation of the activated carbon filter, occupants reported that the number of odor episodes had been reduced, although automobile exhaust odors had still been apparent on several occasions. Measurements showed that the installation of the filter had no effect on the CO concentrations in the northwest zone. This finding is not surprising because an activated carbon filtration medium will act to remove the volatile organic compound components of traffic exhaust, but it will not effect carbon monoxide.

Lower CO₂ concentrations at the ceiling height compared to desktop height indicated that the ventilation air is not being effectively distributed to the occupied zone, causing a problem of stratification. At four of the six sampling locations in the library, desktop CO₂ concentrations were more than 100 ppm higher than ceiling levels. These results show that stratification problems occurred throughout the library.

Based on these findings, retrofit actions were designed to improve environmental conditions in the library. To improve the quality of the outdoor air supply, a recommendation (including design plans) was made to relocate the fresh air intake from street level onto the rooftop. To improve air distribution, a lowering of the ceiling diffusers by removing the existing vertical ducts to the diffusers and installing a three-foot long vertical duct and then reinstalling the diffuser were recommended. This method was considered preferable to simply increasing the velocity of airflow through the diffusers.

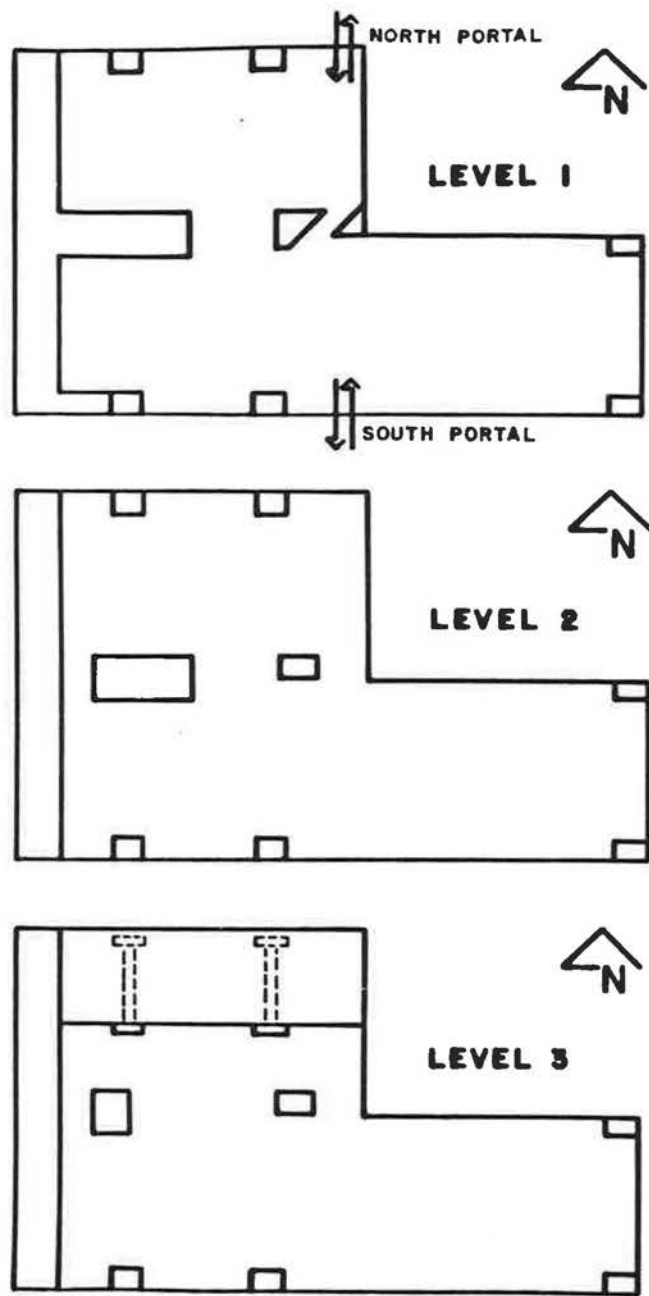
Figure 2. Floor plan of the parking garage

The parking garage is a three-level underground structure, with a total floor area of 184,000 ft². Figure 2 shows the basic layout of the garage. The levels are marked 1, 2, and 3. Level 1 is just below street level and levels 2 and 3 are progressively lower. Traffic enters and exits Level 1 through portals on streets to the north and south. The garage has two traffic circulation spines, which run along an east-west axis and spiral between levels.

Visual inspection of the parking garage indicated that the transverse airflow from the supply vents on the south wall to the exhaust vents on the north was impeded by the spiraling design of the vehicle pathways in the garage which acted as a barrier to effective airflow.

Results of the CO measurements showed a peak concentration of 125 ppm on level 1 during the afternoon rush hour at a location on the north side of the garage. Conditions monitored at this location showed that for a 25 minute period during rush hour, CO concentrations on level 1 remained above 100 ppm. CO levels varied by the time of day and location relative to the supply and exhaust vents. The highest concentrations were found on the upper two levels on the north side of the garage. In these locations, eight-hour time-weighted averages were 28.8 ppm on level 1 and 26.1 ppm on level 2.

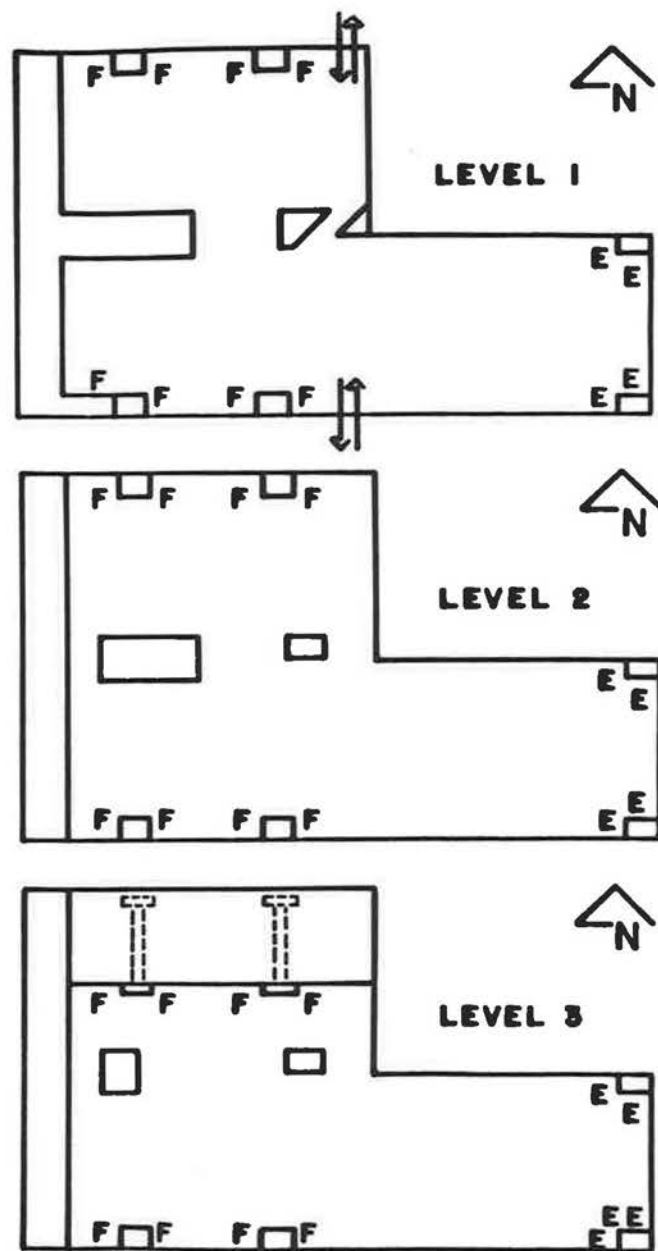
Figure 3. Original configuration of fans in the parking garage; F denotes fresh air supply fans, E denotes exhaust fans

The original (pre 1981) fan configuration is shown in Figure 3. This ventilation system configuration incorporated 24 fresh air vents and 13 exhaust vents. Air flow in the garage was intended to flow from the supply vents on the west side of the garage to the exhaust vents on the east side. The configuration was intended to create positive pressurization that would also force exhaust air out of the two street entrances. However, this configuration created a potential for entrainment of exhaust fumes into the office building above. Fresh air intakes for the upper floors of the building were located directly above the parking garage entrances. Consequently, the ventilation configuration was modified to the current situation.

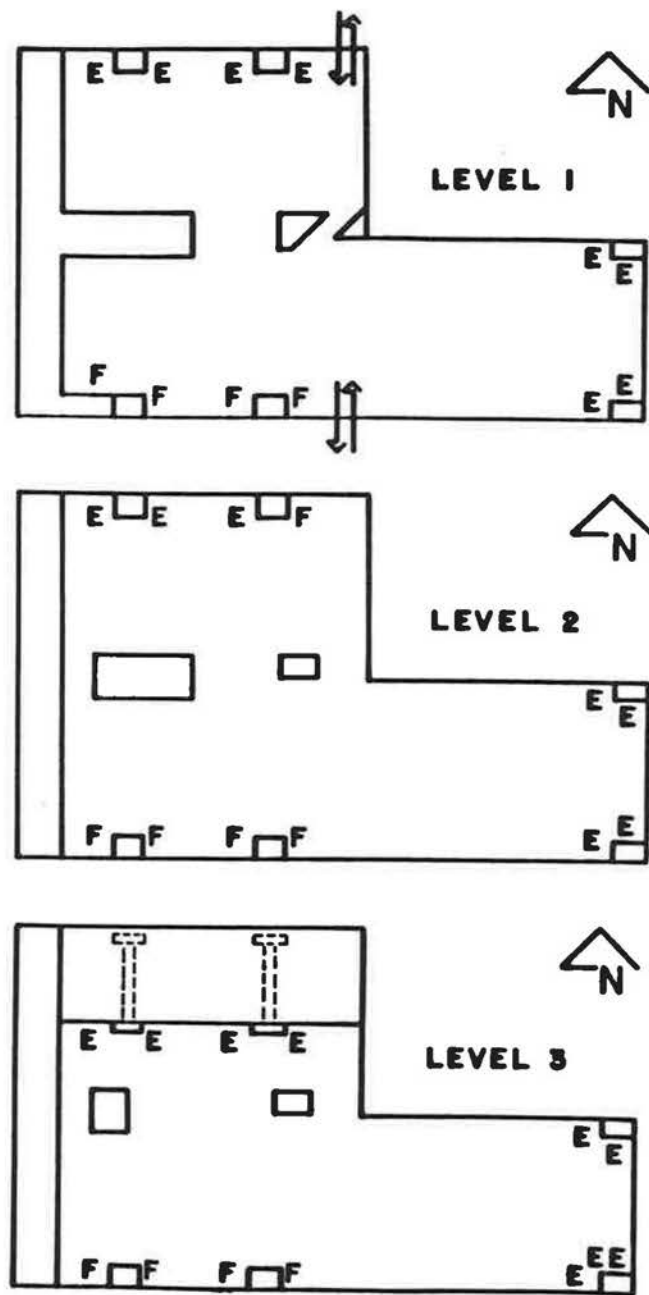
Figure 4. Modified configuration of fans in the parking garage; F denotes fresh air supply fans, E denotes exhaust fans

The current fan configuration is shown in Figure 4. On all three levels of the garage,

the supply fans are located on the south side and the exhaust fans are located on the north and east sides. This modified configuration was intended to promote a transverse airflow from the supply vents on the south wall to the north and east wall exhausts.

The amount of outside air per unit area of floor space being supplied to the parking garage by the original and modified fan configurations was calculated using design specifications from the mechanical plans. The results are shown in Table 1. The amount of outside air supplied to each level of the parking garage for both the original and modified fan configurations was substantially below the ASHRAE 62-1981 standard of 1.5 cfm/ft² (ASHRAE 1981).

1. The transverse airflow pattern was not effective due to the spiraled design of the vehicle pathways. A consequence was elevated CO concentrations toward the north side of the garage.
2. The amount of outside air supplied to the garage did not meet the ASHRAE 62-1981 requirement of 1.5 cfm/ft².
