**Monitoring of Automatic  
Diagnostic Sensors for  
Oil-fired Heating Equipment**

Final Report

**Canada Mortgage And Housing Corporation**  
National Office  
682 Montreal Road  
Ottawa, Ontario

September, 1991  
BLP File No. 2513

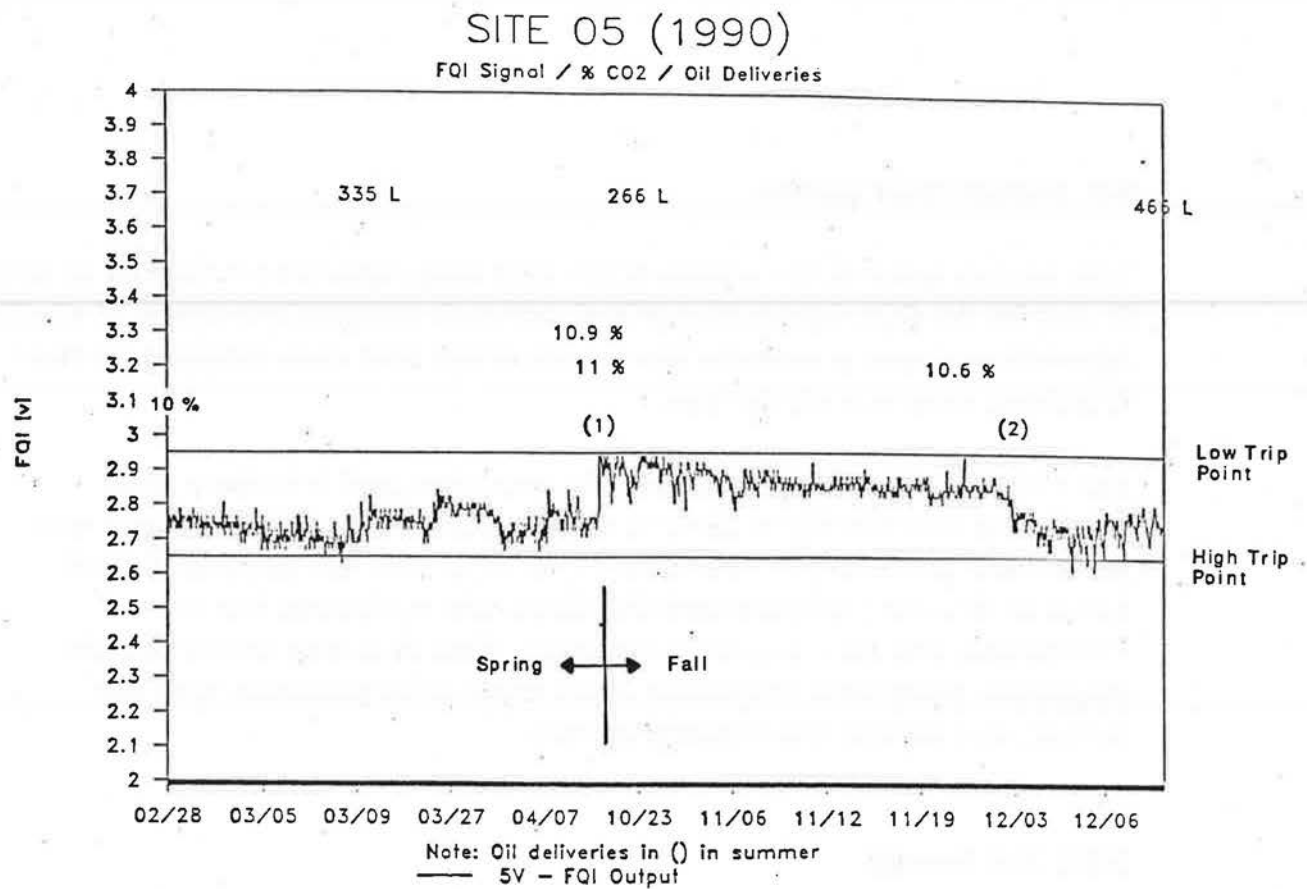
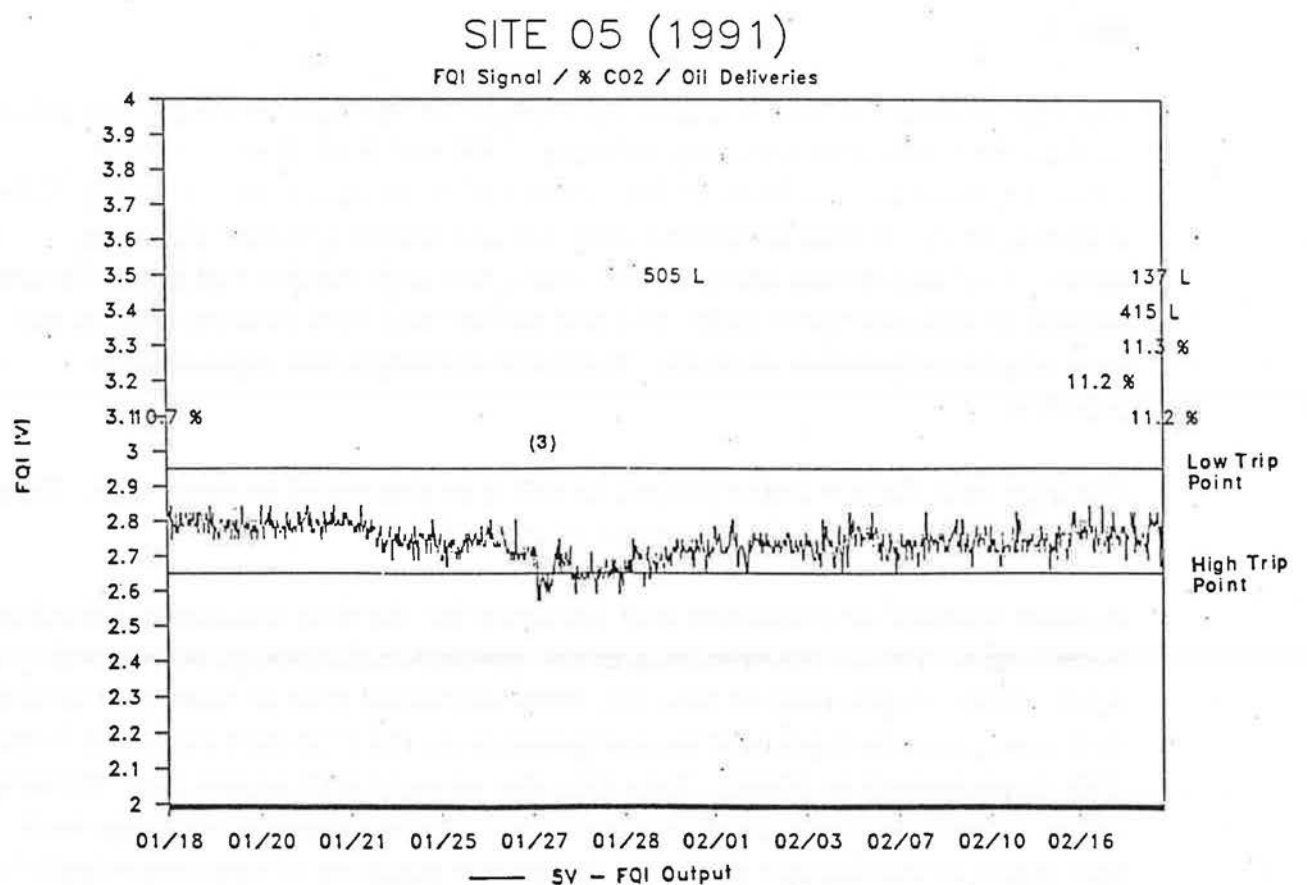
**Figure 3.2- Site 5 FQI Results**

A small amount of downward drift occurred for the first few weeks following installation. This is followed by a minor upward drift through March and April, 1990. A site visit on May 22, 1990 confirmed that at least the upward drift was a true indication of burner behavior as the CO<sub>2</sub> had increased from 10% (installation) to 10.9%. Note that the upward drift begins just following an oil delivery of 335 L on March 19, 1990. Smoke number readings were also taken in the furnace flues as a qualitative measure of soot concentration.

A small jump occurred (item 1) during the burner start-up in the fall, 1990. Note that the jump is consistent with measurements taken at 14:20h on October 5, 1991, which yielded a CO<sub>2</sub> content of 11% and smoke number of 1. A slight downward drift over the fall was confirmed as consistent with measurements taken at 12:05h on November 23, 1990, which produced a CO<sub>2</sub> reading of 10.6% and a smoke number reading of 1.

In early December (item 2) a dip in the FQI signal caused a HIGH alert. As the occupant did not report these alerts, site confirmation was not performed. During the January visit, the CAD cell was cleaned and replaced without resetting the FQI. This produced a short-lived increase in FQI signal (not shown), followed by a fairly rapid return to the FQI value prior to cleaning. Measurements taken during this visit revealed a CO<sub>2</sub> content of 10.6% and trace smoke. This slight downward drift resulted in a HIGH alert in late February (item 3). The FQI status must have been borderline as the alert was not logged by the occupant. After an oil delivery on January 29, 1990, the FQI signal increased and remained stable for the duration of the project. CO<sub>2</sub> measurement taken on February 20, March 19 and April 24, 1991, were consistent with observed stability over this period with values of 11.2%, 11.3% and 11.3%, respectively. The February and March figures were accompanied by trace smoke values, and the final smoke number was 1.

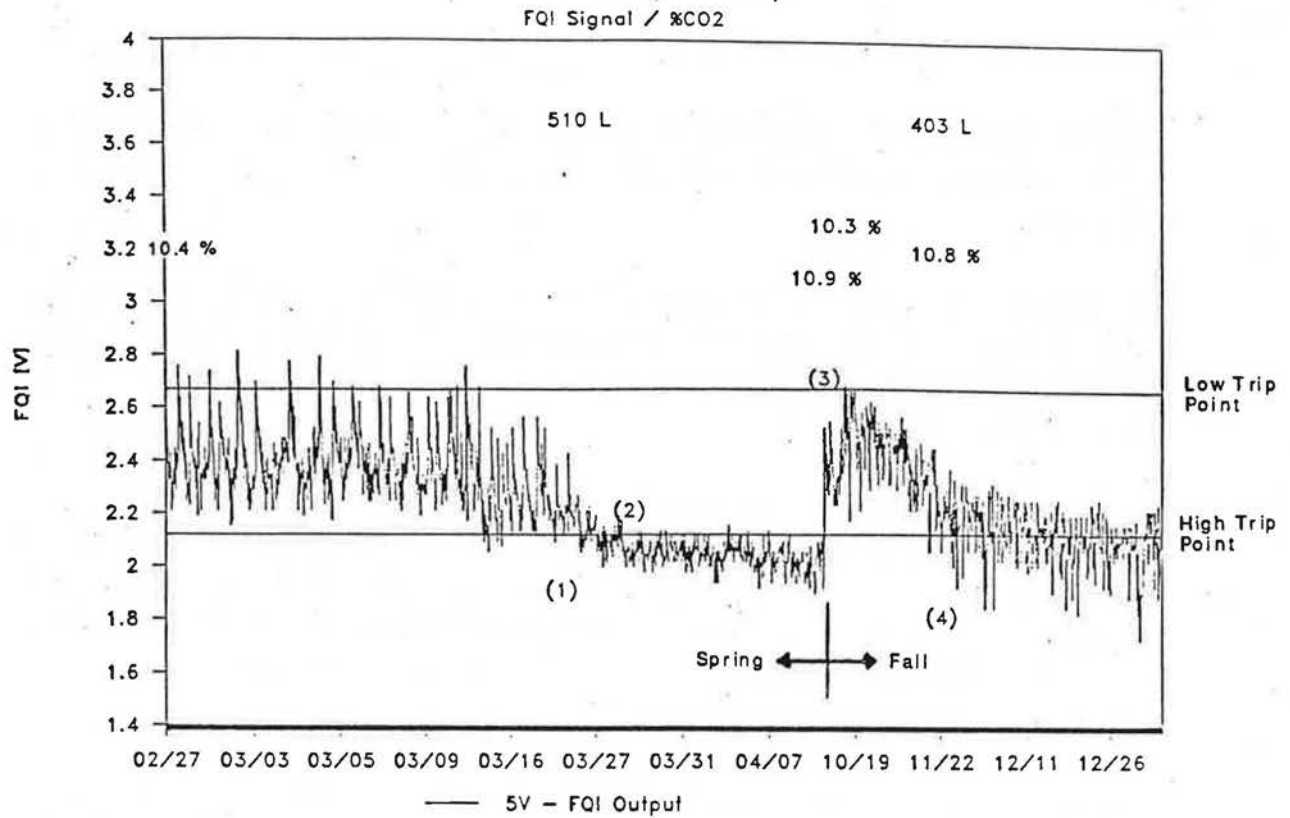
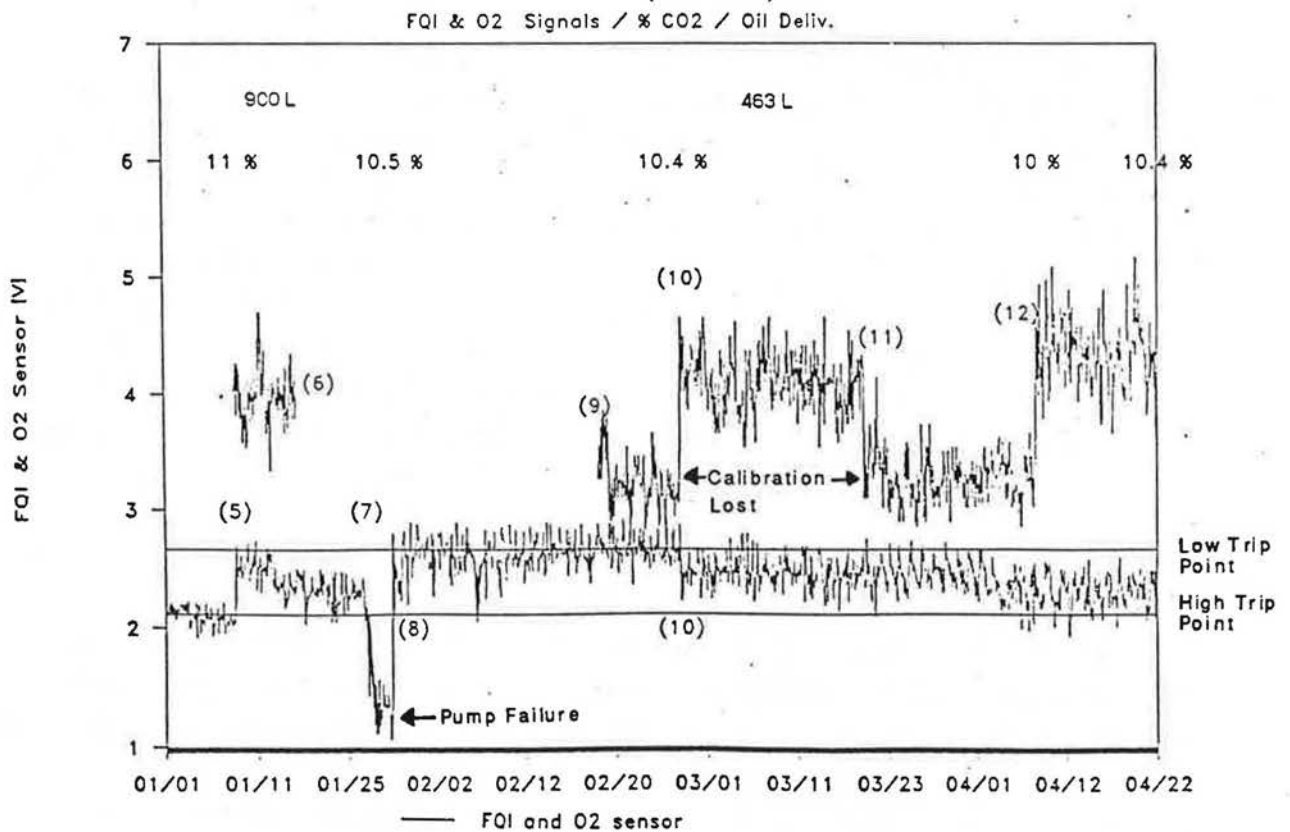
**Figure 3.3 - Site 3 FQI Results**

The FQI signal results for site 3 are presented in figure 3.3. Note that an O<sub>2</sub> sensor was commissioned in January, 1991. The highlight of the site 3 monitoring is the pump failure that occurred at the end of January, 1991.

At site 3 the FQI signal drifts steadily downwards from installation to the signal jump indicated as item (3). As with most sites, the thermocouple was removed temporarily for repairs. Item (1) points to the thermocouple removal (approximately March 19, 1990). Based on similar results of a thermocouple failure at site 4, it is suspected that the ripple in the FQI signal prior to item (1) is a result of the thermocouple signal over-ranging the data logger. Item (2) points to the HIGH alert caused by the gradual drift. On April 26, 1990 at 11:30h, the flue gas CO<sub>2</sub> content was measured at 10.9%, and the FQI reset to 2.5 V (item 3). As the drift was contrary to the CO<sub>2</sub> content change from installation (10.4%), this was a false alert. The signal continued its downward trend following the fall start-up, contrary to an increase in flue CO<sub>2</sub> content from 10.3% to 10.9% measured on October 5, 1990 at 10:48h, and November 23, 1990 at 9:20h, respectively. The continued drift triggered another false HIGH alert (item 4) in late November 1990.

It was suspected that much of the downward drift was a result of the CAD cell being too close to the combustion chamber and that this was causing the CAD cell to be overheated. Overheating the CAD cell rendered it less sensitive. This was equivalent to the CAD cell receiving less light. The long term drift reflected the degradation of the CAD cell over time as its sensitivity was being reduced.

Item (7) indicates a sudden drop in FQI signal and a HIGH alert on January 26, 1991. Follow-up to the alert revealed that a fuel pump seal had failed, and that fuel was leaking from the pump. The pump and motor were replaced and the FQI pot reset on January 28, 1991 (item 8). Note that the drop in FQI signal was consistent with how the FQI signal should have responded to a burner starved of fuel (see table 3.1). It is clear that this incident actually produced a fuel deficiency and this was exactly as indicated by the FQI. At site 1A two separate failures were recorded, once a fuel pump and motor had to be replaced, and then the fuel pump had to be replaced again. In these situations the FQI voltage output changed in a similar manner to warn of impending failure.

Following the pump replacement, the CO<sub>2</sub> content was measured at 10.5%. The next two visits (items 9 and 10 at 18:00h on February 18, 1991, and at 19:00h on February 26, 1991, respectively) produced CO<sub>2</sub> content values of 10.5% and 10.4%. Correspondingly, the FQI signal was very flat at this site as would be expected. During the second visit the FQI was reset because the previous adjustment was incorrectly set to produce too high a signal, producing meaningless LOW alerts. The remaining data shows a small amount of downward FQI signal drift. Note that the lack of drift after CAD

cell repositioning appears to confirm that overheating of the CAD cell was likely to be the cause of the drift problem.

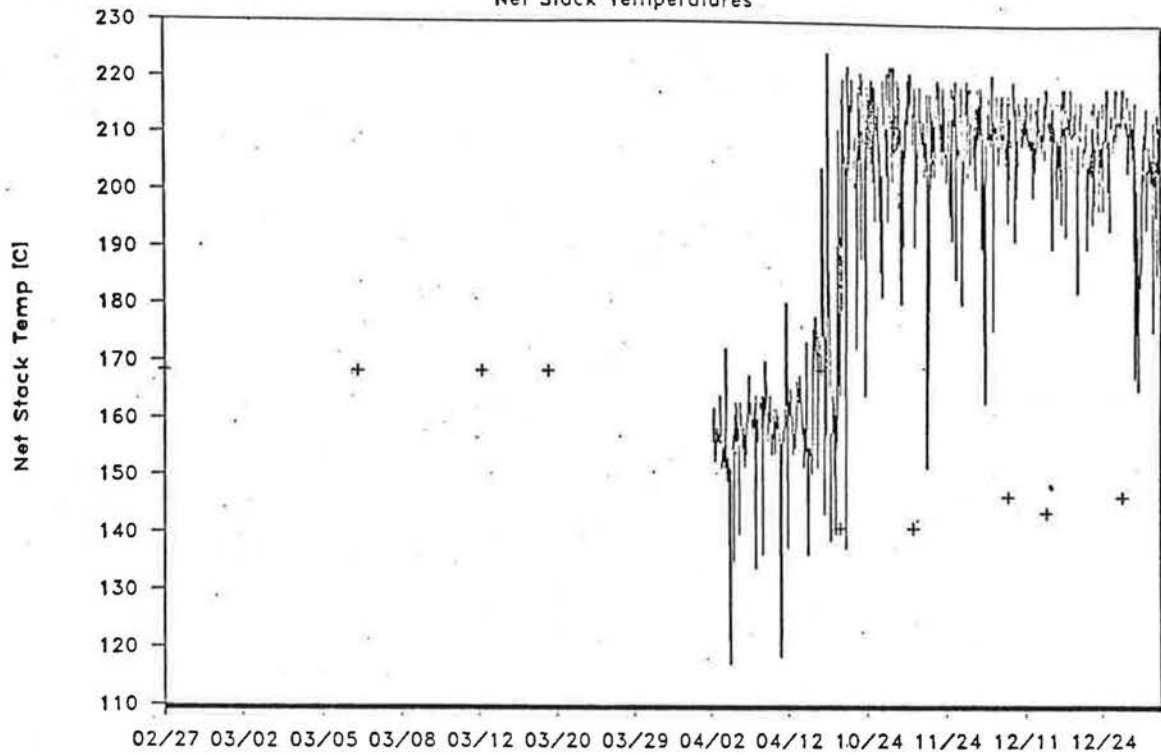
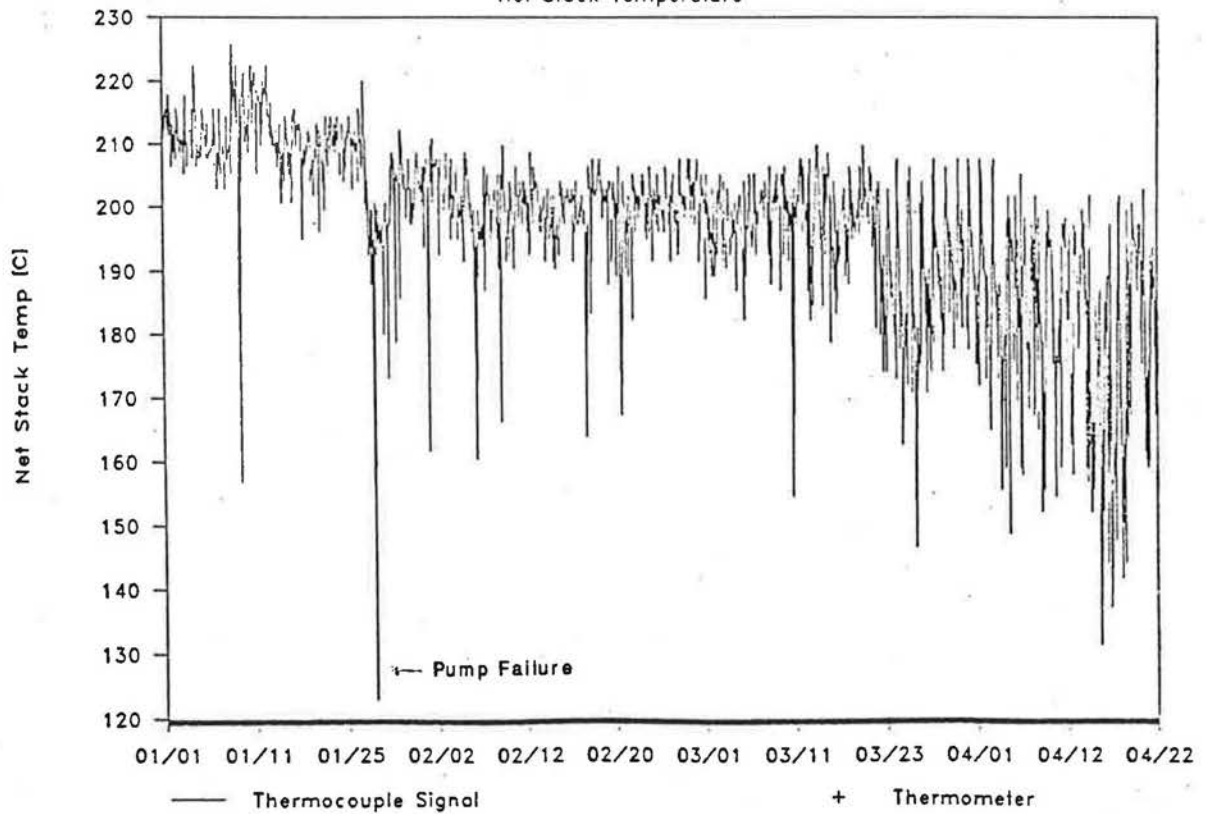
**Figure 3.4- Site 3 Stack Temperature**

The graph of the 1991 high stack temperature during burner cycles has a minimum value just prior to the fuel pump replacement on January 28, 1991. This would be expected as less oil was fueling the burner and therefore temperatures in the burner and flue should decrease.

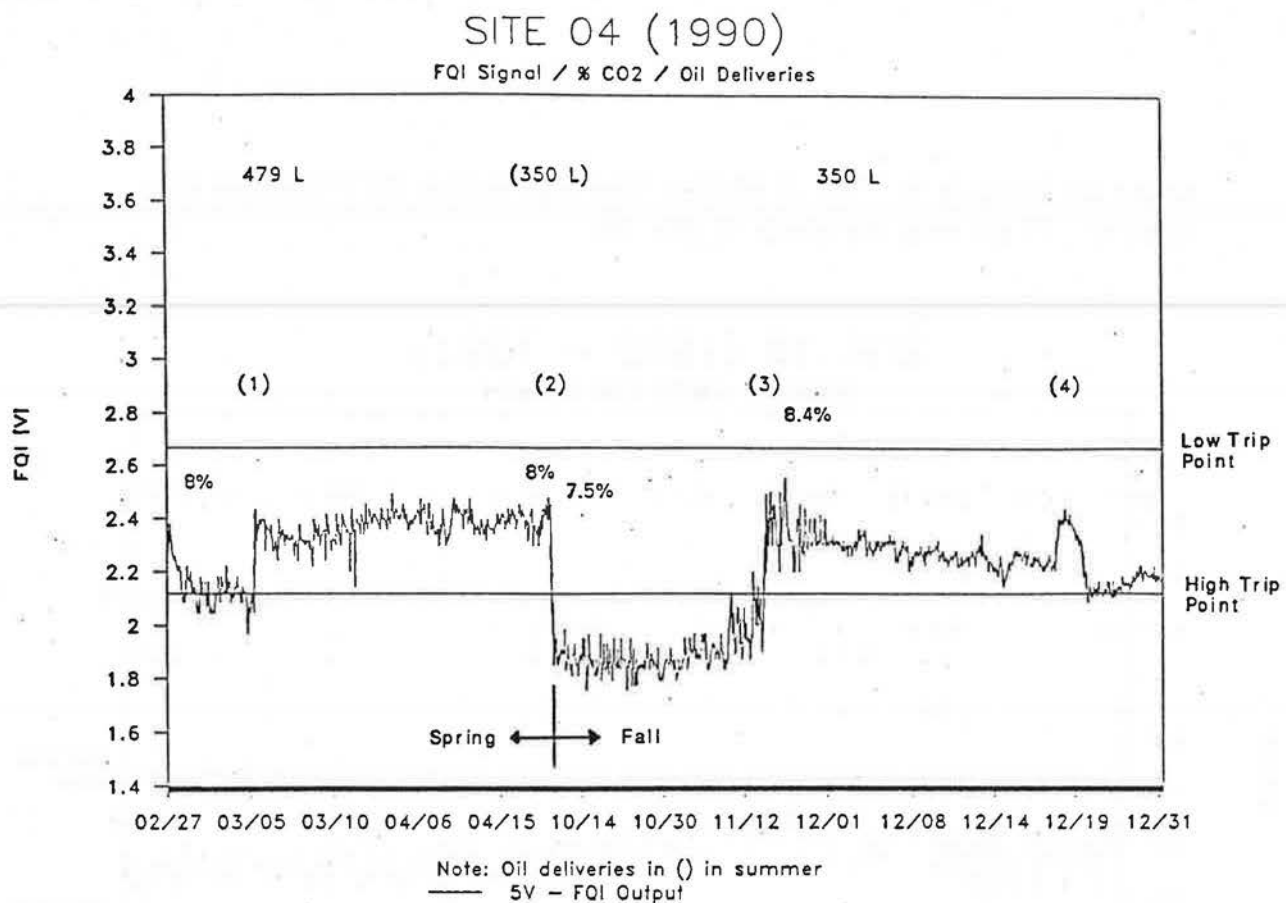
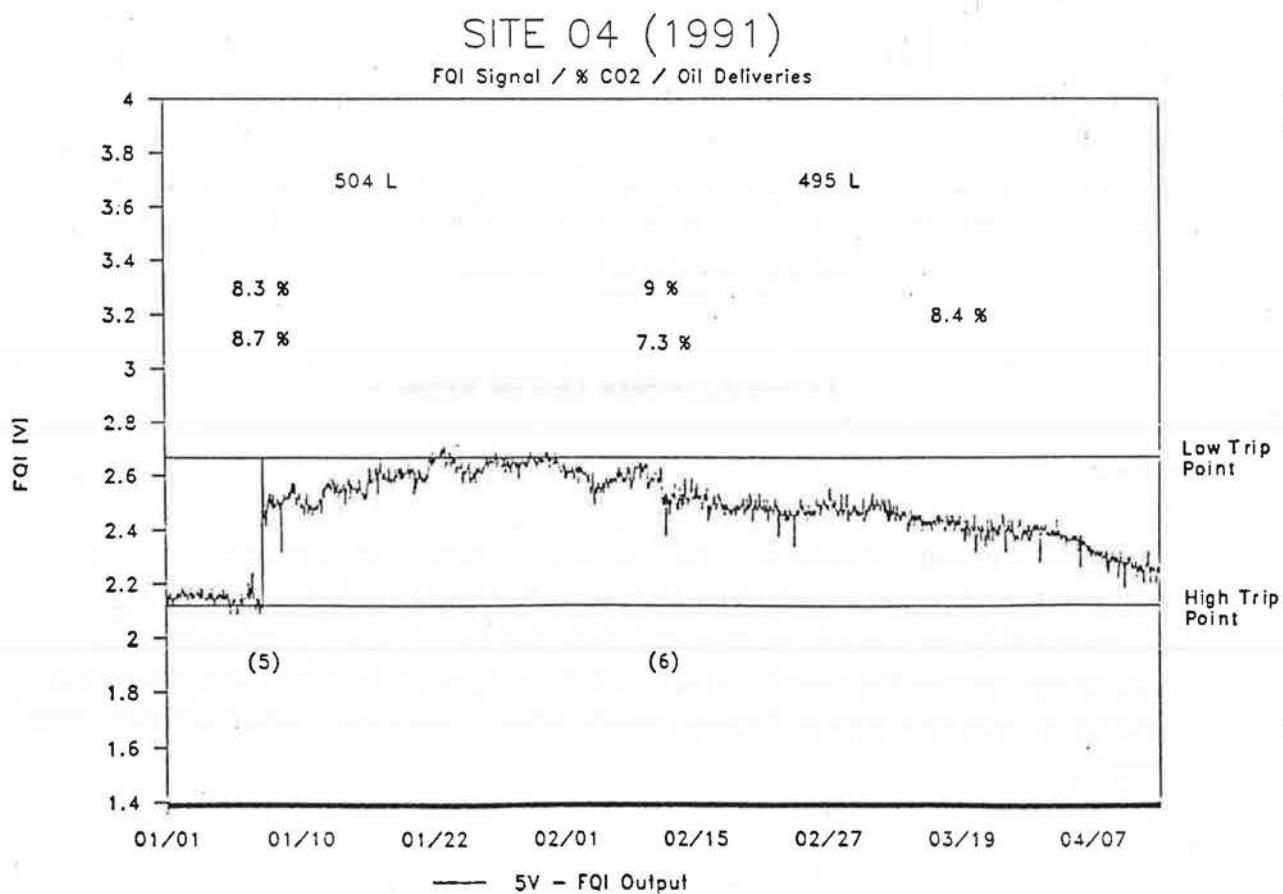
**Figure A.4 – Site 4 FQI Results**

At the fourth test installation, the homeowner would set the thermostat at 20°C at 16:30h until 23:00h at which time it was set to 14°C. The firing cycles were fairly regular at this site, ranging from 20 to 30 minutes. The FQI signal results for site 4 are presented in figure 3.4. The highlight of the project at this site was a clogged nozzle, which occurred during the fall 1990 start-up.

After installation (CO<sub>2</sub> content 8.0%), the FQI signal drifted very rapidly downwards causing a false HIGH alert within about 1 week. This change in FQI signal occurred much more quickly than at the other sites. The reason for this has not been determined. The FQI was reset by adjusting the FQI voltage so that the FQI voltage was 2.5 V when the burner approached steady state conditions at 10:49h on March 5, 1990 (item 1). During a site visit on May 22, 1990 at 19:30h, the CO<sub>2</sub> content was determined to be 8%. This was reflected by the essentially flat FQI signal following item (1) before the fall start-up. When the burner started up in the fall of 1990, a HIGH alert was initiated, and confirmed with a CO<sub>2</sub> measurement of 7.5% taken on October 5, 1990 at 12:00h (item 2). As the FQI had functioned well the previous season, it was decided not to change anything, but to observe site 4. A service visit was made on November 22, 1990 at 12:50h, the nozzle was changed, and the excess air reduced. The CAD cell was noted to be in good condition. The service was correctly reflected by an increase in FQI signal, as the changes had brought the CO<sub>2</sub> content back up to 8.4%.
