AIR TIGHTNESS TESTING AND SEALING
OF HOMES IN OTTAWA, ONTARIO
(PURCHASE ORDER # PHO 11501)

PREPARED FOR
THE ONTARIO MINISTRY OF MUNICIPAL AFFAIRS AND HOUSING,
TECHNICAL SERVICES DIVISION,
RESEARCH AND DEVELOPMENT SECTION

BY
RETROSPECTORS INC..

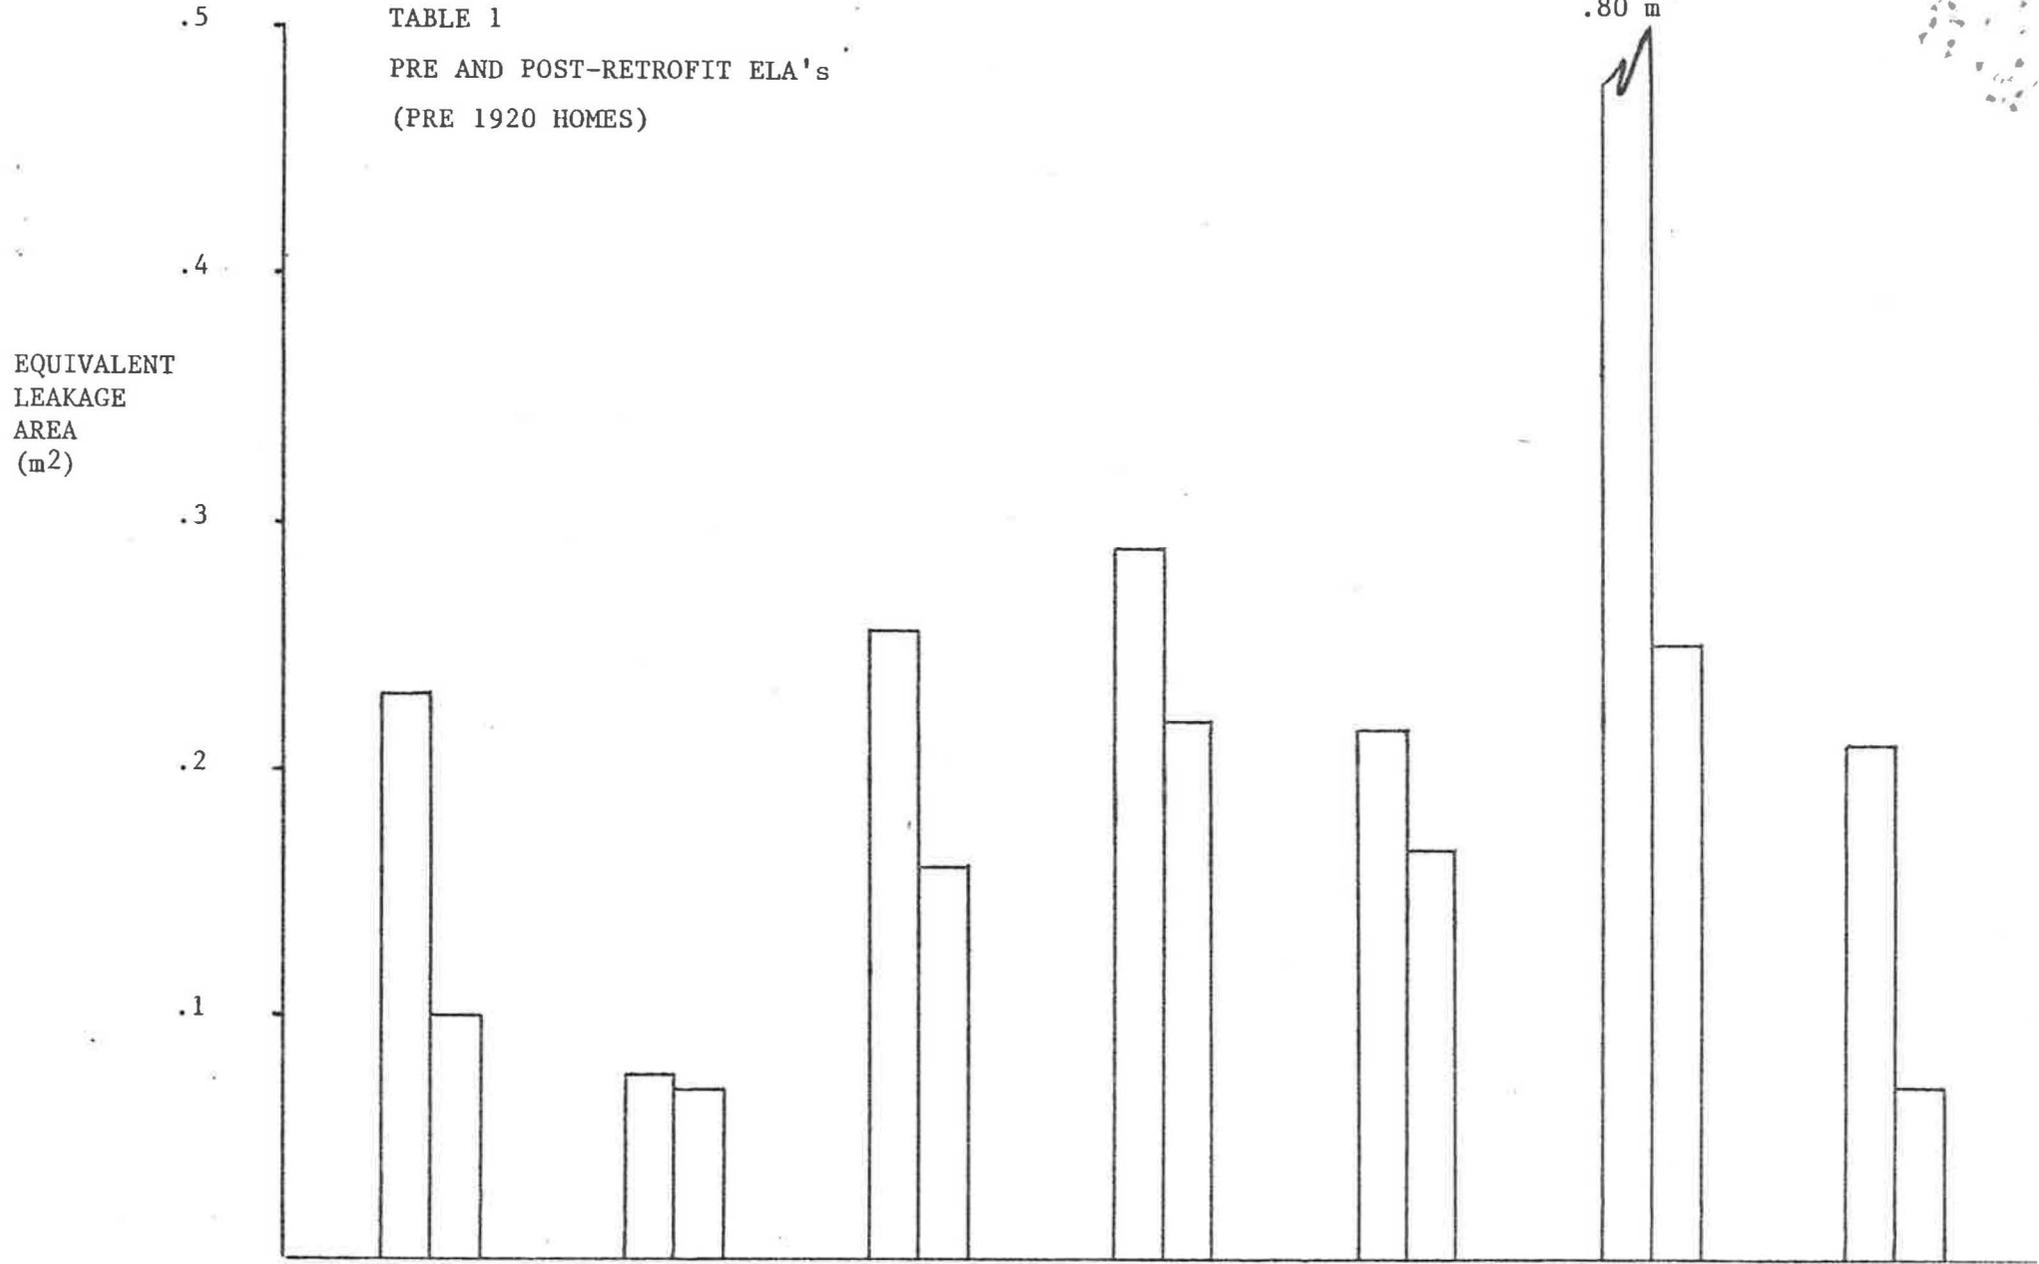
TABLE 1
 PRE AND POST-RETROFIT ELA's
 (PRE 1920 HOMES)

HOUSE #	1	2	3	4	5	6	7
YEAR OF CONSTR.	PRE 1920						
PRE-ELA:	.23	.076	.257	.290	.217	.80	.21
POST-ELA:	.10	.068	.160	.220	.168	.25	.07
% RED.	56%	11%	38%	24%	22%	68%	67%

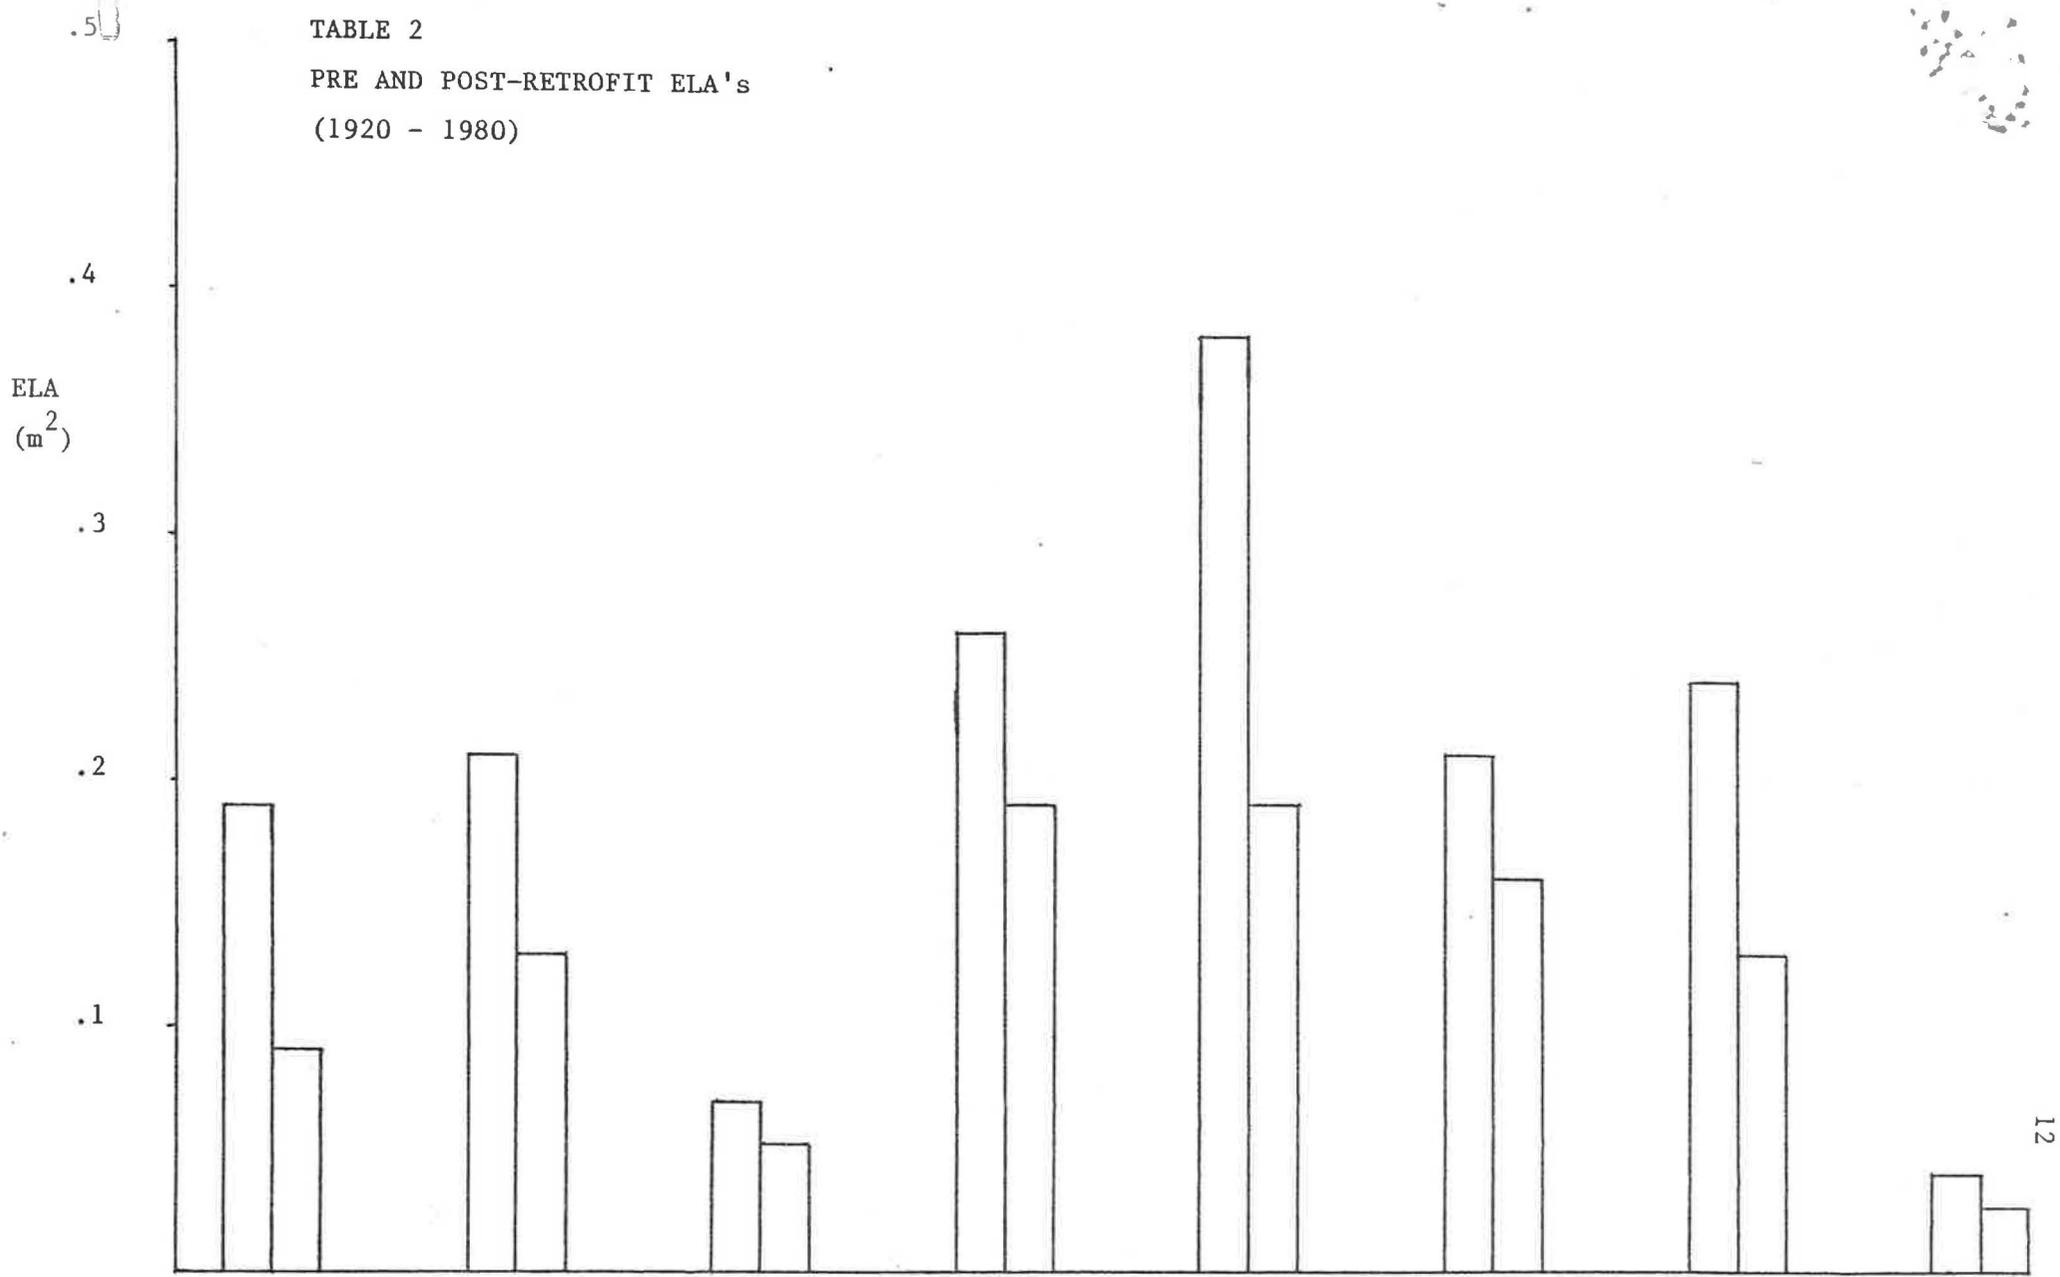
TABLE 2
 PRE AND POST-RETROFIT ELA's
 (1920 - 1980)

HOUSE #	8	9	10	11	12	13	14	15
YEAR OF CONST.	1920-45	1946-60	1946-60	1946-60	1961-70	1961-70	1970-80	1970-80
PRE-ELA:	.19	.21	.068	.26	.38	.21	.24	.040
POST-ELA:	.09	.13	.056	.19	.19	.16	.13	.025
% RED.	53%	38%	17%	27%	50%	24%	46%	37.5%
