MOISTURE ACCUMULATION IN WALLS DUE TO AIR LEAKAGE

A. G. Wilson and G. K. Garden

Technical Paper No. 227
of the
Division of Building Research

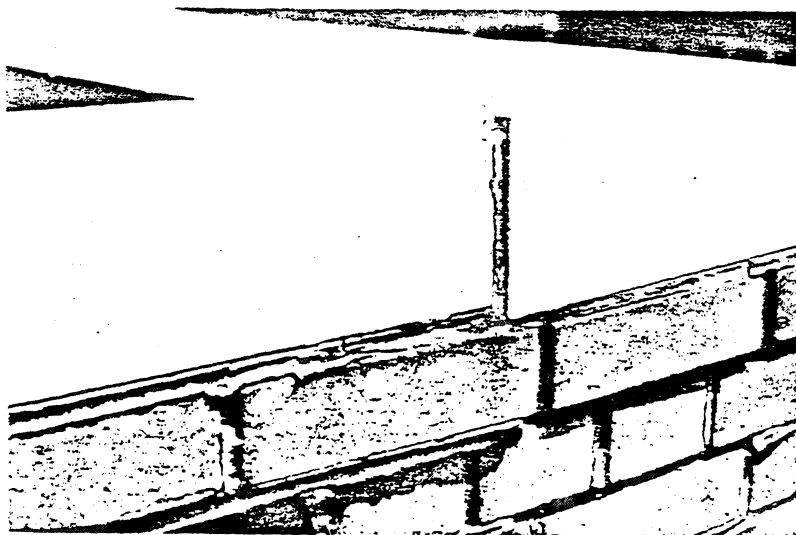
Disruption of masonry (Figure 1) occurred during the first winter after occupancy, at the top of the walls of a masonry-clad, steel-frame, humidified building. With the aid of smoke, it was determined that air was leaking outwards through the unplastered portions of the masonry walls (e.g. above suspended ceilings) and through cracks between structural elements and the masonry. Moisture accumulations (due to condensation) were found to be concentrated adjacent to air leakage paths. Further examination showed that the same problem occurred below window sills (Figure 2). Figure 3 indicates the construction, and patterns of air leakage and condensation at the window sills. The moisture and thermal conditions in both these cases were conducive to the growth of ice lenses [4] in the mortar joints, which caused the disruption of the masonry and lifting of window sills. Other

Figure 1. Disruption of masonry by frost action in wet materials.

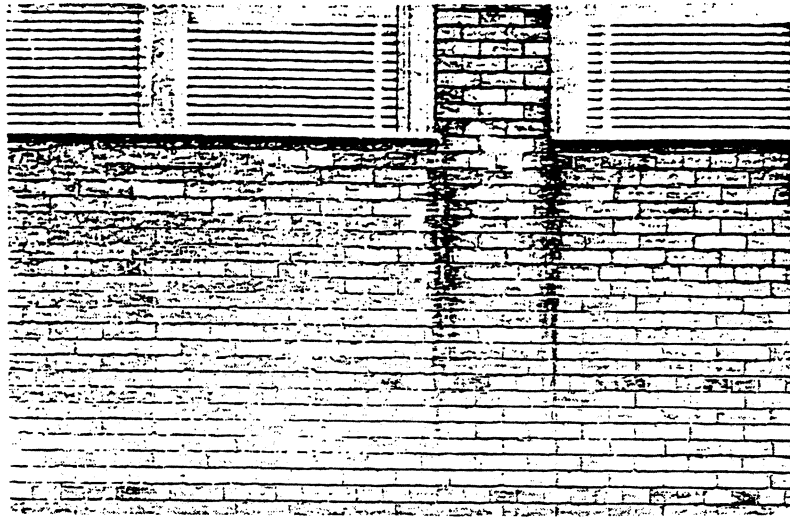
Figure 2. Damage to masonry at window sills as a result of excess moisture from condensation associated with air leakage.

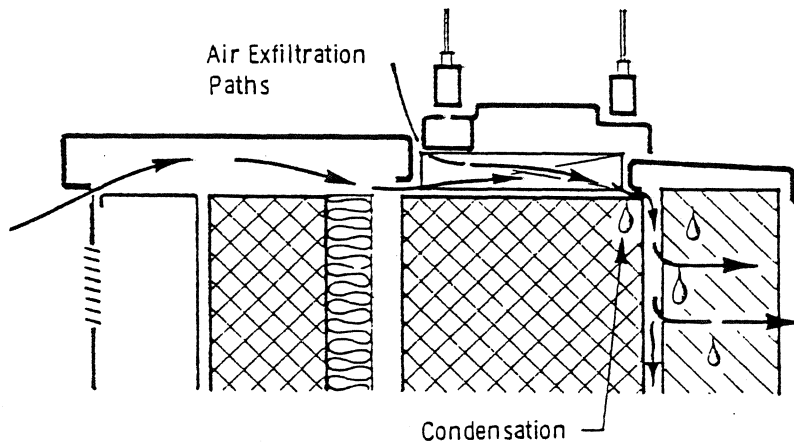
Figure 3. Diagram of window sill showing air leakage paths and location of condensation.

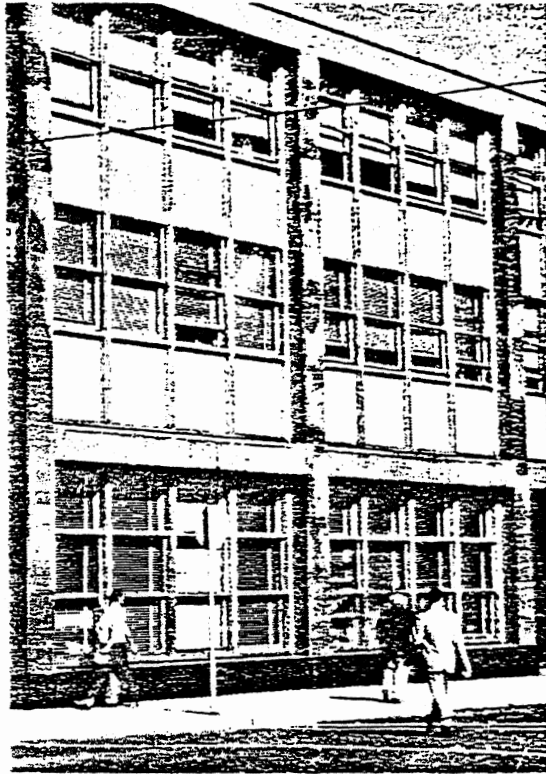
Staining and stone displacement occurred in a building (Figure 4) due to moisture accumulation in the column cladding. The building was not intentionally humidified but the walls were relatively airtight and the mechanical system was inoperative, so that moisture added to the air by breathing, floor washing, and melting of snow from footwear caused a moderate increase in humidity. The humidity level was not constant nor was it sufficient to produce objectionable condensation on the double glazing or metal window frames.

Figure 4. Condensation from air interchange between the building and spaces within the wall produced stains, discolorations and stone displacement.

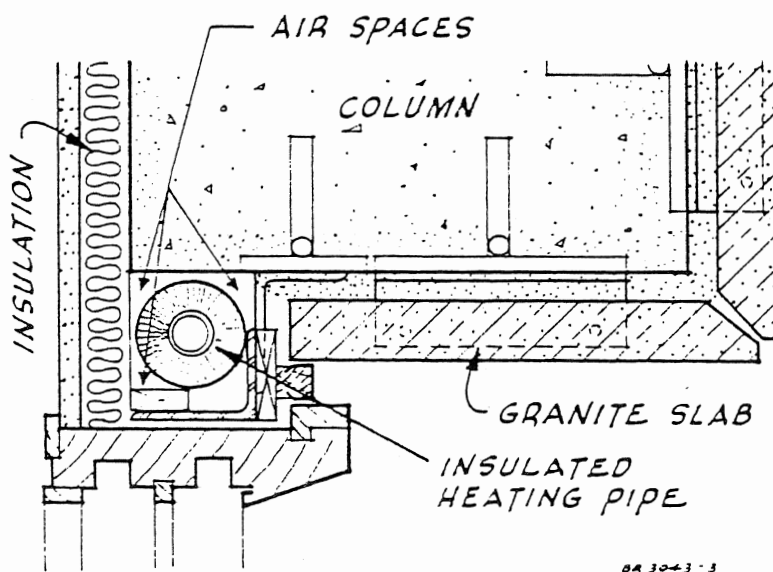
The window jamb detail in Figure 5 shows that the insulated mechanical lines were concealed in wall spaces outside the building insulation. Above the suspended ceiling, the wall finish was omitted and near the floor, the run-outs serving the bank of heating convectors passed through the wall finish. Air interchange between the building and the pipe spaces due to chimney action resulted in condensation on cold surfaces whenever the humidity was high enough. Since it accumulated as frost, sustained conditions for condensation were not necessary to provide a large quantity of water. Upon thawing, most of it was absorbed by the backup mortar. Refreezing of the water in the mortar produced ice lenses that displaced the column cladding stones (Figure 6). Once the cladding was displaced, air exfiltration increased and contributed to the moisture accumulation, as did rain penetration at certain times of the year.

Figure 5. Window jamb detail showing spaces within the wall.

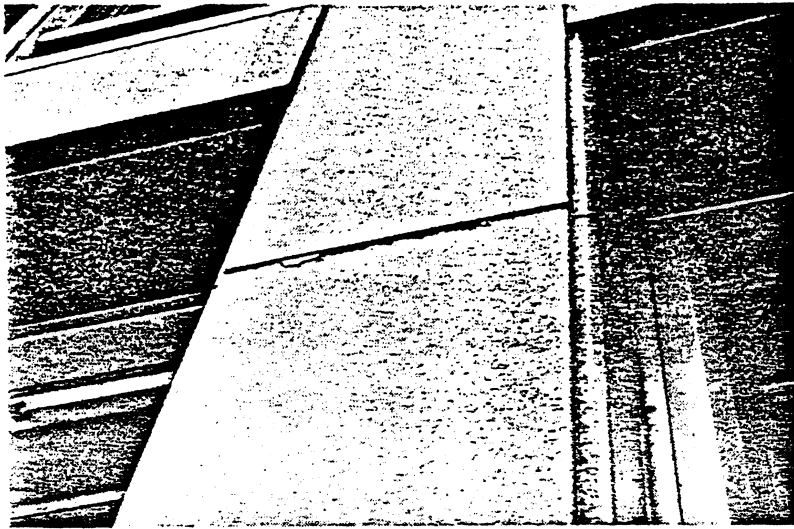
Figure 6. Spalling and displacement of column cladding.
