## Details of the First-Round Retrofits at Twin Rivers

DAVID T. HARRJE

*The first-round retrofits at Twin Rivers were directed to isolating the attic from the living area and basement, reducing air flow around windows and doors, and reducing heat flow from the forced-air distribution system to the basement. Details of materials used and their placement are presented. The design of the first experiment is also given. These retrofits were grouped into four packages and were deployed in phases over a single winter in twenty-four instrumented townhouses of identical floor plan.*

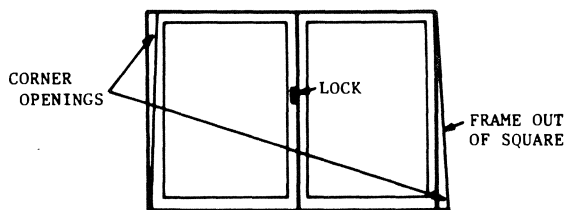
The object of this retrofit is to limit the amount of air infiltration resulting from crack openings, especially around windows and doors. The leakage around windows has been traced to three causes: (1) the lack of squareness of the window frames, leading to open spaces even with the windows shut, either these frames were installed as a parallelogram (see Fig. 1) or the house settled after the window installation; (2) the poor condition of the seal between the glass and aluminum frame; (3) air channels past the molding surrounding the window. Leakage around the patio door was found to have similar origins. Leakage around the front door was found to be the result of a poor alignment at the threshold and the poor condition of the magnetic seal strips on the sides and top of the door.

Fig. 1. Poor fit of window in its frame.

The windows were improved in the following manner. The normal seal on the sliding window, which relies on a stiff fuzz strip, was augmented by the use of closed cell vinyl foam strips 0.5 cm × 1.0 cm (3/16 in. × 3/8 in. cross-section) attached to the sliding windows (see Fig. 2). The lock mechanism was also adjusted to force the windows into the frame. Where the metal frames were attached to the wood frame, where the glass was attached to the metal frame, and where the wood molding was attached to the wall-

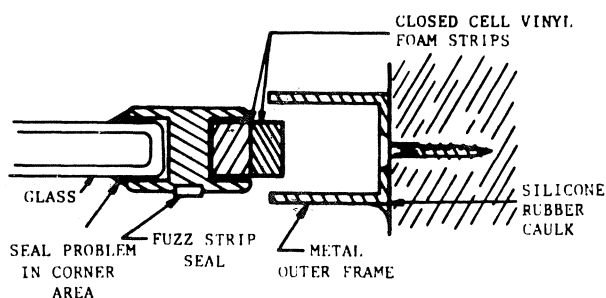
Fig. 2. Window seals.

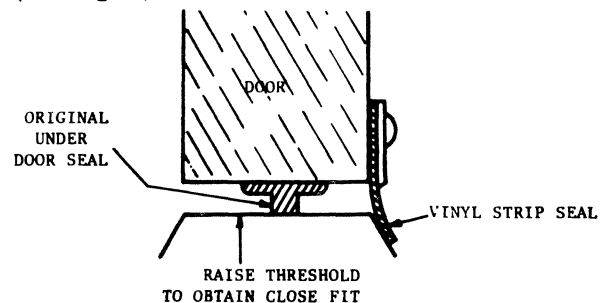
Fig. 3. Door seals — bottom.

The front door sill was adjusted in height to meet the original seal surface on the lower portion of the door. When this alone was inadequate, an additional strip of vinyl with aluminum backing was screwed to the door (see Fig. 3).

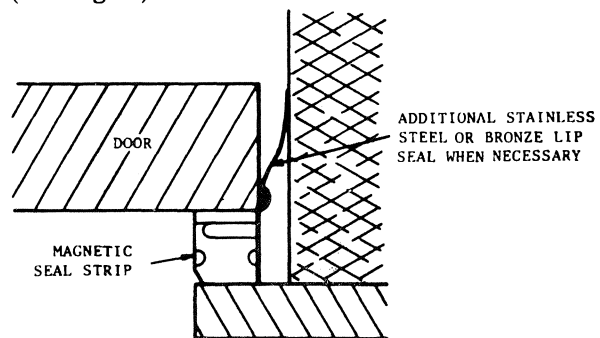
Fig. 4. Door seals — sides.

The magnetic seals on the sides and top of the door opening were repaired where problems, particularly corner gaps, were found. In a few cases an additional lip seal was added (see Fig. 4).

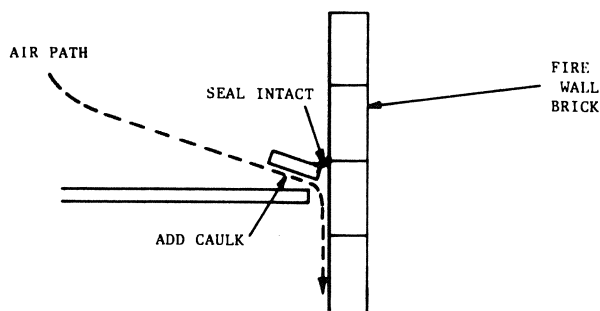
Exterior caulking was used around the patio door frame and the closet overhang. When the vertical joint between masonry and frame was inspected, it was found that the principal cause for infiltration (as first suggested by the infrared photographs) was

Fig. 5. Passage for outside air at edge of facade.

warping of the batten in the batten-board homes (see Fig. 5). In these homes a caulking joint was made, using the appropriate color polysulfide synthetic rubber sealant or clear silicon rubber sealant.
