PRESSURISATION TESTS OF SELECTED APARTMENTS AS A BASE FOR ANALYSIS OF NATURAL VENTILATION IN MULTI FAMILY BUILDING

J. Sowa

Warsaw University of Technology, Institute of Heating and Ventilation, Warsaw, Poland

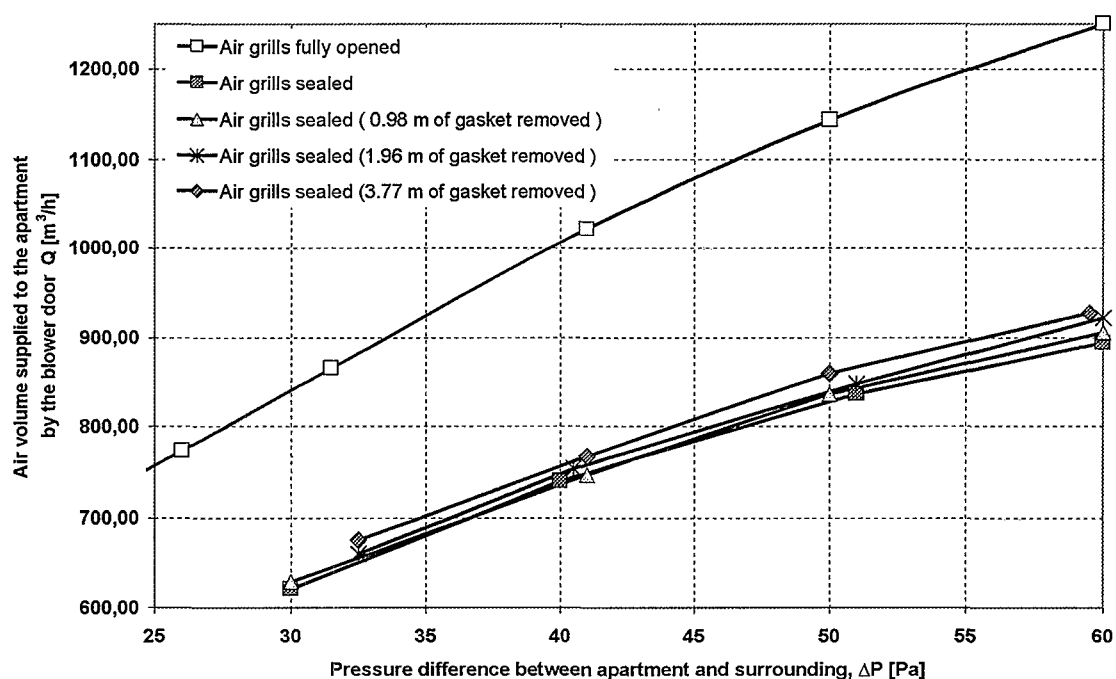
Figure 2. Influence of length of removed gasket on pressure characteristics

One apartment has been pressurised several times to investigate the influence of air sealing of windows on their infiltration coefficient. Additional tests were performed with ventilation grilles and gas flue sealed and partly removed gasket (0.98 m, 1.96 m and 3.77 m). The results are presented at figure 2.

Changes of pressure characteristics indicated (fig 2) that in tested apartment simple air-sealing of windows with "o"-ring gaskets decreased infiltration coefficient of windows by approximately $0.2 \text{ m}^3/\text{h}\cdot\text{m}$ at 10 Pa (reference pressure in Poland). Estimation results can not be generalised for whole building. Probably the more leaky windows were the bigger improvement was made.

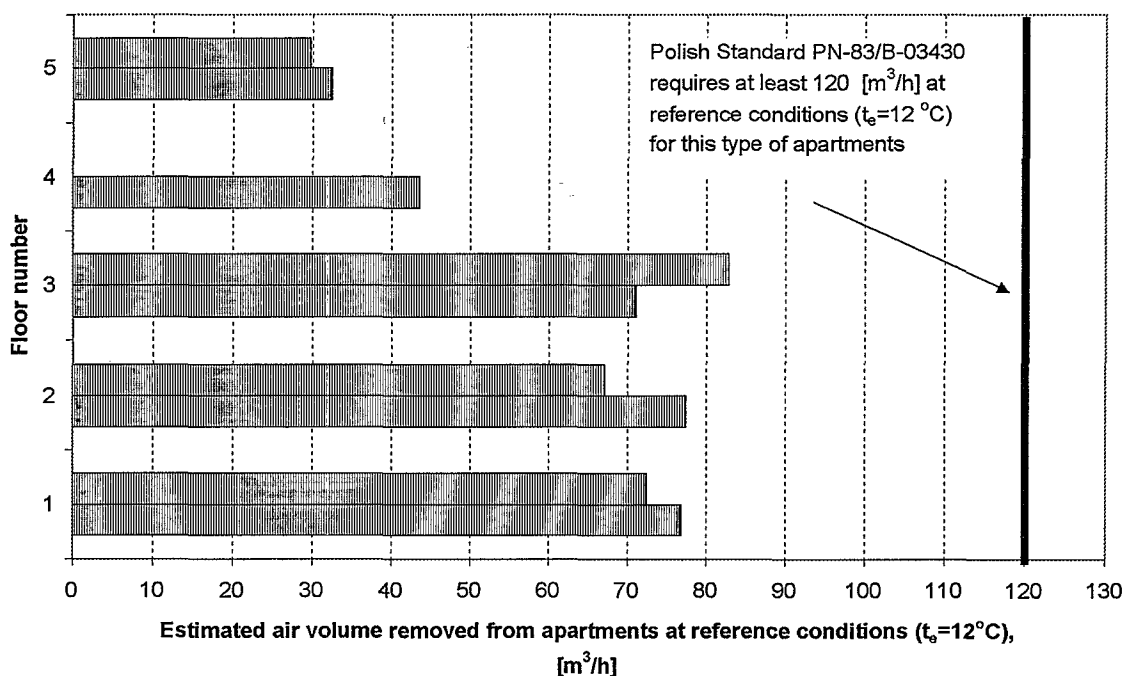
Figure 3. Estimated air volume vs. requirements of Polish standards

Air volumes in all tested buildings are less than minimum required by building codes and standards (from 24.7% to 69% of requirements). Moreover, air volume exhausted by the stacks from apartments at 4 and 5 floors is much lower than from apartments located at floor 1 to 3 (figure 3). This indicates that cross sections of ventilation stack are not dependent on magnitude of driving forces decreasing, off course, with floor number.

Pretty tight windows are not the only one reason of too low air change rates. Additional calculations have been performed for the reference temperature ($t_e = 12\text{ }^\circ\text{C}$) and the case when windows are ajar (there is no pressure drop during outside air supply). Estimated air volumes removed by stacks from different apartments vary from 29.0% to 95.8 % of volumes required by the Polish Standards. It indicated that existing stacks do not perform well.
