# Mold in dwellings: field studies in a moderate climate

Hugo S.L.C. Hens

*K.U.-Leuven, Department of Civil Engineering, Laboratory of Building Physics  
B-3001 Leuven, Belgium*

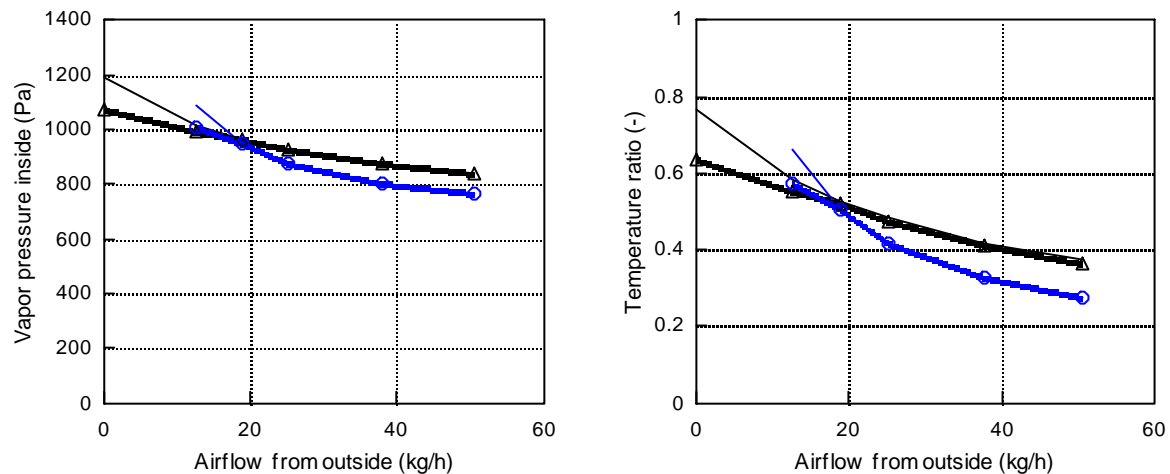
Figure 1 Sleeping room in series with a bathroom, inside vapor pressure and critical temperature ratio during the month of January ( $\theta=2.7^\circ\text{C}$ ,  $p=663$  Pa). Black gives the results with inflow from the bathroom, blue without. The thick lines stays for 2  $\text{m}^2$  of single glass in the sleeping room, the thin lines for double glass and better.

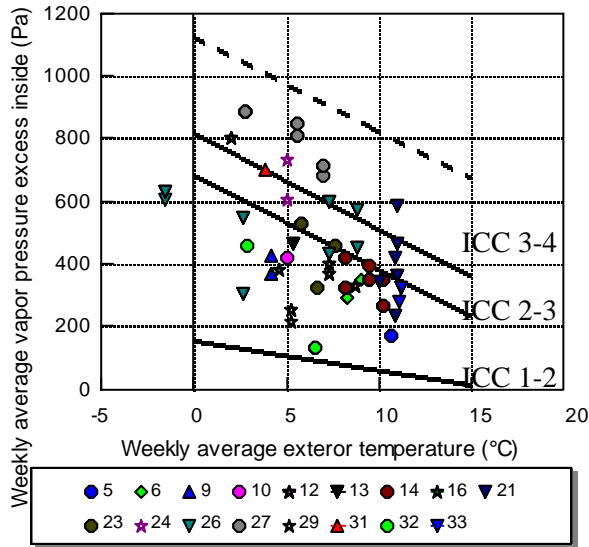
Inside temperature, inside relative humidity and inside vapor pressure excess were measured in the 17 cases with asterisk. Figure 2 compares the weekly average with the indoor climate class thresholds as used in Belgium. The dashed line gives the limit between indoor climate class 3 and 4 for Ukkel, Belgium, as proposed by Annex 24 (Sanders, 1996). Apparently, moldy residential buildings are not excessively humid. Of the 17 cases measured, only 12, 21, 23, 24, 26 and 27 belong to ICC 4, building with high indoor humidity. Case 12 struggles with rain penetration, while the cases 21, 23, 24, 26 and 27 are all too air-tight for adventitious ventilation.

Figure 2 Weekly mean inside vapor pressure excess as function of weekly mean exterior temperature. The numbers refer to the case in the matrix

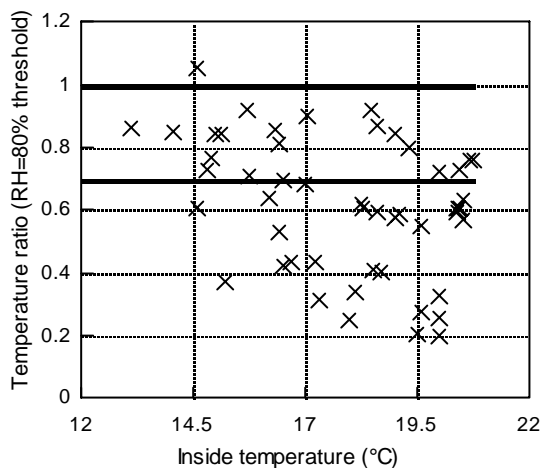
Figure 3 Temperature ratio for the RH=80% threshold.

We also calculated the temperature ratio needed too prevent mold from developing, using the monthly mean threshold of 80%. Figure 3 summarizes the result. One point passes a ratio 1. Reason: the very high relative humidity inside in that case. The figure underlines that a temperature ratio 0.7, a value advocated as an acceptable 5% risk reference, may not be as safe as supposed.

In fact, in twelve cases a value higher than 0.7 is needed to prevent mold from developing. However each case could be explained. Ten concern bedrooms. In moderate, humid climates, bedrooms are poorly heated which leads to a high relative humidity inside (Sanders, 1996). In case 5 a cupboard was fixed against the outside walls hindering heat exchange with the room. Case 12 suffered from rain penetration. The cases 9, 16, 21, 23, 24, 27, and 32 showed insufficient ventilation (building too airtight). We should therefore handle the 0.7 temperature ratio not as a stand-alone assurance but add four requirements: ventilation guaranteeing good IAQ, only vapor produced inside as moisture source, enough heating, U-values low enough to give a temperature ratio 0.7 behind cupboards. Also, quite clear from the matrix, we practically always look to rooms with 2, 3 or 4 exterior walls. This lowers the radiant heat exchange between surfaces.

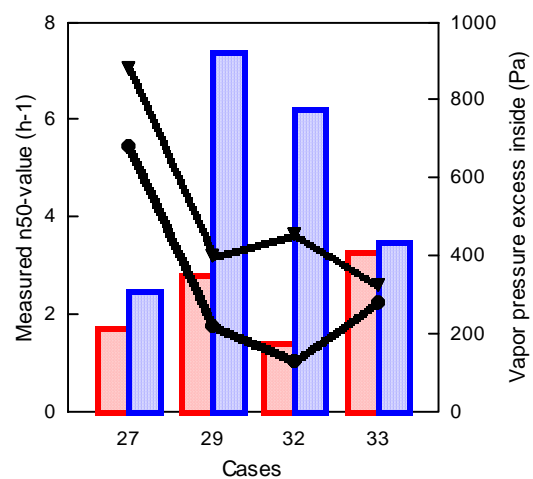
Figure 4  $n_{50}$ -values. Red bars for ventilation grids sealed, blue bars for ventilation grids open. The black lines give the minimum and maximum weekly mean vapor pressure excess inside

Finally, the air-leakage measurements,  $n_{50}$  in column 1, are shown in figure 4. With the ventilation grids sealed, air-leakage in all four cases was too low to assure enough adventitious ventilation. In case 27, opening the few grids (kitchen hood, toilet vent) had no effect. In case 29 it seems as if the grid system is well dimensioned. This is not. Each room got a ceiling outlet but no inlet. In case 32 the apartments were equipped with extract ventilation. Some inhabitants however removed the fuses (fans are somewhat noisy). Case 33 finally had hardly a grid to open! Anyhow, only case 27 reflected air-tightness in the vapor pressure excess measured. Main reason: quite some window use in cases 29 and 33, correct usage of the extract ventilation in most apartments in case 32.
