Case Study Field Evaluation of a Systems Approach to Retrofitting a Residential HVAC System

I.S. Walker, J.A. McWilliams and S.J. Konopacki

September 2003

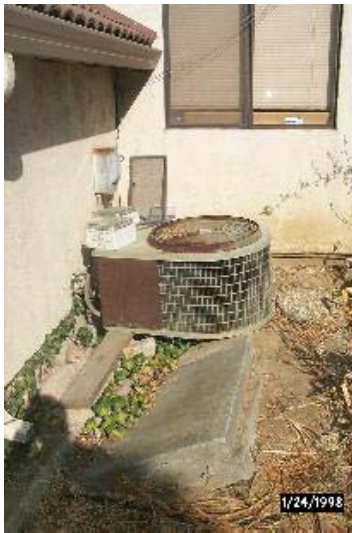
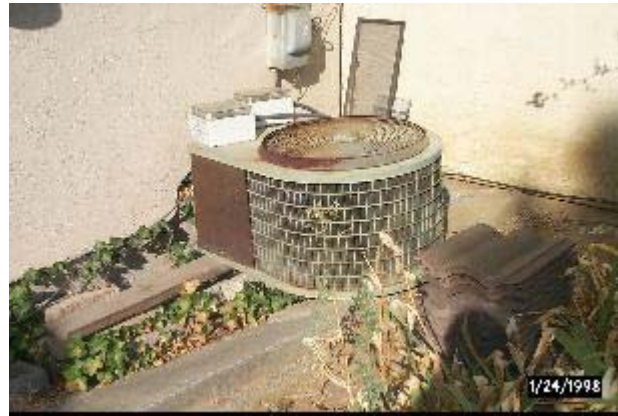
The house had the following combination of problems: low-efficiency heating and cooling equipment (**Figures 3** and **4**), leaky and poorly insulated ducts (**Figure 5**), and a leaky exterior envelope (also in **Figure 5**). In addition, the air handler, furnace, cooling coils and most of the duct system were located outside the conditioned space in the garage and attic. A few major components of the shell leakage were easily identified in this house: several large mechanical chases that were open to the attic, as well as a building cavity return that was open to the garage and the attic. The HVAC system was undercharged and operating at only 2/3 of its rated capacity. We suspected that the refrigerant line had a leak due to the low charge in the system. Also, the homeowner reported problems in cooling the upstairs of the house.

Figure 4. Existing AC condensing unit outside near rear of garage showing poor condition of unit [heavily corroded sheet metal fasteners and significant dirt/dust accumulation blocking flow into coil] and subsided slab [stressed refrigerant tubing and subsequent leakage of refrigerant].

3. A downsized *Amana Prestige Ultra RCE* high efficiency split system air-conditioning package consisting of a remote condensing unit (RCE36A2D) and an over-sized cooling coil (Aspen BBL48+X2: 48 kBtu/h (14 kW)) was selected with the following specifications: 36,000 Btu/h (10.5 kW) nominal capacity, 0.73 SHR and 14 EER at standard conditions and 1200 cfm. A Seasonal Energy Efficiency Ratio (SEER) of 12 or greater is the standard for an Energy Star® qualifying central air conditioner. The cooling coil was relocated from the garage to the attic. The condensing unit was relocated from a sun-exposed area behind the garage with unstable soil to a shaded area

on the opposite end (north) of the house with a new slab on stable soil as shown in **Figure 8**. The old unit was placed on a very poor slab that has tilted considerably.

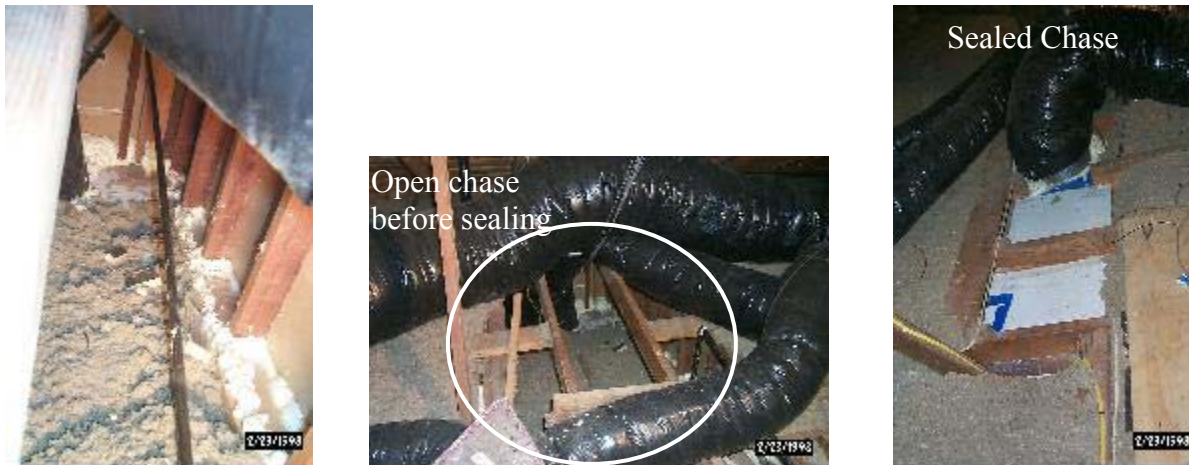
Figure 6. Sealing cavities connecting the house to the attic. Foam is a useful sealing tool for small holes and cracks at building component intersections (left). Duct board insulation can be used to block off large open areas (center and right)

1. The sealing of the envelope was very successful – mostly because this particular house had significant large leaks that we were able to access. We sealed over 1200 cfm of leakage at 50 Pa (about one-quarter of the total leakage). The sealing included: air-sealing of the attic floor plane (2 large chases) as shown in **Figure 6**, the installed Therma-Dome (attic pull-down staircover), leaks between the old return (which communicated with the garage) and the conditioned space, and plumbing penetrations in the conditioned space.

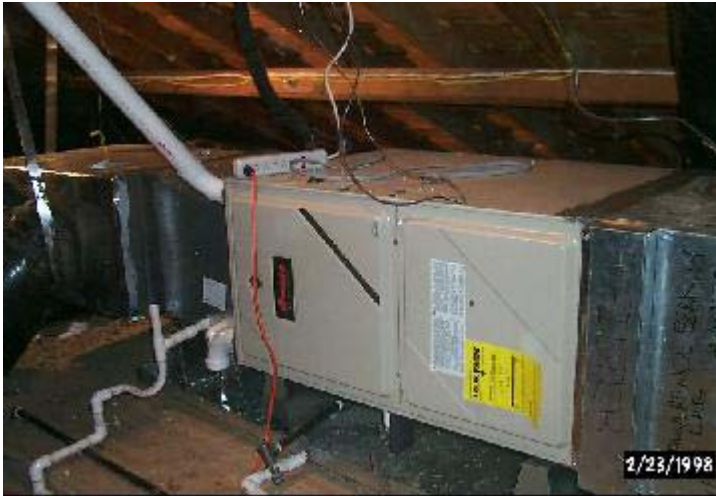
Figure 7(a). New cooling and heating equipment on attic floor [right to left: return plenum, air filter, air handler, furnace, cooling coil and supply plenum].

4. The existing gas furnace and air-handler were removed from the garage and replaced with a downsized high-efficiency unit in the attic to allow for the use of an economizer. An Amana Air Command 95IIQ GUYA horizontal flow variable speed two-stage gas furnace (GUYA070BX40) with a $\frac{3}{4}$ hp blower motor was selected with the following specifications: 66,900 Btu/h (20 kW) high-fire rate output, 46,400 (13.5 kW) Btu/h low-fire rate output and 95.5 AFUE at standard conditions. In direct vent mode, this furnace is designed to draw combustion air from the outside; however it was installed to draw combustion air from the attic. The furnace flue pipe was installed through the roof as shown in **Figure 9**. The air handler is equipped with a General Electric ECM (Electronically Commutated Motor) (2.3 Series). These motors are advertised to be 20% more efficient than a standard motor at full load and 30% more efficient at low speed. The DC design allows the fan speed to be easily adjusted over a large continuous range of speeds. The new system used a control strategy that slowly increased the air handler speed at the beginning of each cycle. Another advantage of these motors is that the torque does not change much with an increase in load so the fan is able to overcome ductwork resistance, and deliver a given airflow regardless of duct restriction.

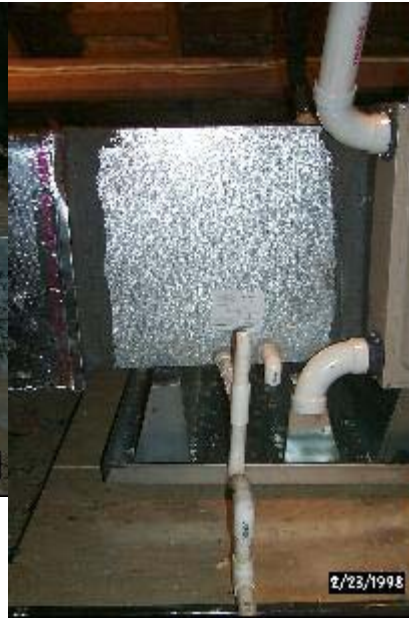
Figure 7(b). New cooling coil with condensate drains and top of furnace with combustion air intake and exhaust.

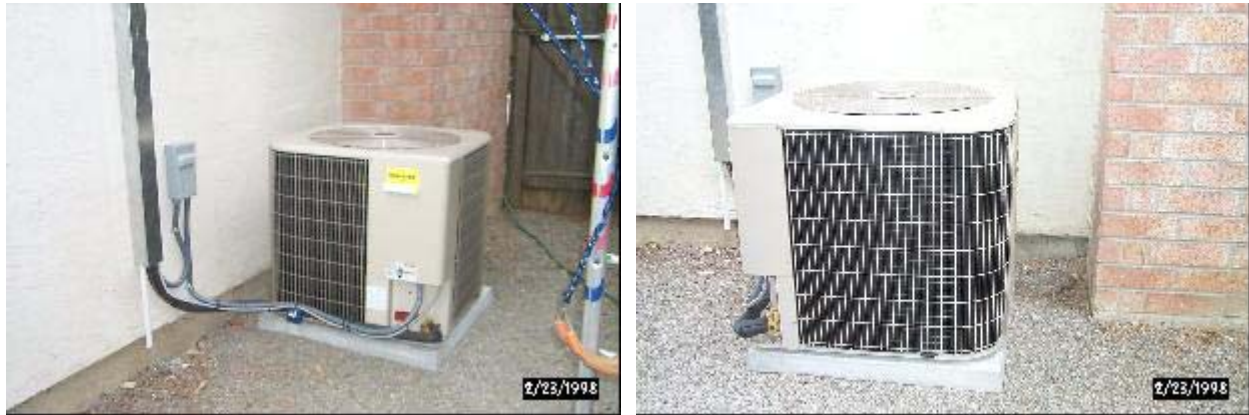
Figure 8. New AC condensing unit on shaded side of house.

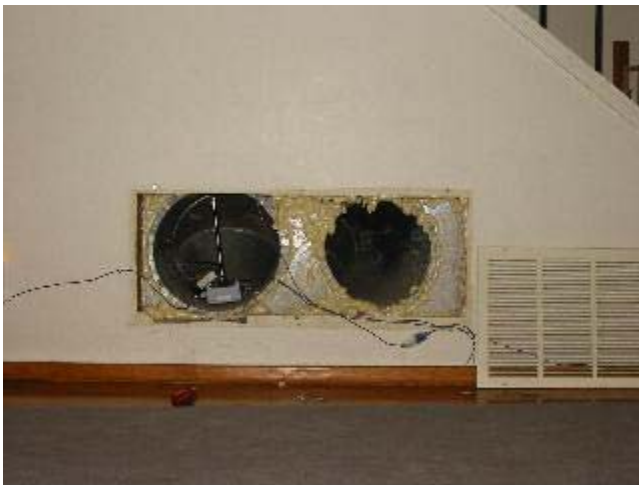
Figure 16. Duct sealing of downstairs return using foam. [the sensor that is visible is a relative humidity sensor, there is also a temperature sensor in the duct].

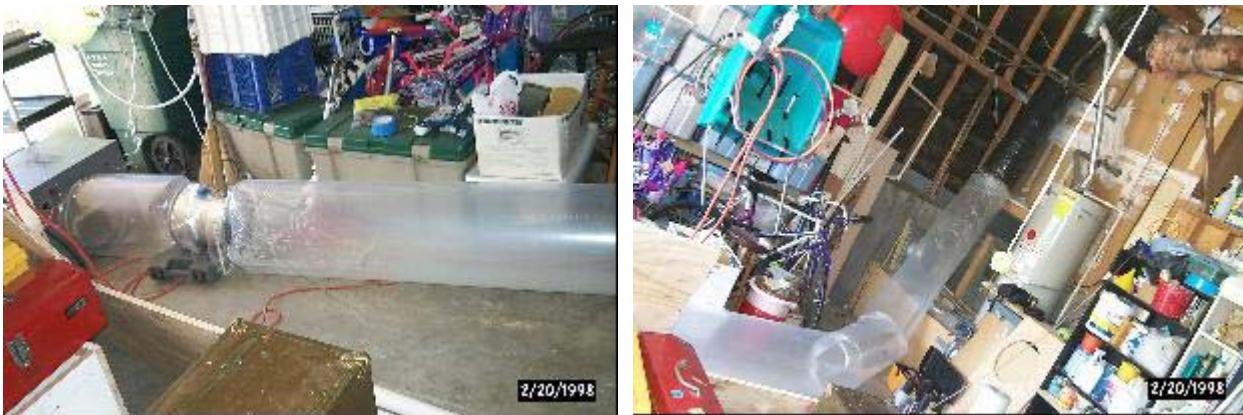
Figure 17. Aerosol apparatus for duct sealing in garage.

14. Our goal was to seal supply and return ducts to less than 10% of air handler flow, which is the standard for best practices (e.g. Energy Star Ducts). The ducts were sealed using manual methods and with the aerosol method developed by LBNL. But we did not meet this specification (14% return leakage, 9% supply leakage) due to excessive leakage at the economizer outdoor air damper. **Figure 16** shows the duct sealing using foam of the downstairs return. The aerosol method internally seals leaky ducts by injecting an aerosol sealant into the duct system as shown in **Figure 17**.
