Monitoring of the Building Envelope of a Heritage House A Case Study

Abstract

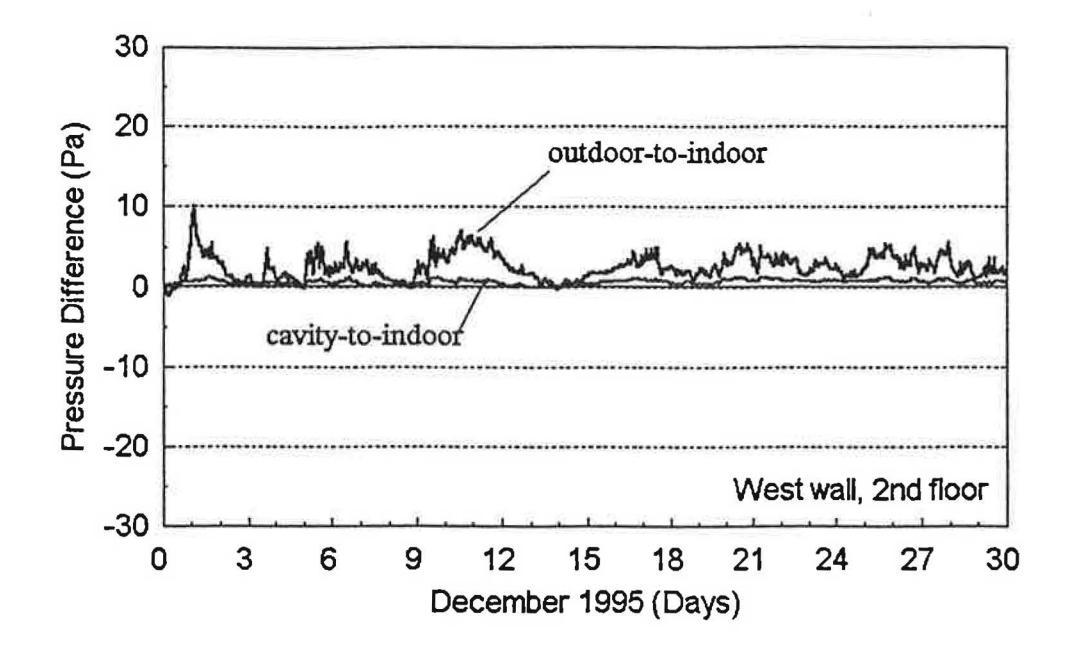
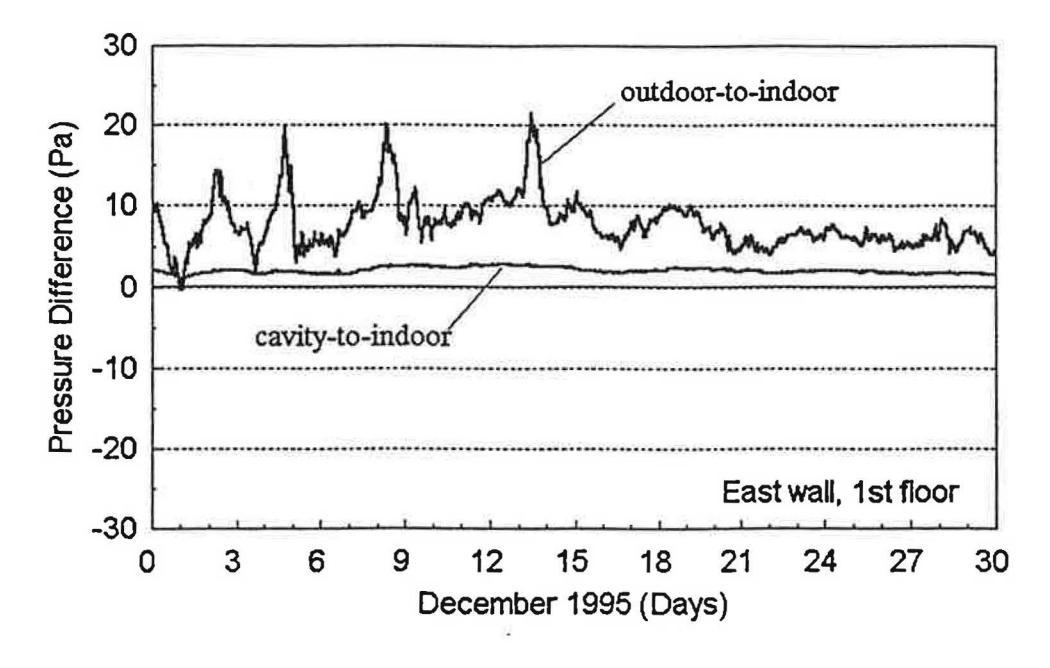
<u>Figure 4:</u> Pressure differential, outdoor-to-indoor and wall cavity-to-indoor, December 1995.

The indoor air pressures (hourly average) were below the outdoor air pressure at the locations monitored (for example, during Dec. 95, mean values were 7.7 Pa & 2.5 Pa for the first and second floors respectively, Fig. 4). The air pressure in the wall cavity was also higher than indoor air pressure (during Dec. 95, mean values of 2 Pa & 0.6 Pa for first & second floors respectively). The negative indoor air pressures essentially eliminated the leakage of the humid indoor air into the wall cavities and thus eliminated the potential for condensation on colder cavity surfaces. On the other hand, cold exterior air travelled through wall spaces, ceiling spaces and openings in the interior surfaces. This caused localized cold spots and ice formation on interior surfaces in several areas including walls and ceilings that have connection to the outdoors. This led to condensation and crack development. The latter was probably caused by dimensional changes due to changes in moisture content and temperature of the wall and ceiling materials.

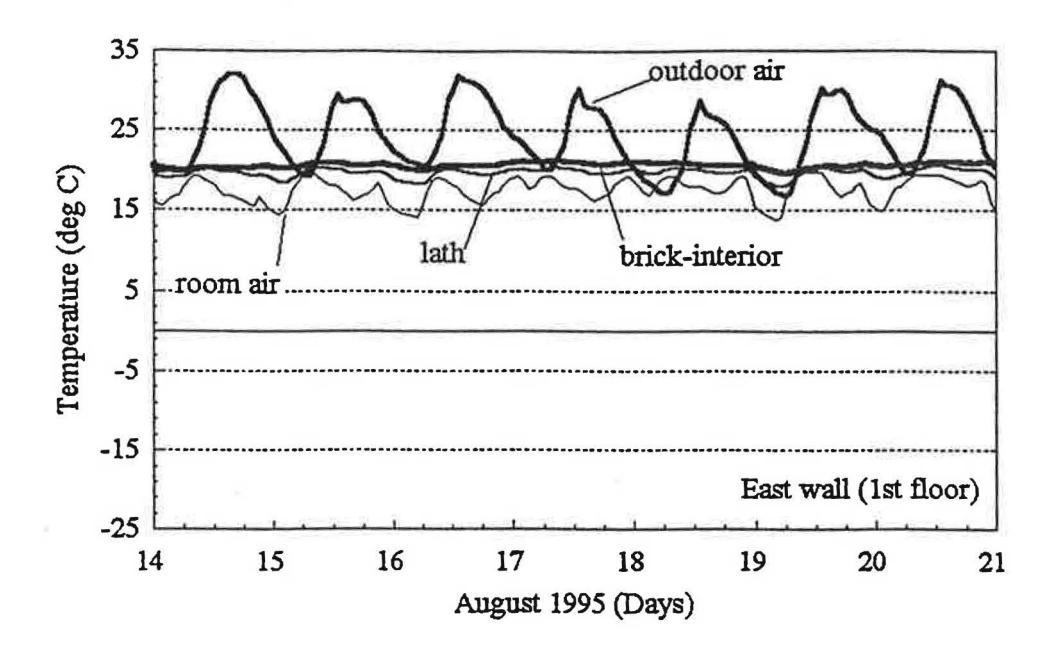
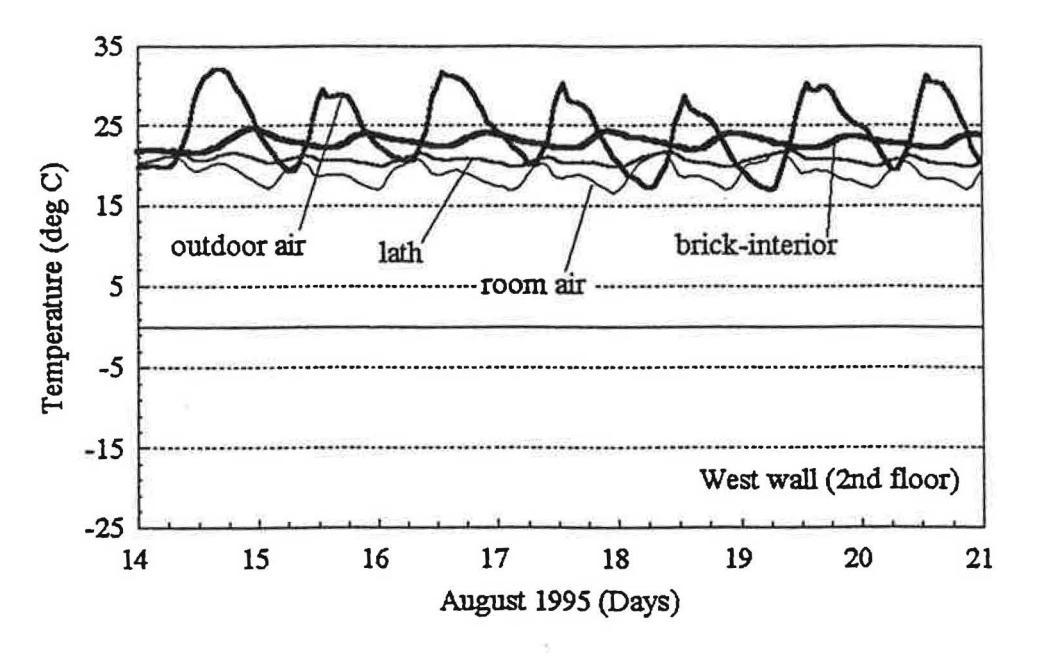
<u>Figure 5</u>: Temperatures of brick interior surface and intermediate lath within wall cavities and indoor and outdoor air, for selected periods in August 1995.

Indoor temperatures: During the summer, indoor air temperatures varied between 13°C and 22°C. Figure 5 shows that indoor air temperatures frequently dropped to 13°C during the night and rose to over 20°C the following morning. The figure also shows that indoor air temperatures tend to follow the diurnal variations in outdoor air temperature with a lag of about 12 h. This suggests that the HVAC system, which operated continuously, had limited control of indoor air temperatures especially during the summer. During the winter the variation was small (typically 20 to 23°C; Fig. 6) because the radiators had individual thermostats.

Wall-cavity: The variation in the surface temperatures of the brick and the lath within the wall cavities (air spaces in the walls) generally followed the daily average of the outdoor air temperature partly due to the damping effect of the thermal mass of the masonry wall (Figs. 5 & 6). The variations of surface temperatures in the east wall-cavity were less than those for the west wall-cavity surfaces. This is because the east wall is shaded by a neighbouring highrise building and a large tree. In addition, a west wall normally receives more sun than an east wall.

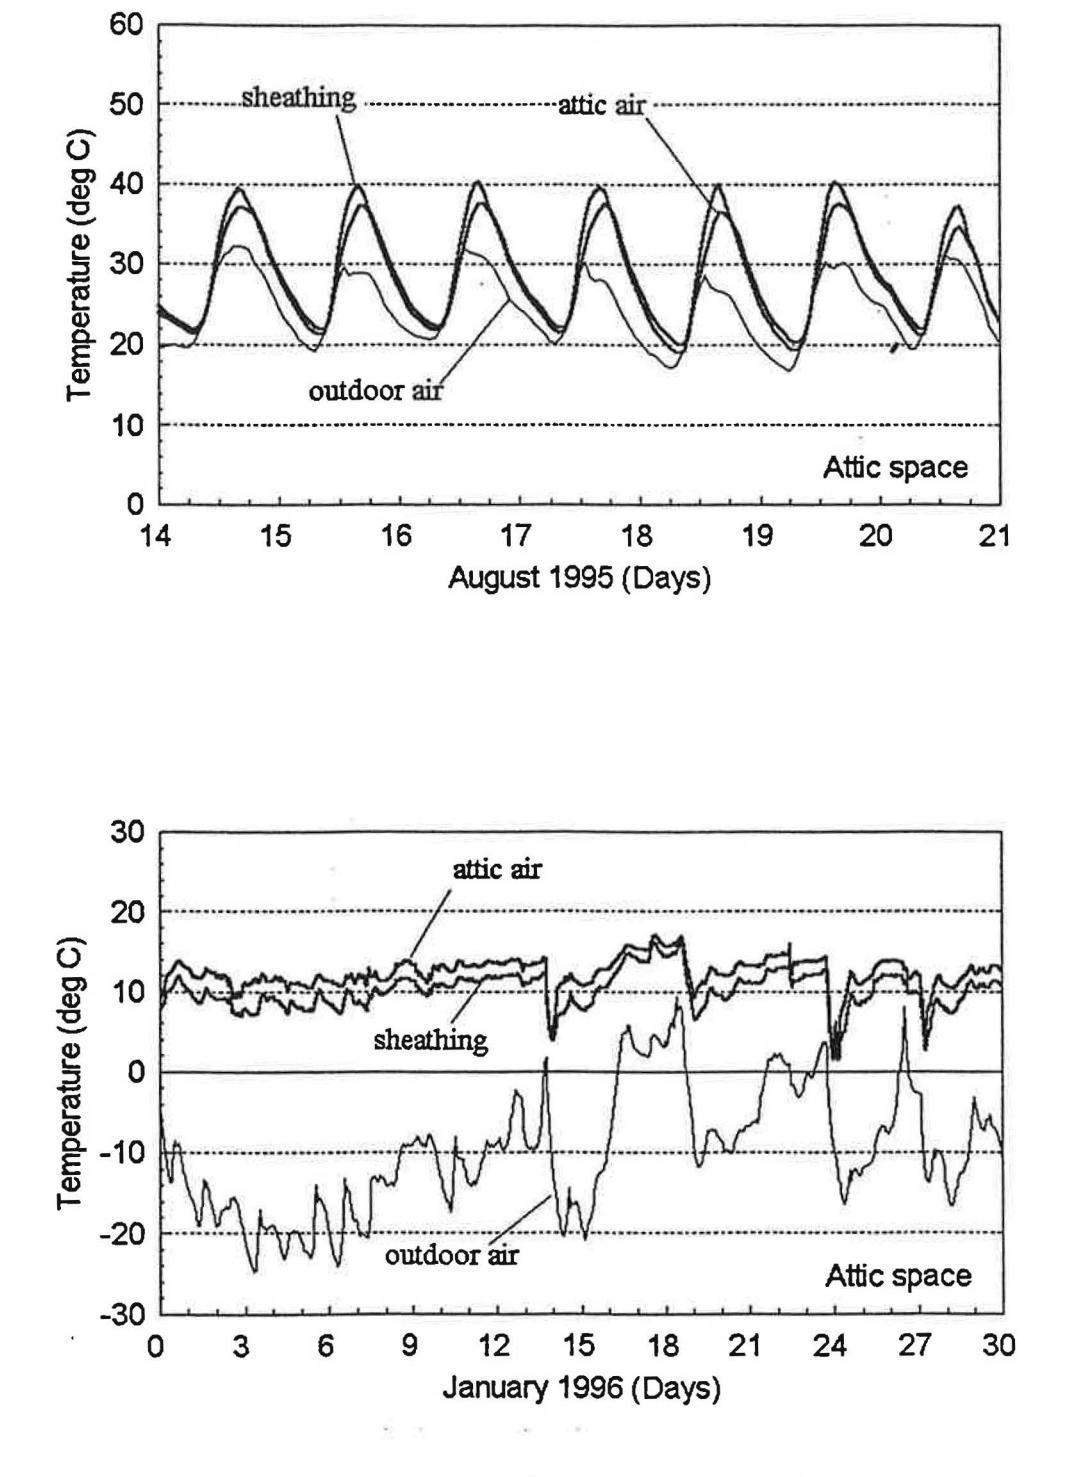
<u>Figure 7</u>: Temperatures of roof sheathing, attic air and outdoor air, for selected periods in August 1995 and January 1996.

Attic space: Figure 7 shows the variation of temperature in the attic space above the third floor mechanical room during winter and summer. Solar heat caused a large increase in the roof sheathing and attic temperature in the summer. In winter the roof sheathing and air temperature were more stable and were usually much higher than the outdoor air temperature (15-20°C higher; the temperature only approached the exterior temperature on windy days). This indicates a large heat loss into the attic space with the major part probably caused by air leakage. This also explains the ice-damming which is a problem on this building.

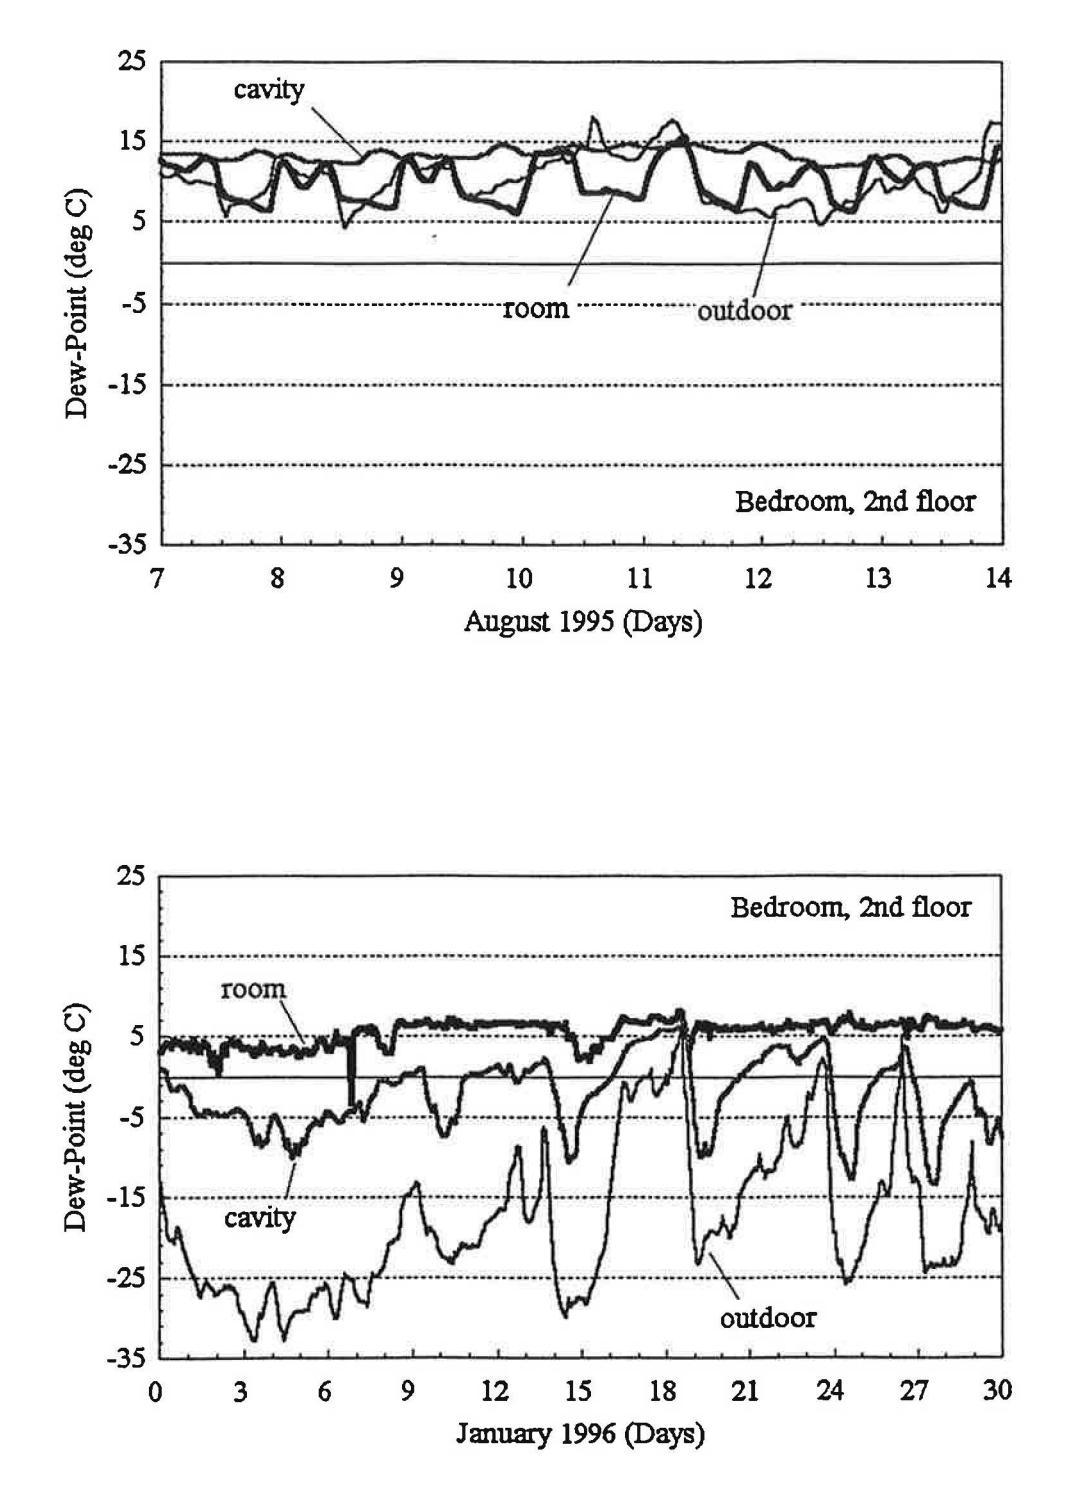
<u>Figure 8</u>: Dew-point of room air, wall cavity air and outdoor air, Mr. King's Bedroom (west wall, 2nd floor), for selected periods in August 1995 and January 1996.

Indoor air: The RH of the indoor air varied from room to room and also from month to month (Table 1). It far exceeded specified indoor conditions. The variation in RH during August was partially due to the large variation in indoor air temperatures. Figure 8 shows that variation in indoor air dew-point during August had a diurnal variation similar to the outdoor air dew-point (the dewpoint is representative of the moisture in the air). Measured RH during the summer shows that the HVAC system did not adequately control the relative humidity. Possible causes may include improper operation, location, or type of the humidistat; faulty controller operation; or insufficient dehumidification capacity of the HVAC system.

Wall cavity: The RH in the wall-cavity exceeded 60%. Figure 8 shows little variation in the cavity air dew-point during the summer while in winter it followed the variation in outdoor air dew-point. The results also indicate that, during summer, the brick is drying into the cavity air which led to higher dew-point in the cavity than in the indoor air.

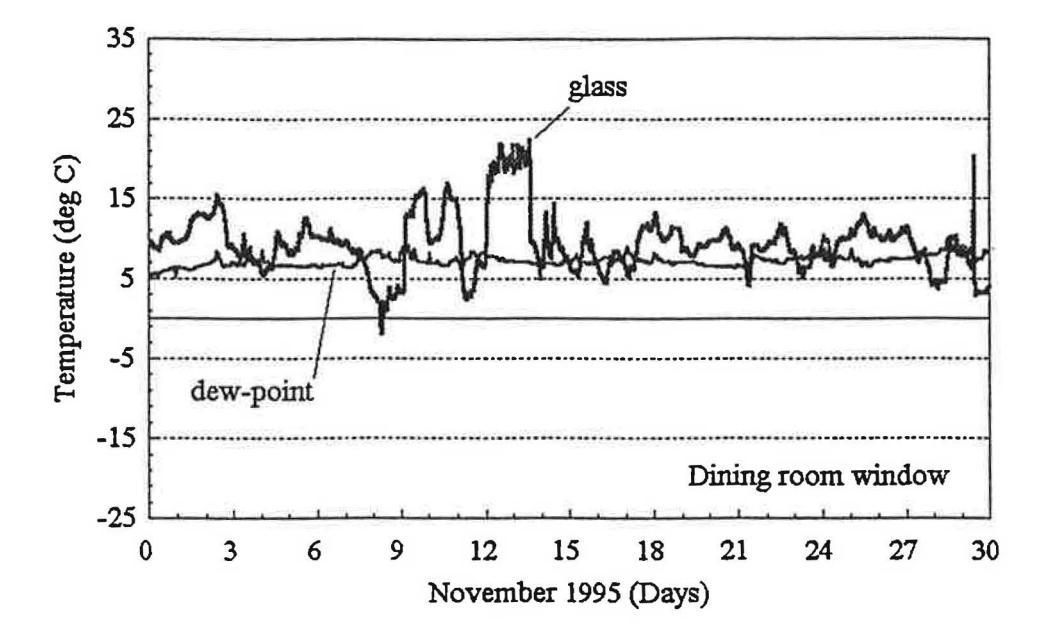
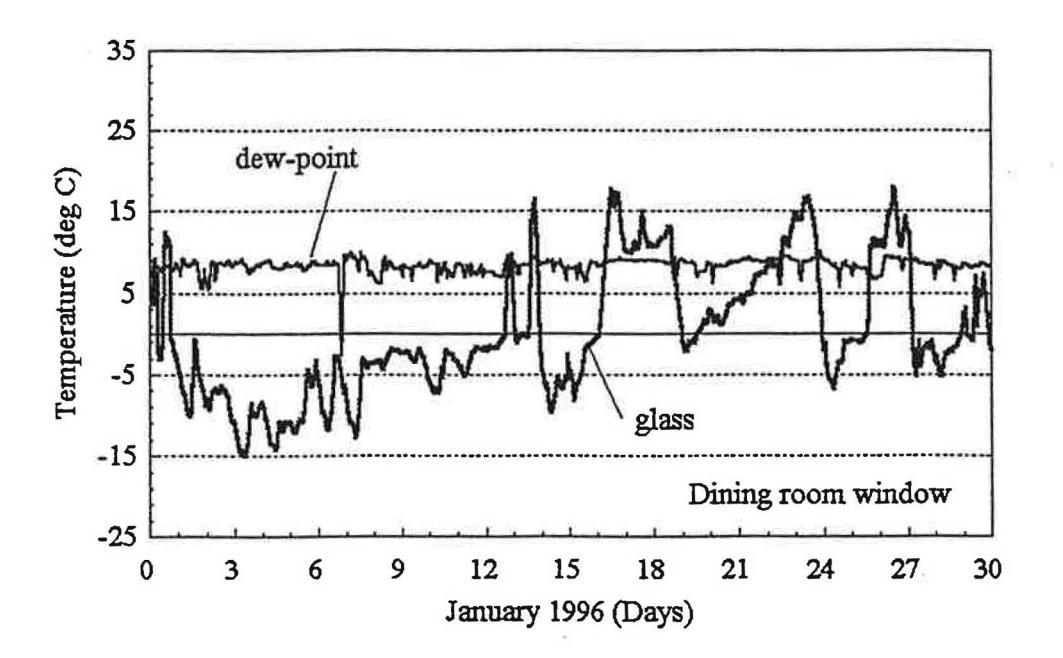
<u>Figure 9</u>: Temperatures of dining room window glass (single-glazed) and dew-point of indoor air, November 1995 and January 1996.

Windows: Extensive condensation and ice buildup was observed on the singleglazed window during the winter months. The surface temperature of the singleglazed window in the dining room dropped below the dew-point for several days during November and for most of January (Fig. 9) and apparently below freezing. Water stains and wood swelling were evident on the sill of the dining room window.

The windows require immediate attention. The high indoor humidity has caused excessive condensation on the windows. To reduce the adverse effect of condensation on the durability of the windows, the thermal performance and airtightness of the windows should be improved. Thermal performance could be improved by using double glazed storm windows. In this way the historic value of the windows would be least affected. The original storm windows can be kept in storage.
