Sample Thermographic Images

INFRARED THERMOGRAPHY

BUILDING SCIENCES LTD

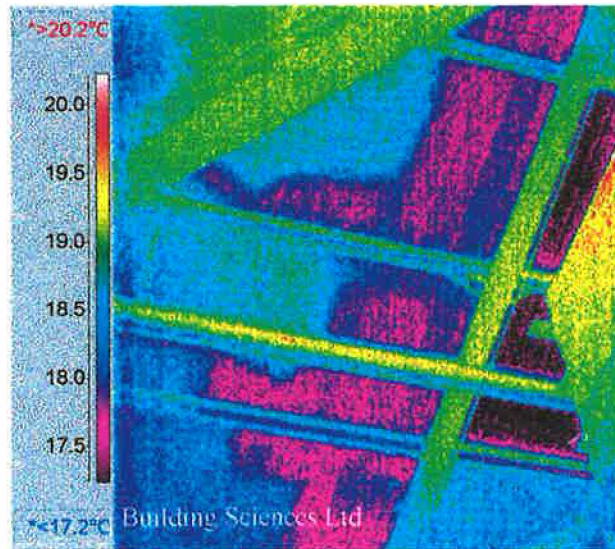
Warehouse Roof Internal Survey

This warehouse roof is a twin skin construction with man made mineral fibre insulation sandwiched between. The dark blue area indicates where this insulation has been completely omitted from the roof assembly.

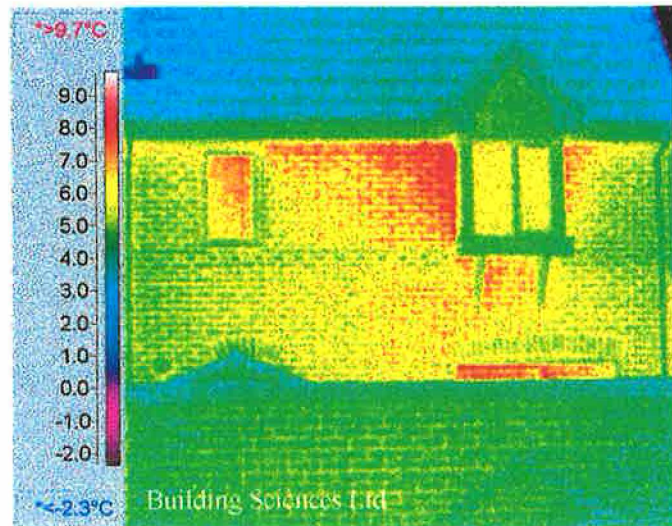
Domestic Unit

This image shows a traditional brick cavity construction. The upper oriel window is causing substantial heat loss at its junction with the wall. This is identified by the red flares emanating from this area.

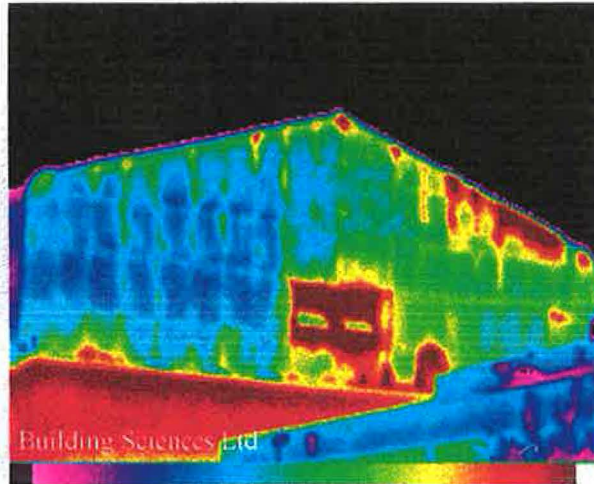
Workshop/Laboratory

This twin skin metal clad unit displays severe problems with the cladding. Large quantities of air leakage have led to moisture accumulations within the insulation quilt. This allows significantly greater heat loss and presents a fabric degradation problem.

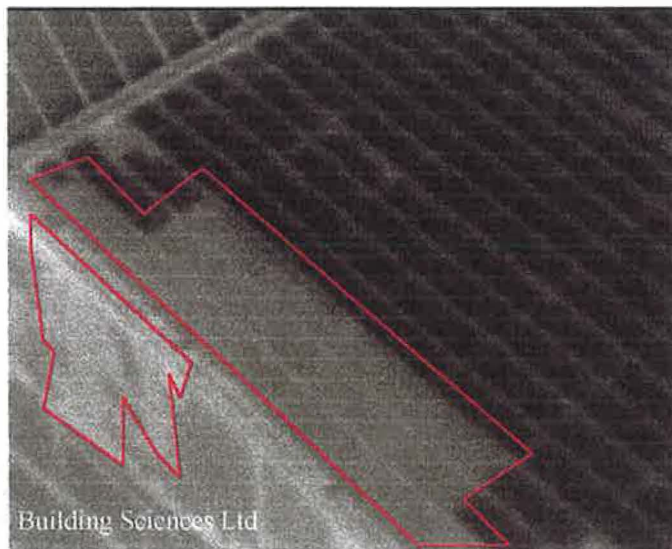
Warehouse Roof

This twin skin built up roof shows a large area of missing insulation. This was located close to the verge condition. This can be seen as the light area boxed in red. The missing insulation allows greater heat loss and thus produces a warmer exterior surface temperature. In addition to the roof failure the gable wall also shows signs of misplaced and missing insulation.

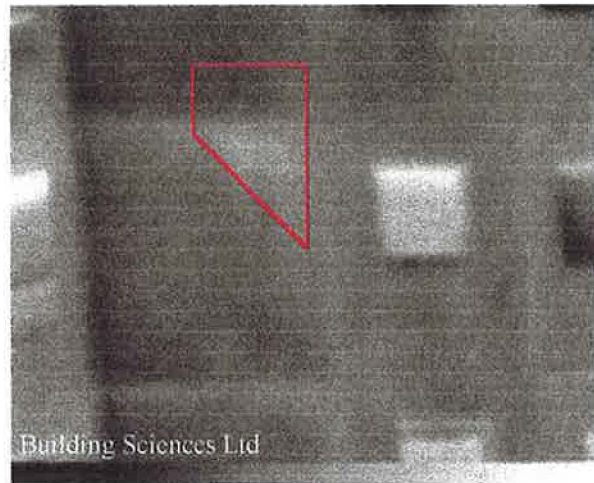
Multi Storey Unit

This wall panel shows signs of thermal failure at the top right. The brighter flare indicates air leakage and moisture build up. This is due to condensation forming when moisture in the warm interior air condenses as it passes towards the outer layers of the joint condition.

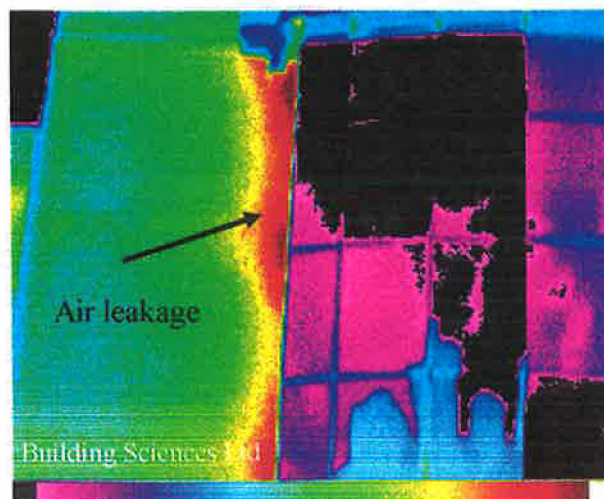
Commercial Building

This colour image shows severe air leakage between two construction systems on a new build project. Individually the glazed curtain walling (green) and stone cladding (purple) appear to be performing well but the junction between the two has failed. The large red flare indicates the extent and of air leakage along the joint.

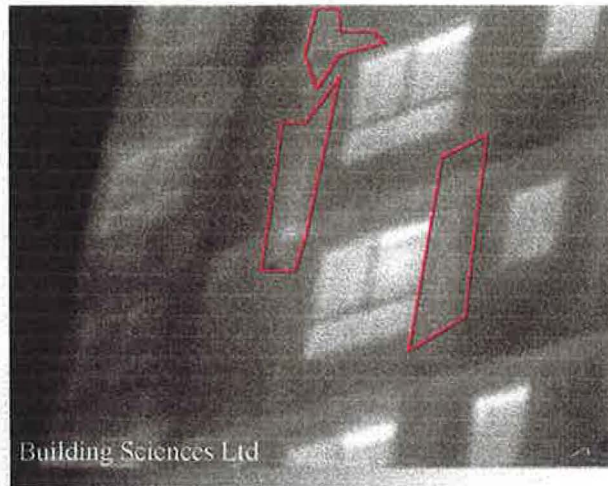
Multi Storey Unit

This multi storey building was constructed with precast concrete panels. The vertical and horizontal joints had failed and the panels were displaying severe degradation. This image highlights some air leakage paths (also allowing water ingress) where the joint system had completely degraded. Also noted is the extent of thermal bridging at the party walls and floors.

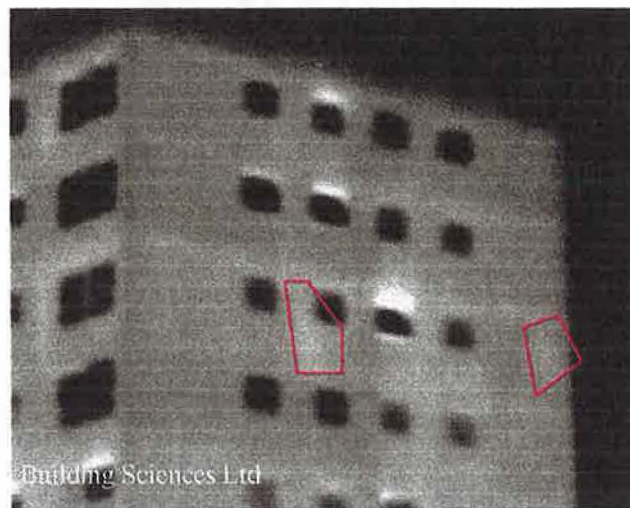
Multi Storey Unit

This multi storey block displayed various areas of performance failure. The generally poor level of thermal insulation was compounded by localised areas of moisture ingress. These produced spalling of the concrete and large heat losses.

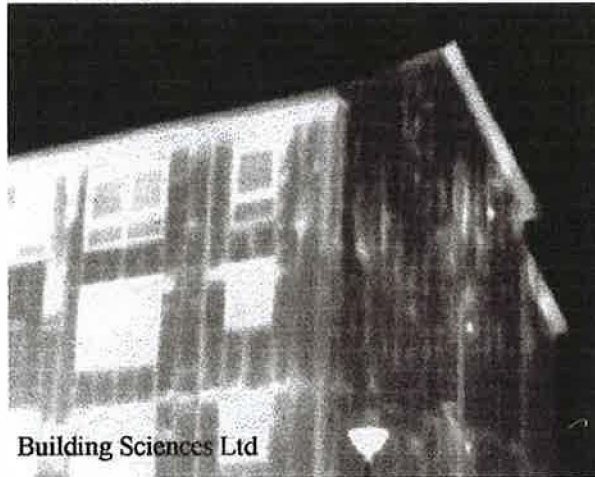
Cement Board Wall Cladding

This four storey block of domestic flats had severe air leakage and insulation failures. The construction of the subject was a brick cavity wall over-clad with cement panels. The bright lines on the image show the position of timber fixing battens behind the panels. The numerous irregular bright spots and bands indicate that a combination of insulation failures, air leakage and moisture accumulations exist. These areas were easily located and were subsequently investigated by removing the necessary panels.

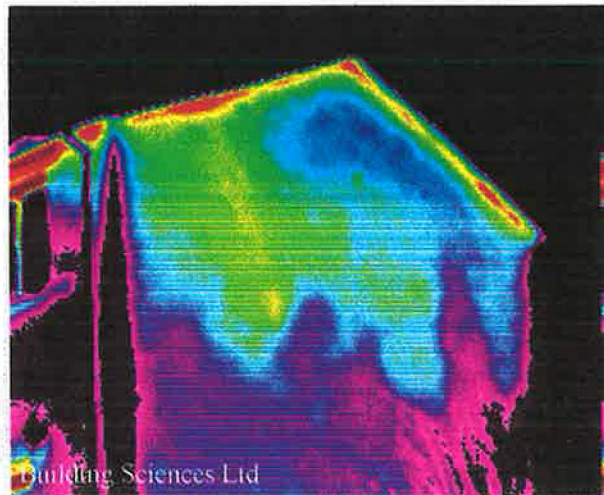
Domestic Insulation

This cavity gable wall has been filled with blown fibre insulation. The irregular pattern indicates that the fill is incomplete and that large areas remain uninsulated. Also noticeable are the large air flares at the verge condition showing substantial heat loss via the loft space.

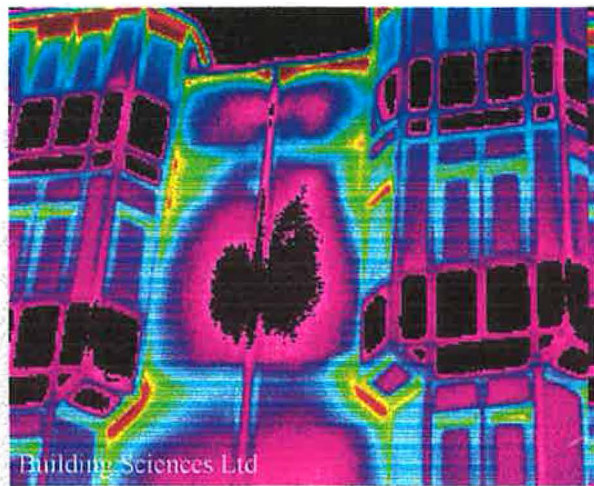
Commercial Office

Severe air leakage at the cladding joints led to condensation and corrosion. This is identified by the red and green patterns. The mechanical systems within this building could not be properly balanced due to the loss of air occurring through the external wall at the plenum floors.

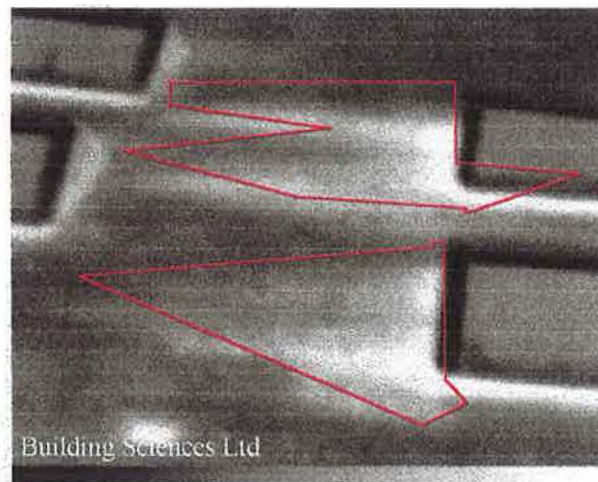
Flat Roof Survey

Thermography can quickly identify areas of defective insulation due to moisture ingress. Large areas can be surveyed rapidly and the affected areas outlined with spray paint for subsequent visual identification. This image shows where water ingress has occurred adjacent to roof lights. The bright white areas boxed in red indicate the presence of moisture.

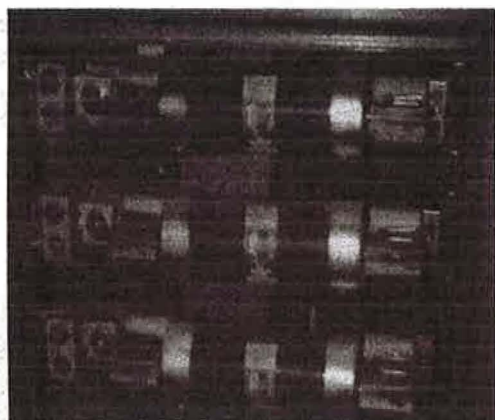
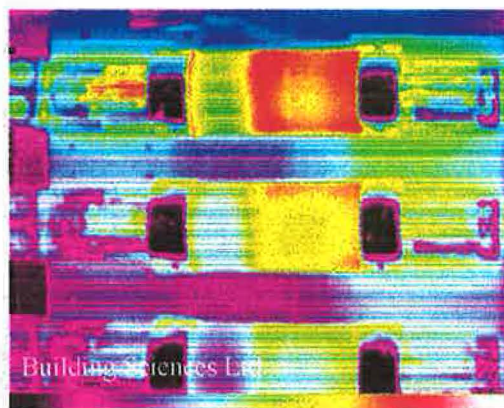
Electrical Plant Surveys

Shown above are a visual and thermographic image of a three phase disconnect with the top switch showing signs of overheating. Thermography can quickly and remotely identify this type of problem and prevent large scale power failures.

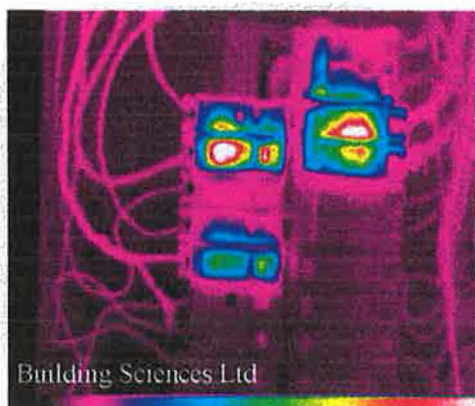
Fuse Distribution Boards

Again thermography can be employed to quickly assess the performance of individual circuits by scanning the fuse boards. Overloaded fuses are seen here with white centres. The overloaded circuit heats up and can threaten fires if connections are poor.
