INTEGRITY TESTING

HALON PROTECTED ROOMS

LEAKAGE TESTING REPORT

SWITCH ROOM

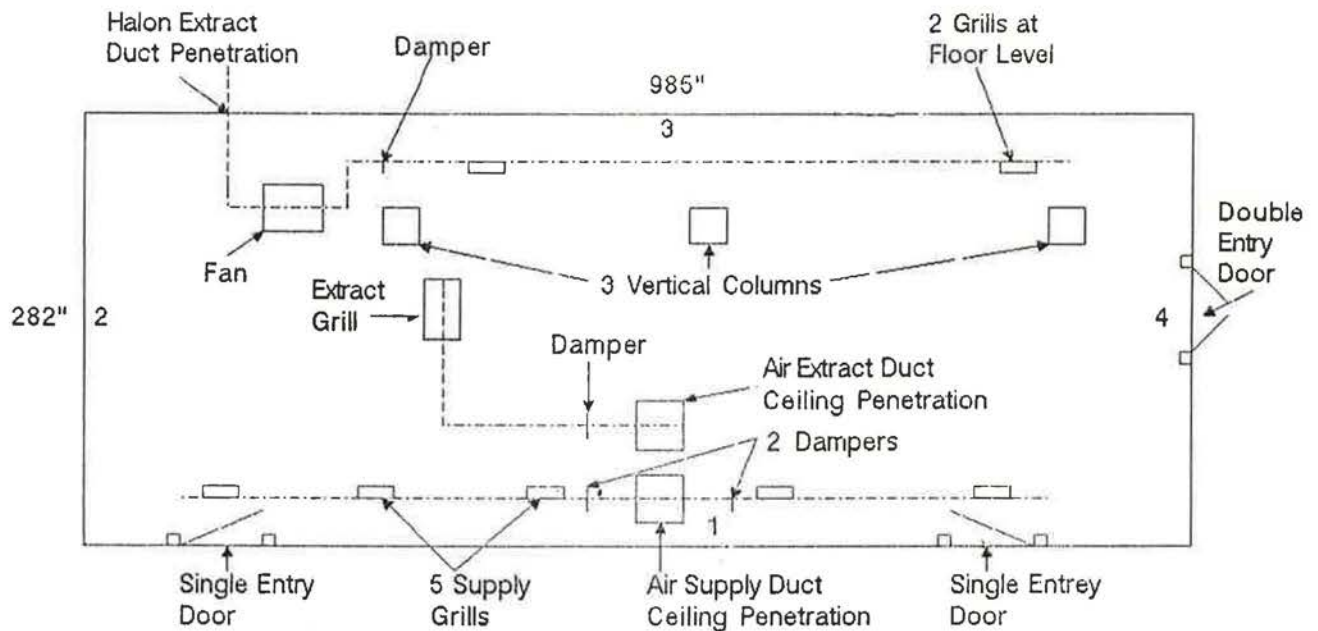
* Room Height: 145 inches from ceiling to floor.

* This room has a concrete floor.

Walls One, Two and Four are concrete block construction, with horizontal fire proof covered beams at the tops. The construction of Wall Three is lower wall concrete blocks, mid wall windows, upper wall panel construction.

* Air supply enters through a ceiling duct penetration along side Wall One. The ducting then splits through two dampers and runs through a high level duct with five grills alongside Wall One. These two dampers were manually closed during the test.

- * Air extract is through a ceiling duct penetration alongside Wall One. The ducting flows at high level through a damper to one central room extract grill at high level. The damper was manually closed during the test.
- * Halon extract is via a fan located along side Wall Three and exhausts through a duct in Wall Three. Upstream of the fan is one damper, powered closed, the high level ducting then dropping to two floor level extract grills.

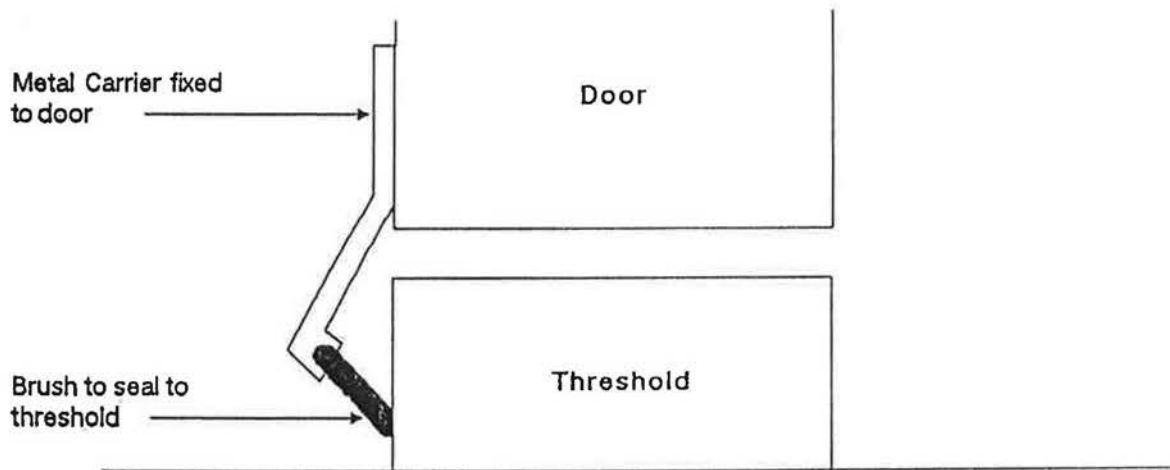
Sometimes doors have no threshold. As a result any Door Bottom Sweeps (DBS) will brush against the floor for the full sweep of the door as it is opened and closed. On doors which are regularly used this will result in significant wear/deterioration of the DBS. It is recommended that hardwood thresholds are fitted below doors to permit the following type of sweep arrangement to be used.

If it is decided not to fit thresholds then the brushes will wear excessively. In this case these brushes should be examined at least every six months to assess their continuing effectiveness.

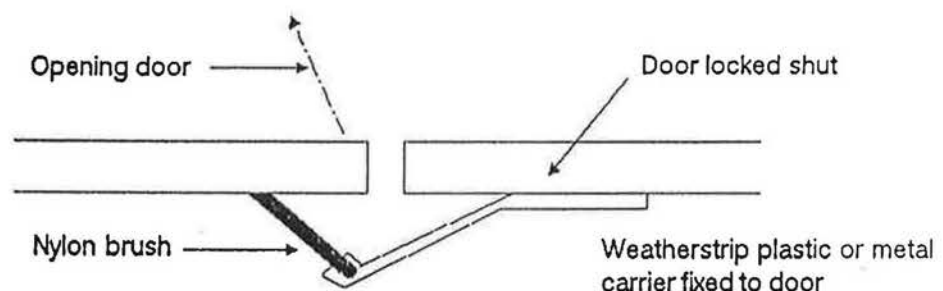
Regarding double wooden doors of rooms which have no centre jambs and therefore weatherstripping (W/S) the gap between the doors has to be carefully considered. With wooden doors the edges can sometimes be rebated and brush inserts fitted. For some types of metal doors 'O' Tube or custom formed silicone gaskets can be considered. Alternatively, we suggest that one 'nominated' door in each set is considered as 'locked closed' and is only opened very occasionally for plant machinery access. With this arrangement the following could apply.
