# Air for Smoke Control

ROBERT E. TAYLOR

Affiliate ASHRAE  
Chairman, ASHRAE TC 5.6,  
Control of Fire & Smoke

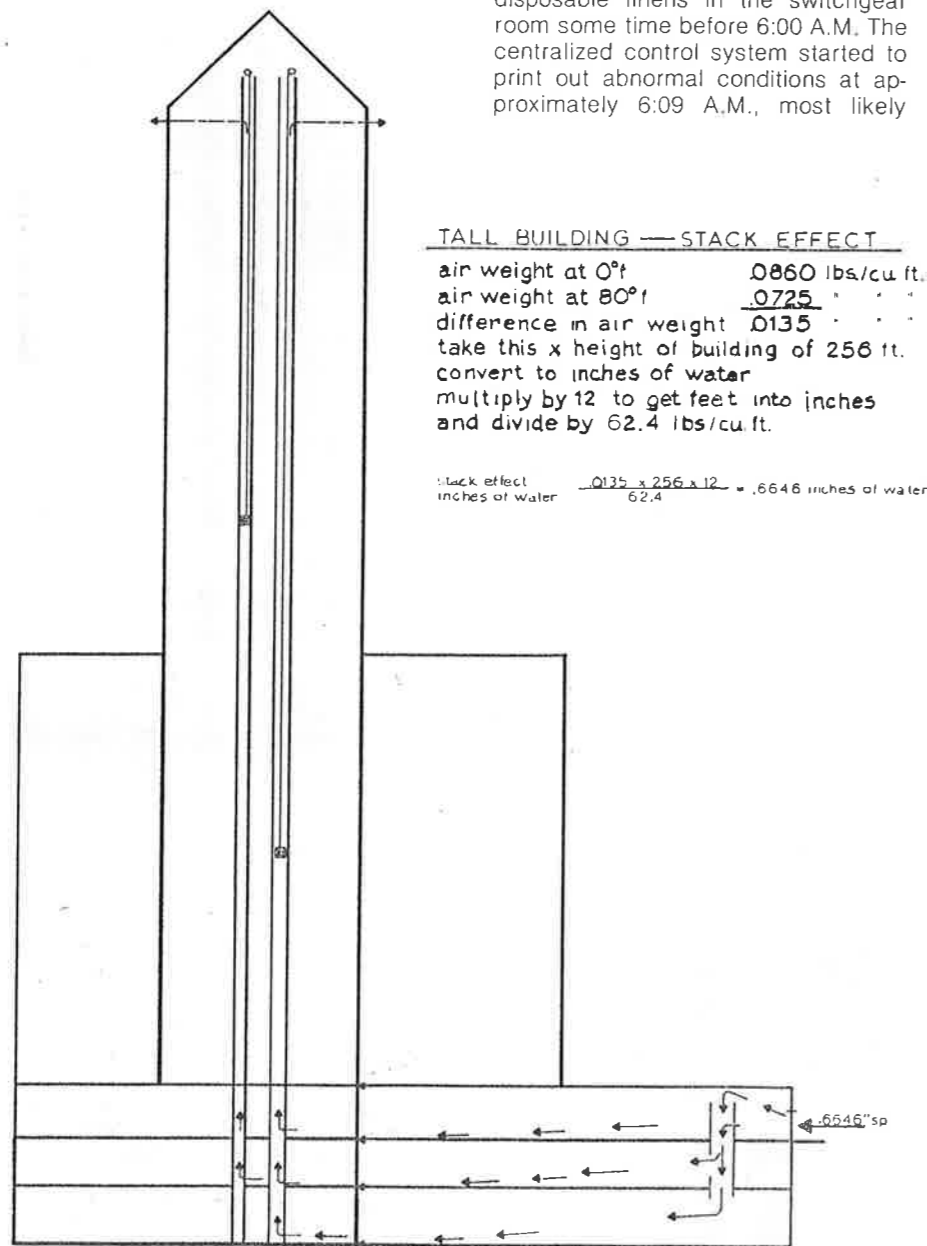
In this case smoke from an alleged arson fire in a basement D.C. switchgear room traveled horizontally through exposed open and empty electrical conduit to a corridor area near an elevator lobby. Due to stack effect, the smoke then moved vertically up through an elevator shaft to the top stories of the 22-story building. As the smoke built-up on patient floors, an estimated 165 patients were moved down stairways by the hospital staff. Patients from 16 through 10 were

Fig. 1, shows how the smoke moved via "stack effect" up the elevator shaft and stairwells as doors were opened for the evacuation. None of the nurses or patients appears to have suffered any long term effects. It should be noted that the coatings on the wiring that was burning was old and basically did not involve modern polymers.

The smoke spread from the switchgear room to the base of the tower through empty electrical conduit and some partially filled conduit from which the cover plates had been removed or were removed by the fire department in the corridor near the central elevator shaft. This allowed substantial smoke into the elevator lobby for movement upstairs.
