# CANADIAN BUILDING DIGEST

## Control of Air Leakage Is Important

by G. K. Garden

CBD 72

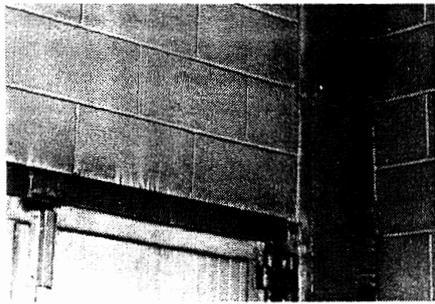
There is often no easy identification of air leakage, but smoke can be used to make air movement visible. Evidence that it has been occurring, however, is shown by the feather pattern of dirt deposits that appear adjacent to cracks or joints, such as may be seen in Figure 1

Figure 1 Dirt patterns as evidence of air leakage.

where air has been leaking through the crack between the masonry wall and the structural column. It has also been occurring between the door frame and the wall. The door head detail of Figure 2 shows that air leakage between the door and its frame had been considered, for a compressible gasket was incorporated as weatherstripping, but there was not sufficient recognition of the fact that a masonry wall is air permeable. Although the paint film on the block wall reduced the air permeance of the surface, the joint between this film and the door frame was not sealed.

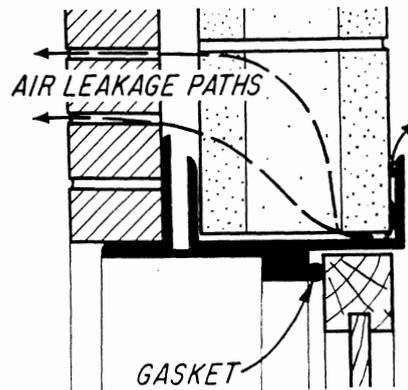
Figure 2 Door head section showing air leakage paths.

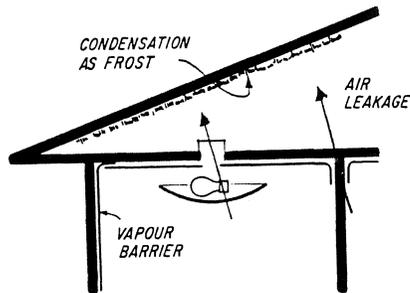
Figure 3 Detail of the roof indicating air leakage paths.

The effect of air leakage through a building envelope can sometimes be seen in a heavy frost accumulation on the under side of the roof in an attic space. Upon melting the frost will produce the same effect as a roof leak. Openings through ceilings that will permit the leakage of moist air into a roof space are indicated on the roof detail of Figure 3. Severe accumulations of frost can develop over a prolonged period of extreme cold weather despite generous allowance for natural ventilation. Although ventilation is of considerable value in reducing the severity of condensation problems, it is not a substitute for preventing leakage of moist air into a cold space.
