NBS BUILDING SCIENCE SERIES 105

Retrofitting an Existing Wood-Frame
Residence for Energy Conservation—
An Experimental Study

D. M. Burch
C. M. Hunt

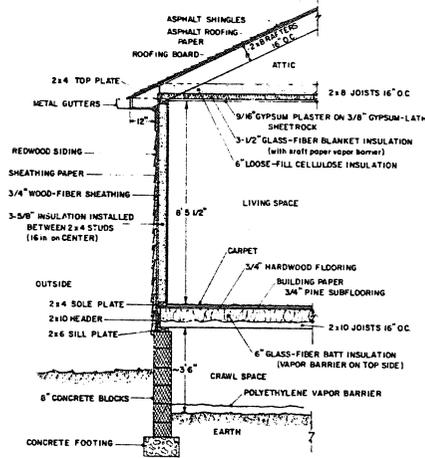
FIGURE 1. Typical cross-section of the house after retrofitting.

- Floor**
 3/4-in hardwood (oak) floor
 building paper
 3/4-in pine subflooring
 2 x 10 wood joists placed 16 in on center
- Wall**
 9/16-in gypsum plaster
 3/8-in gypsum-lath sheetrock
 2 x 4 wood studs placed 16 in on center
 3/4-in wood-fiber sheathing
 sheathing paper
 7/16-in redwood siding
- Ceiling**
 9/16-in gypsum plaster
 3/8-in gypsum-lath sheetrock
 2 x 8 wood joists (with 3/4 in glass-fiber blanket insulation with a kraft-paper vapor barrier installed between the joists)
- Sloping Roof**
 2 x 8 rafters placed 16 in on center
 3/4-in wood sheathing
 asphalt roofing paper
 1/8-in asphalt shingles
- Attic End Walls**
 2 x 4 wood studs
 3/4-in wood-fiber sheathing
 sheathing paper
 7/16-in redwood siding

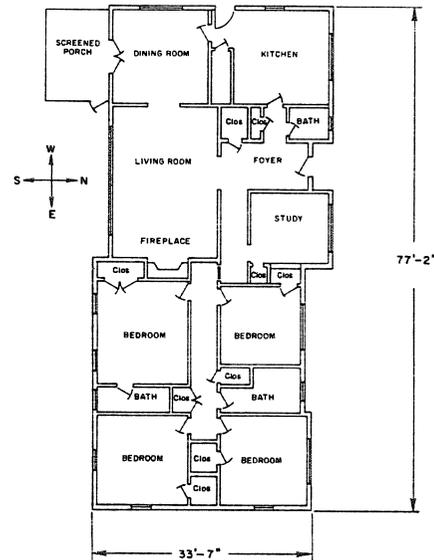
FIGURE 2. Floor plan of the test house.

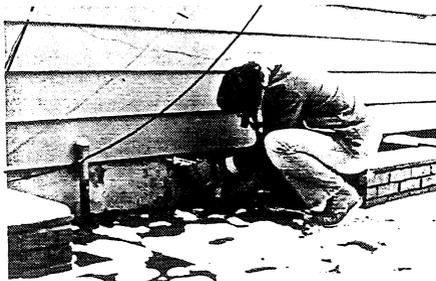
FIGURE 3. Caulking compound being applied to foundation sill.

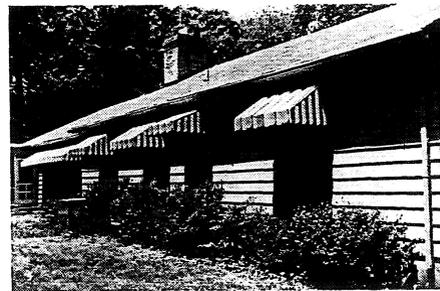
FIGURE 4. A photograph of the south side of the house showing the awnings.

Before the post-retrofit summer cooling energy measurements, aluminum awnings were installed above the windows on the south side of the test house. A photograph of the south side of the test house after the awnings were installed is given in figure 4.

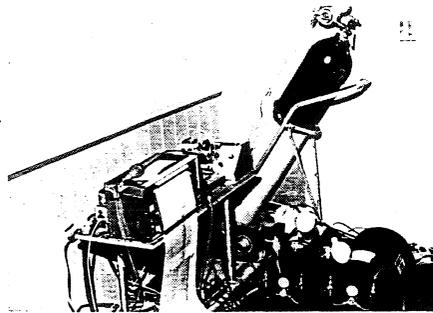
FIGURE 5. Apparatus used to measure air-leakage rates for the test house.

Sulfur-hexafluoride concentrations were measured with a gas chromatograph equipped with an electron-capture detector. A photograph of the measurement apparatus is shown in figure 5.

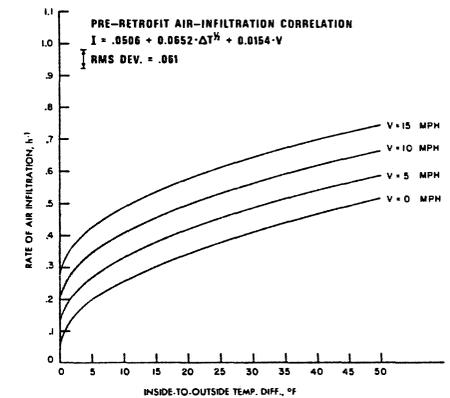
FIGURE 6. Pre-retrofit air-infiltration correlation.

A plot of eq (7) is given in figure 6. Under typical winter conditions, $\Delta T = 35^\circ\text{F}$ (19.4°C) and $V = 7$ mph (3.1 m/s), the rate of air infiltration is roughly 0.5 air changes per hour. At design conditions, $\Delta T = 55^\circ\text{F}$ (30.6°C) and $V = 15$ mph (6.71 m/s), the air-infiltration rate for the test house is 0.75 air changes per hour. These figures indicate that the test house in its original state had low air-leakage rates, due to good construction and good weather-stripping around the doors and windows.

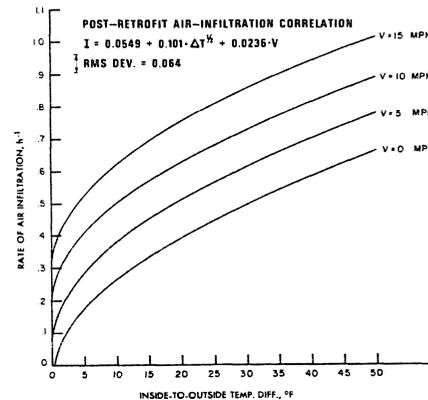
FIGURE 7. Post-retrofit air-infiltration correlation.

Eq (9) is plotted in figure 7.

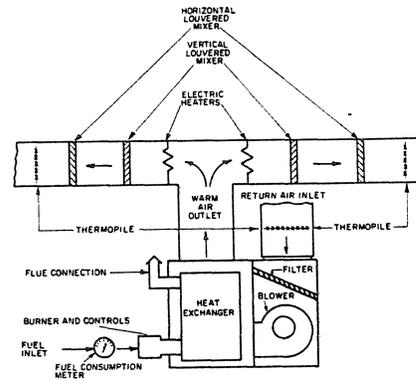
FIGURE 8. Schematic diagram of furnace system showing the location of measuring transducers.

In order to obtain meaningful duct velocity and temperature rise measurements, it is necessary that the measurements be made at a station in the duct having nearly uniform temperature profiles. A schematic diagram of the original oil-fired furnace system showing the location of the measurement transducers is shown in figure 8. Note that the air-delivery duct system has two major supply branches, one delivering conditioned air to rooms located over the basement, the other feeding the rooms located over the crawl space. For the pre-retrofit heating-energy measurements, uniform temperature profiles were created in each major supply branch by installing louvered air-mixing devices which were constructed according to specifications given in reference [18]. The heating

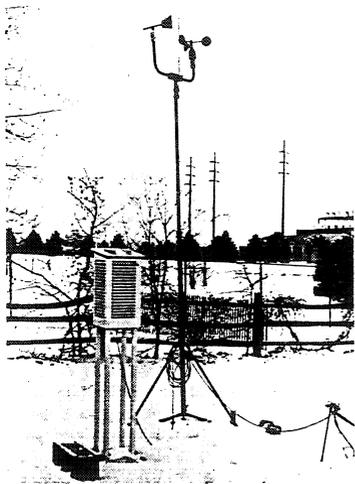
direction vane. The louvered enclosure shown in figure 9 contained a copper-constantan thermocouple for measuring outdoor temperature and a humidity-sensing element which produced a millivolt signal proportional to relative humidity. During the pre-retrofit heating energy measurements, the total solar radiation incident on a horizontal surface was measured with a pyranometer mounted on top of the louvered enclosure shown in figure 9. After the pre-retrofit heating energy measurements, the pyranometer was relocated on the roof of the test house. The outdoor ambient temperature was also measured with thermocouples installed on the north side of trees located behind the test house.

A photograph of the weather station used in the present study is shown in figure 9. This weather station was located approximately 60 ft (18.3 m) in front of and in line with the west end of the test house. This particular location was selected so that the wind direction and velocity sensors, mounted at the 18-ft (5.5 m) level, would be exposed to the prevailing winter northwest wind. Wind velocity was measured with a rotating-cup anemometer, and wind direction was measured with a wind-

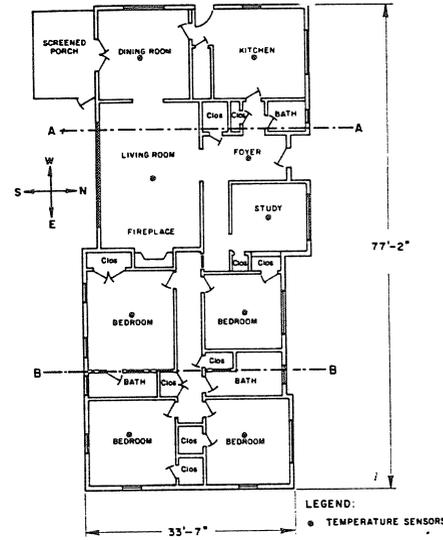
FIGURE 10. Floor plan of test house showing location of temperature sensors.

A relative humidity sensor (the same type that was used in the weather station) was placed indoors in the center of the living room next to the mid-height thermocouple. For the post-retrofit measurements, identical relative humidity sensors were installed in the crawl space, basement, and the attic. In all cases, an ambient air temperature thermocouple was placed next to each humidity sensor.

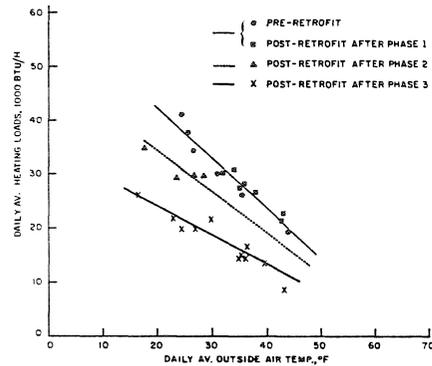
FIGURE 11. Measured heating loads for the unoccupied test house after various stages of the retrofit.

Since the measured daily-average heating loads for the unoccupied test house are approximately equivalent to heat-loss rates, relations (11) and (12) were used to normalize the measured heating loads for the unoccupied test house to the average wind velocity (4.2 mph (1.88 m/s)) and average indoor temperature (67.9°F (19.9°C)) of all the winter heating energy measurements. Normalized daily-average heating loads of the unoccupied house before and after the various stages of the retrofit are plotted as a function of daily-average outdoor air temperature in figure 11. The straight lines were obtained from a least-squares procedure.

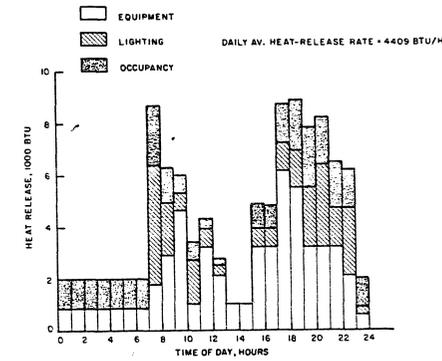
FIGURE 12. Energy-release rates for equipment, lighting, and occupancy.

plant during each hour of every . If the test house had been occupied, the heat released by occupant-related activities would never have been sufficient to satisfy the heating load of the house over the conditions for which the house was tested. Therefore, the daily-average heating load for the test house, having an occupancy schedule of figure 12, would be equal to the heating load for the unoccupied test house (see fig. 11), less the daily-average heat-release rate for the occupancy schedule of figure 12.

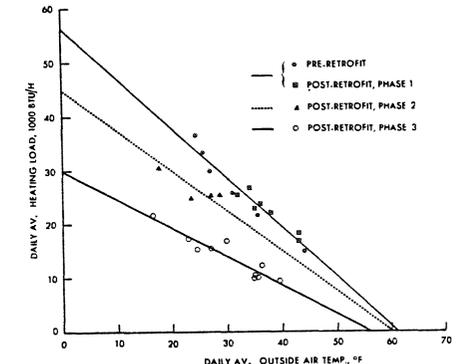
FIGURE 13. Heating-load correlations for the occupied test house after various stages of the retrofit.

The first term in the foregoing equations represents the heat-loss rate from the test house. The second term represents daily-average internal heat-release from occupancy, lighting, and equipment, and heat gain from solar radiation through the windows. Recalling that the daily-average heat-release rate for the occupancy schedule is 4,409 Btu/h (1,291 W), it is seen that the average solar load is calculated to be 1,971 (557 W) and 1,731 Btu/h (507 W), respectively, which are not unreasonable figures.

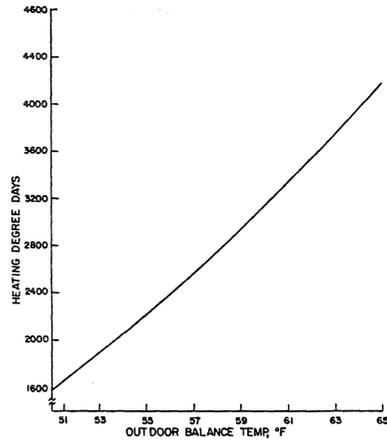
FIGURE 14. Heating degree days as a function of outdoor balance temperature for Washington, D.C.

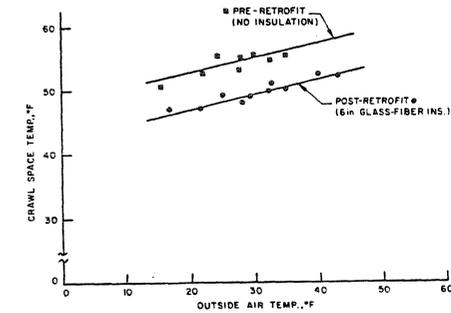
FIGURE 15. Pre- and post-retrofit winter crawl-space temperatures.

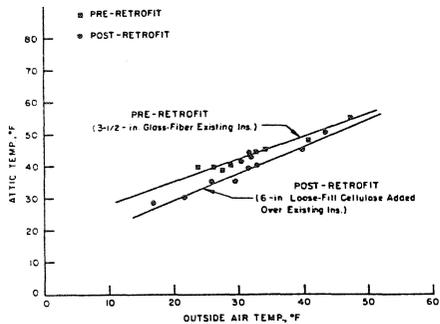
FIGURE 16. Pre- and post-retrofit winter attic temperatures.

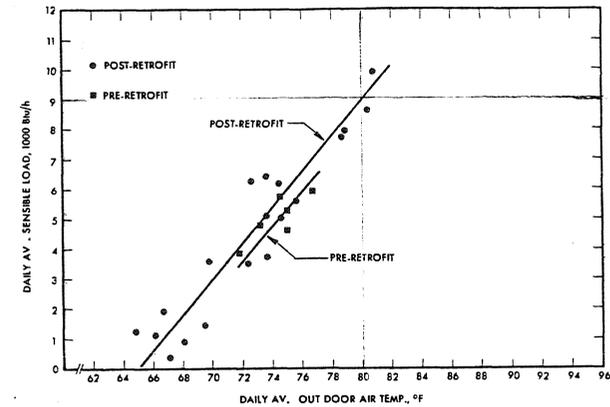
FIGURE 17. Pre- and post-retrofit sensible cooling loads.

FIGURE 18. Pre- and post-retrofit latent cooling loads.

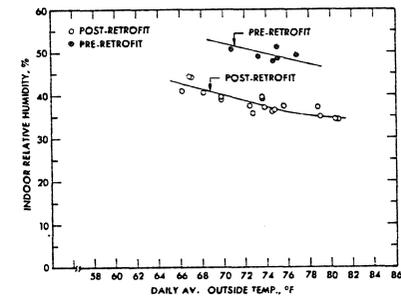
FIGURE 19. Pre- and post-retrofit summer indoor relative humidities.

The reductions in latent load were attributed to a change in the relative humidity levels in the living space. As shown in figure 19, the relative humidity in the first-floor living space was significantly reduced after the retrofit. The reduction in indoor

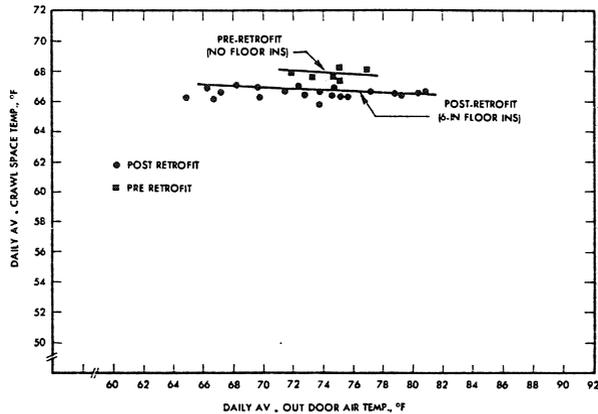
FIGURE 20. Pre- and post-retrofit daily average summer crawl space temperatures.

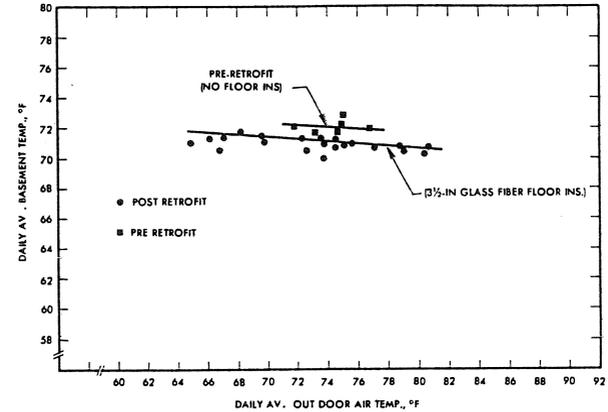
FIGURE 21. Pre- and post-retrofit daily average summer basement temperatures.

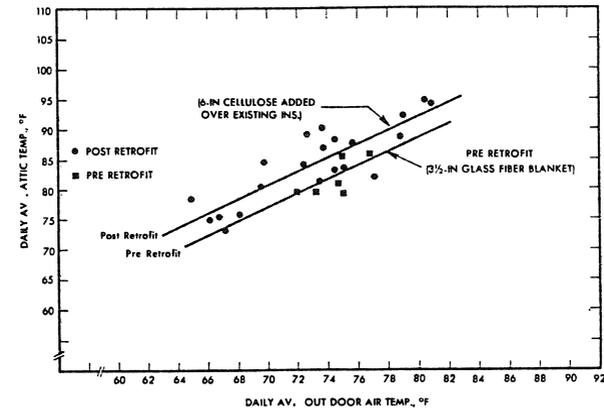
FIGURE 22. Pre- and post-retrofit daily average summer attic temperatures.

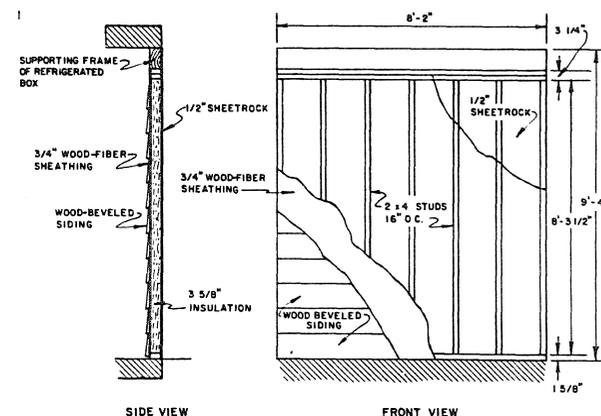
FIGURE 23. Construction details of laboratory test wall.

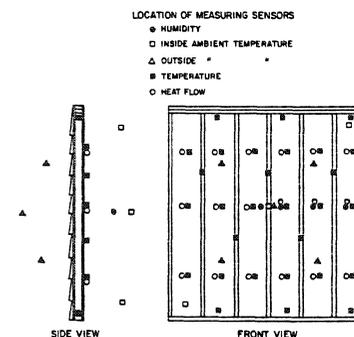
FIGURE 24. Location of measurement transducers on laboratory test wall.

Front and side views of the test wall showing the location of the measurement transducers are given in figure 24. Each pair of wall cavities insulated with different material was instrumented in a similar

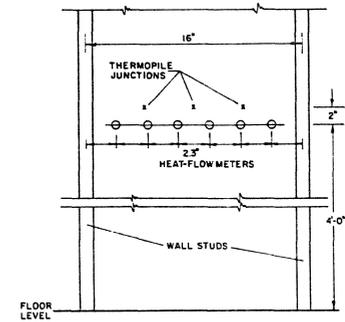
FIGURE 26. Elevation view of wall section of the test house showing heat-flow measuring station.

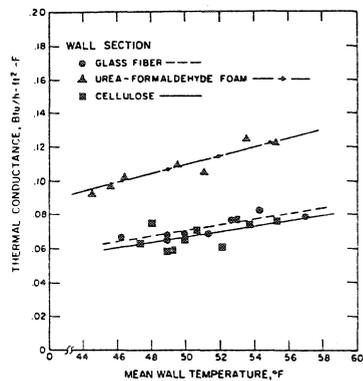
FIGURE 27. The effect of mean wall temperature on the thermal conductance of the three separate wall sections.

The thermal conductance of the U-F wall section (see fig. 27) is seen to be substantially higher than corresponding values of the other wall sections.

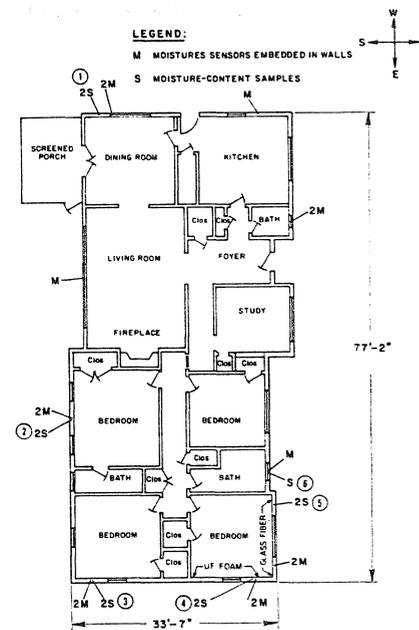
FIGURE 28. Floor plan of the test house showing location of humidity sensors and place where moisture content samples were cored out.

Ten days after the test house was insulated, small narrow-range humidity and temperature sensors were installed between the insulating material and the sheathing midway between the studs. The specific location of these humidity sensors is denoted with the symbol "M" on the floor plan in figure 28. The U-F foam and glass-fiber wall

^a See figure 28 for location identification.

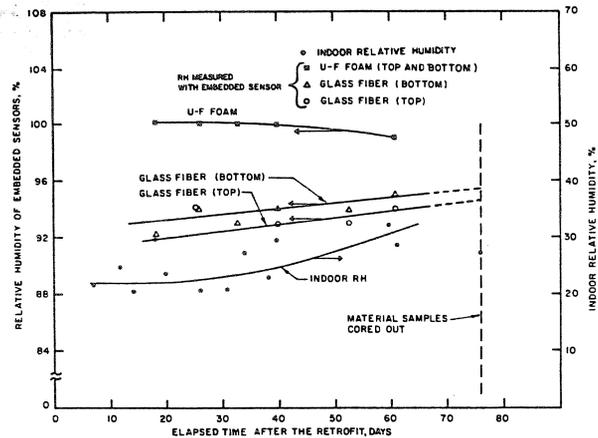
FIGURE 29. Variation of indoor relative humidity and relative humidities of embedded sensors.

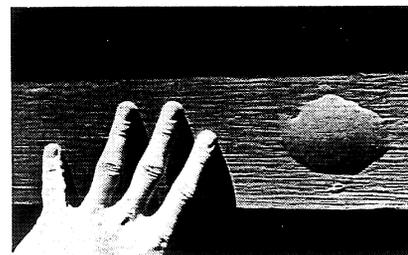
FIGURE 30. Water blister at exterior surface of U-F wall section.

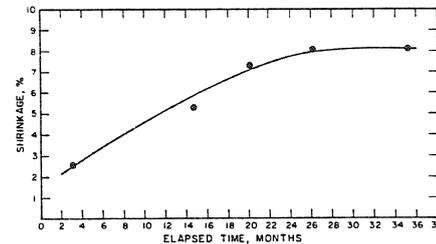
FIGURE 31. Percent linear shrinkage of urea-formaldehyde foam insulation as a function of elapsed time.

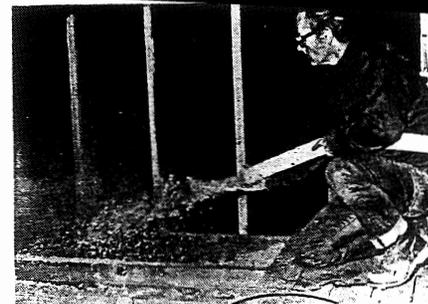
FIGURE A-2. Loose-fill cellulose being blown on top of the existing ceiling insulation.

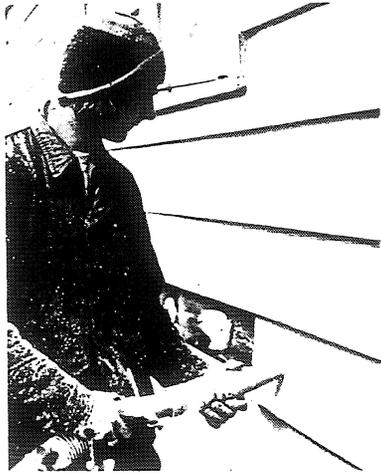
FIGURE A-3. Cellulose fiber being blown into the walls of the test house.

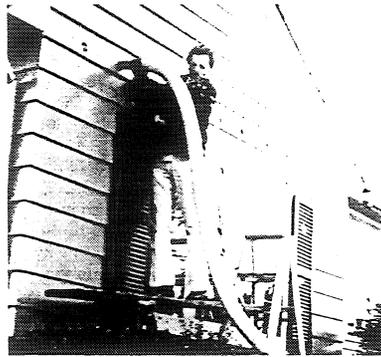
FIGURE A-4. Glass fiber being blown into a wall section.

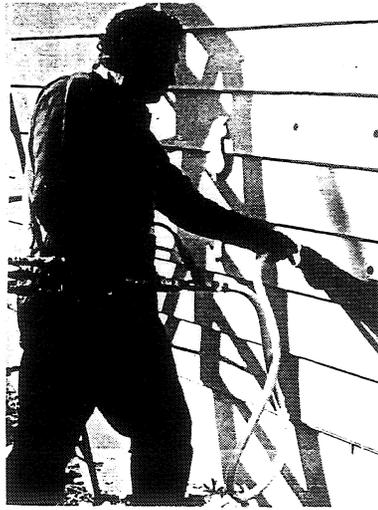
FIGURE A-5. Urea-formaldehyde foam being blown into a wall section.

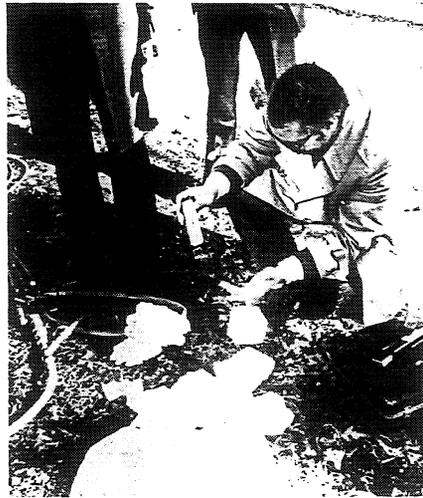
FIGURE A-6. Technical representative measuring wet density of the U-F foam.

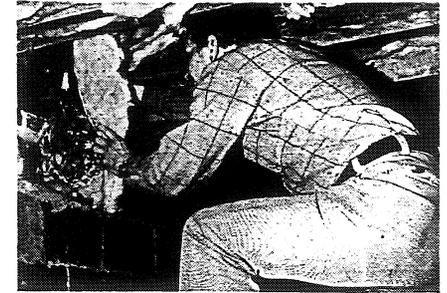
FIGURE A-7. Glass-fiber batts being installed under the floor in the crawl space.

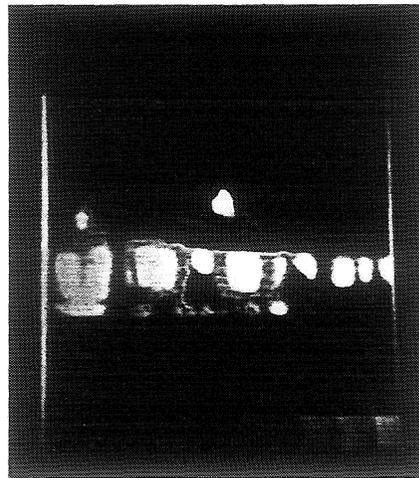
FIGURE B-2. Overall view of exterior surfaces of the test house. (b) Thermogram before retrofit.

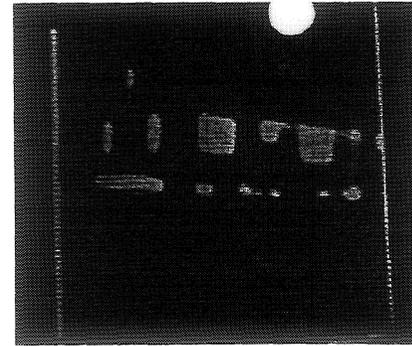
FIGURE B-2. Overall view of exterior surfaces of the test house. (c) Thermogram after retrofit.

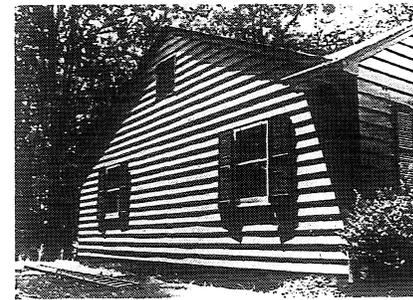
FIGURE B-3. East end of test house. (a) Conventional photograph.

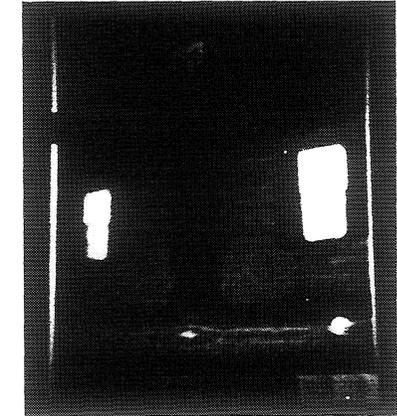
FIGURE B-3. East end of test house. (b) Thermogram before retrofit.

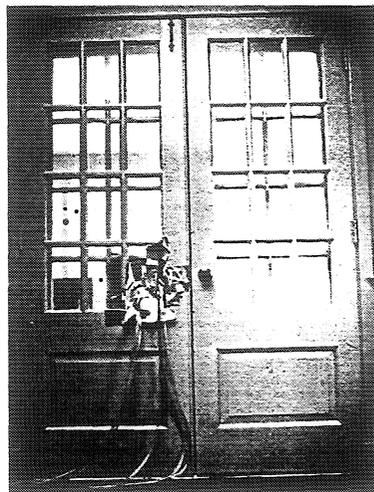
FIGURE B-4. Interior surface of dining room door.
(a) Conventional photograph.

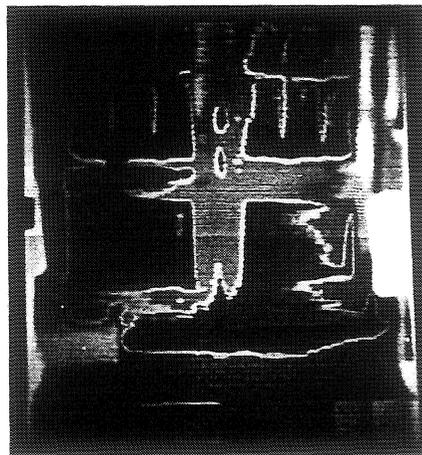
FIGURE B-4. Interior surface of dining room door.
(b) Thermogram before retrofit.

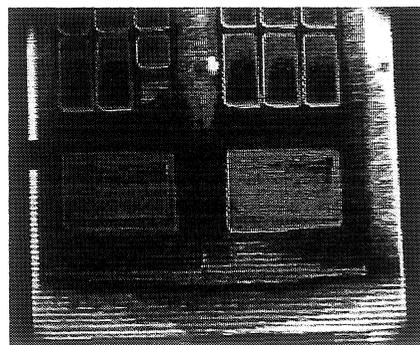
FIGURE B-4. Interior surface of dining room door.
(c) Thermogram after retrofit.

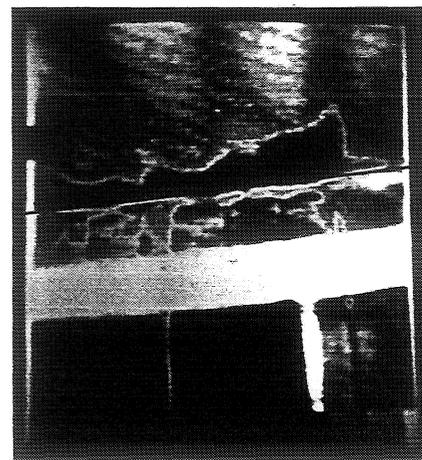
FIGURE B-5. Interior view of ceiling-wall interface above the bay window in living room.

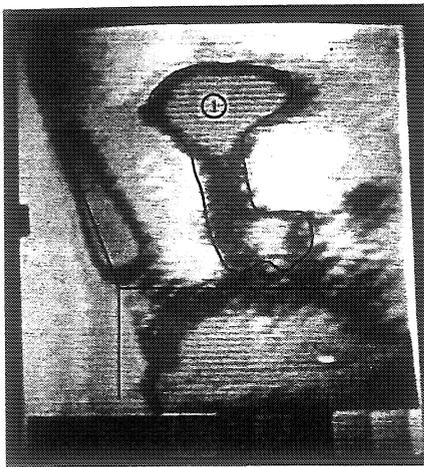
FIGURE B-6. Interior view of upper corner of northeast bedroom.
(b) Thermogram before retrofit.

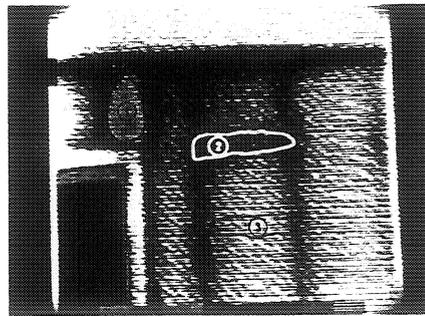
FIGURE B-7. Winter thermogram of inside surface of U-F wall section.

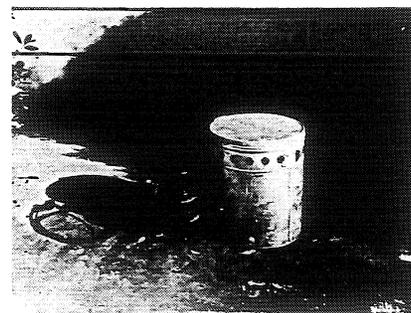
FIGURE C-1. Drum-type smoke distributor.

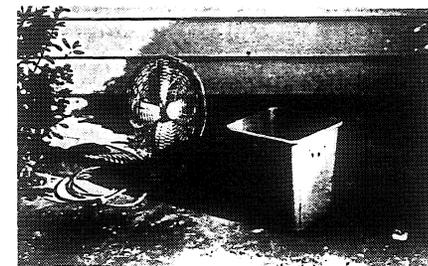
FIGURE C-2. Fan and metal trash basket used to distribute white pyrotechnic smoke.

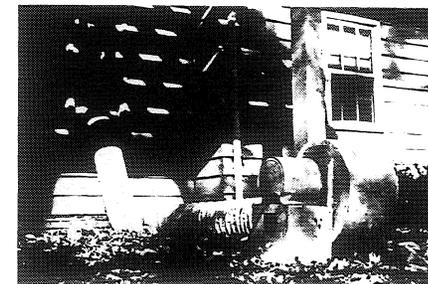
FIGURE C-3. Centrifugal blower connected to the window panel with a flexible hose.

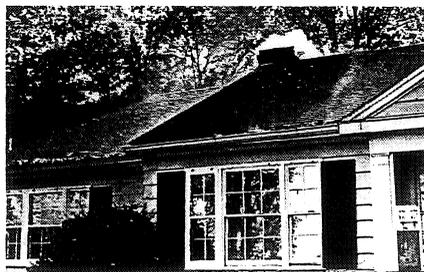
FIGURE C-4. Major air leakage path through the chimney.

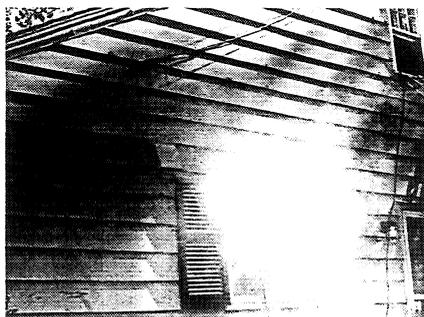
FIGURE C-5. Major air leakage path through kitchen exhaust opening.
