INFRARED THERMOGRAPHY AND THERMAL INSULATION
IN BUILDINGS

BERTIL PETTERSSON

STATENS PROVNINGSANSTALT

SWEDISH NATIONAL AUTHORITY FOR TESTING, INSPECTION AND METROLOGY
Laboratory of Building Physics and Heating & Ventilation

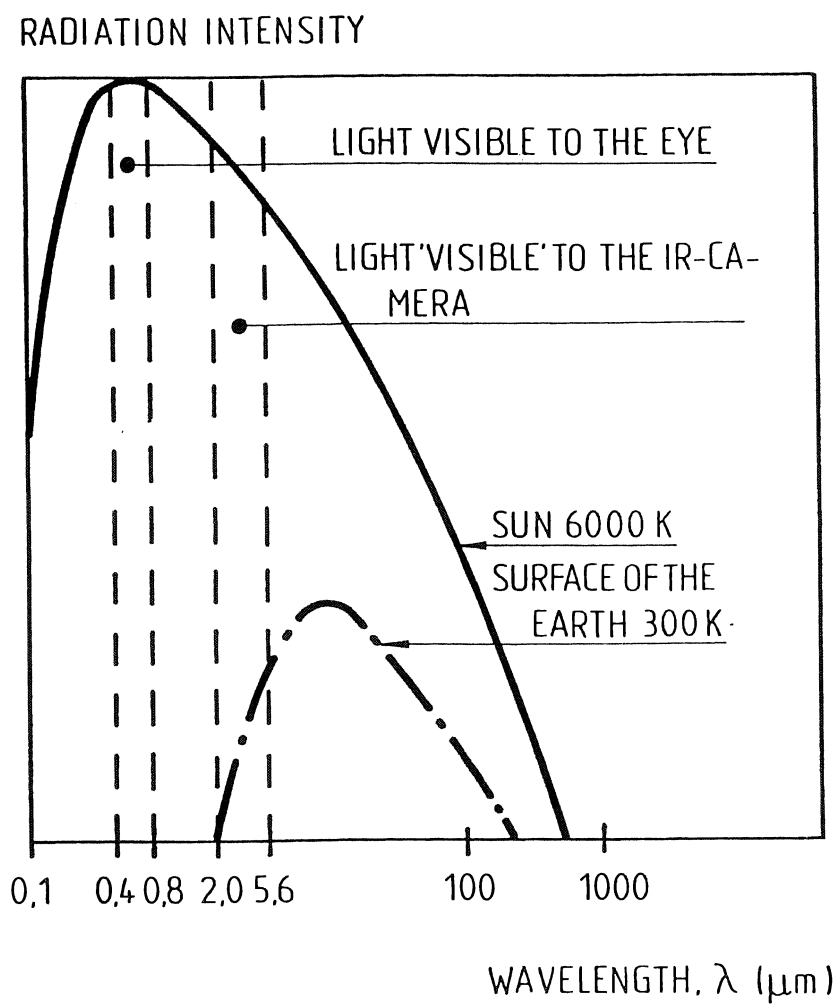
Fig. 2 Intensity of radiation emitted by an ideal black body at different temperatures as a function of the wavelength.

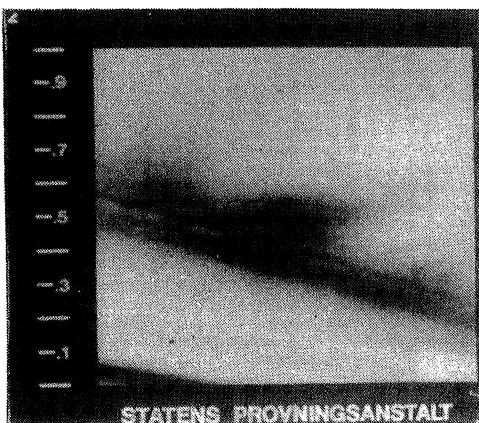
3 b) Thermogram of an area of wall/ceiling. No imposed isotherm (monochrome image).

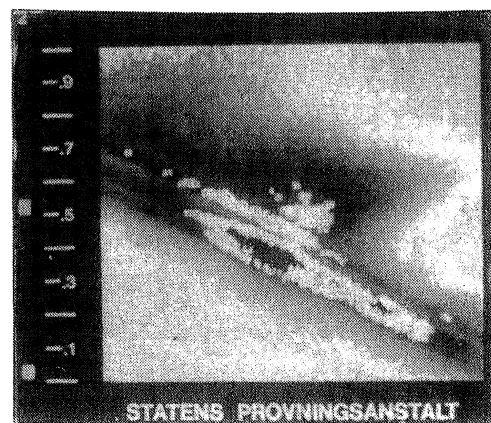
3 c) Thermogram of the same area as in b with two isotherm markings (isotherm image).

ture between different parts of the surface, the IR-camera is equipped with an isotherm function. With the aid of this, parts of the surface which give the same radiation can be marked in the thermogram. An isotherm image is obtained (Fig. 3 c). The isotherms can be set at any temperature and a variable temperature range can be covered in the image. Some types of cameras are equipped with two isotherm functions. The method used to find the real temperature in °C is shown in Fig. 4.

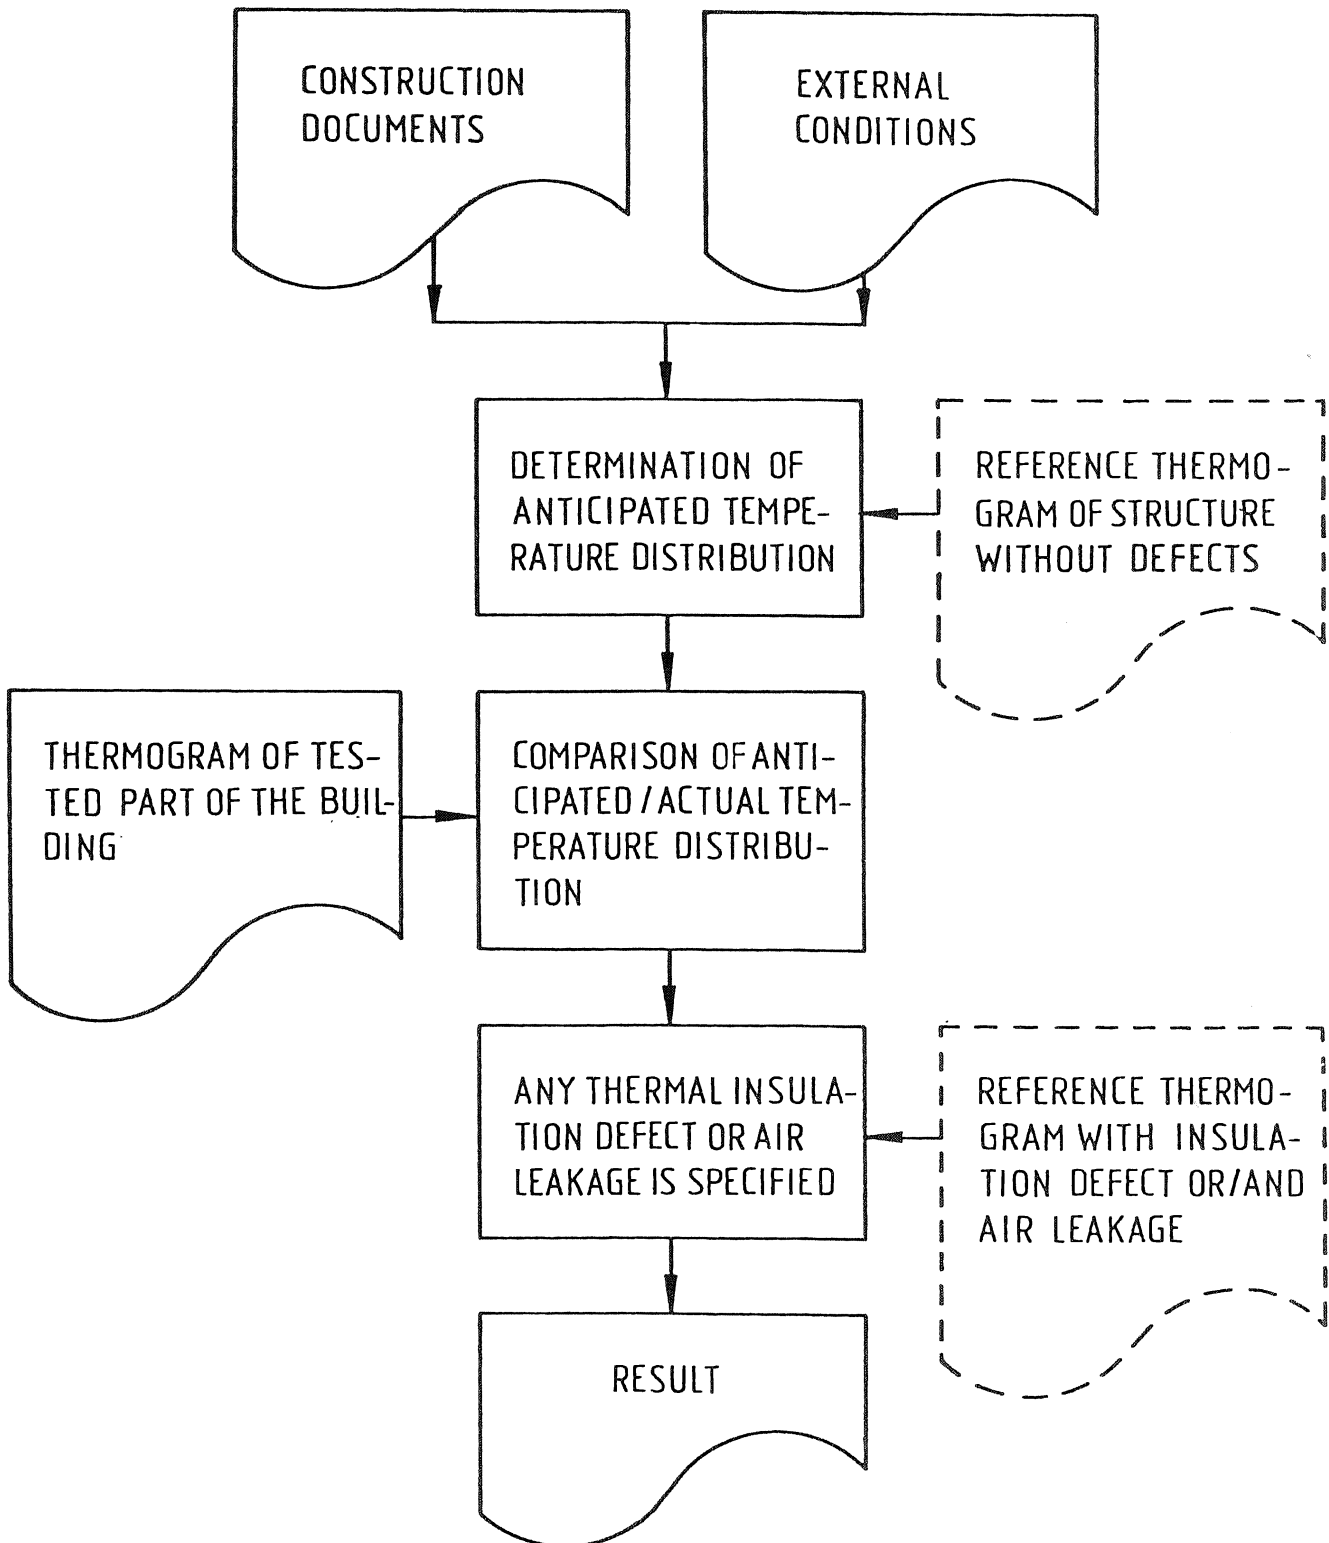
Fig. 6 General procedure in interpretation of thermograms. Dotted boxes indicate suggested use of reference thermograms.

thermal insulation defects and points of air leakage of various kinds. The general procedure in interpretation of thermograms is schematically represented in Fig. 6.

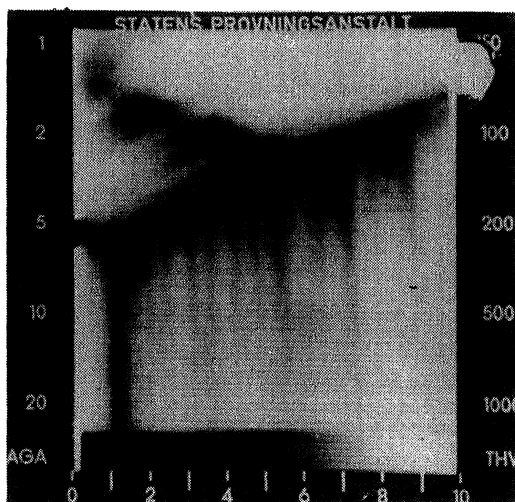
Fig. 12 c Thermogram from a section with defect. The measured difference between the "normal" surface temperature and the cold (dark) portion is about 3°C . Air velocity measured at the ceiling is approximately 1.0 m/s.

Air leakage through the structure often causes a local drop of surface temperature in the vicinity of the leakage point. The cooled area has often an uneven temperature distribution, giving an anomalous shape in the thermogram (Fig. 12).
