3rd AIC Conference, September 20-23 1982, London, UK

PAPER 11

AIR INFILTRATION AND AIR TIGHTNESS TESTS  
IN EIGHT U.S. OFFICE BUILDINGS

RICHARD A. GROT AND ANDREW K. PERSILY

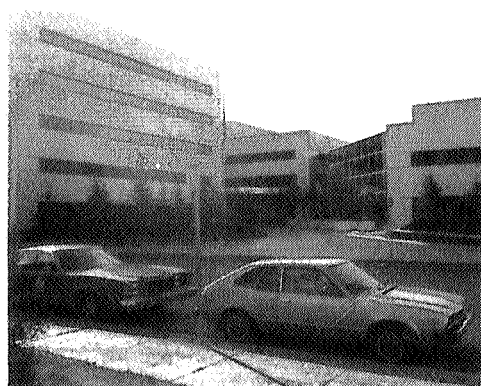
Figure 2. Schematic and Photograph of Federal Building in Anchorage, AK

**ANCHORAGE FEDERAL BUILDING**  
Schematic of Overhead view

for the purpose of the study (less than 10,000 M<sup>2</sup> occupiable area). These small office buildings range in height from 2 to 5 stories. A summary of the characteristics of the buildings is given in table 1. Schematics and a photograph for each building are given in figures 2 to 9. All but two of the buildings have variable volume air handlers in the major zones of the buildings. They are heated by perimeter heating systems which are usually hydronic. The building in Columbia has two air perimeter heating systems. In the building in Norfolk heaters and air conditioners have been added to the air system on floors which proved difficult to heat or cool. They all have central chiller systems for cooling the core spaces of the buildings. The buildings in Anchorage and Springfield have underground garages. The building in Norfolk has an exterior garage which occupies part of floors 1 to 4.

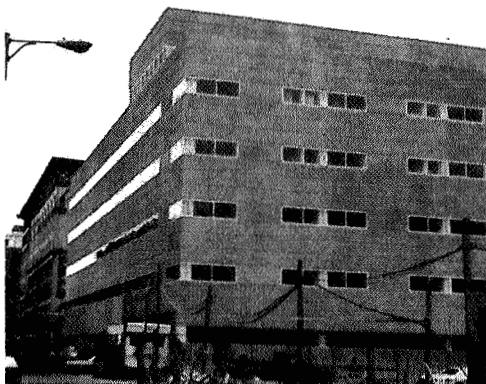
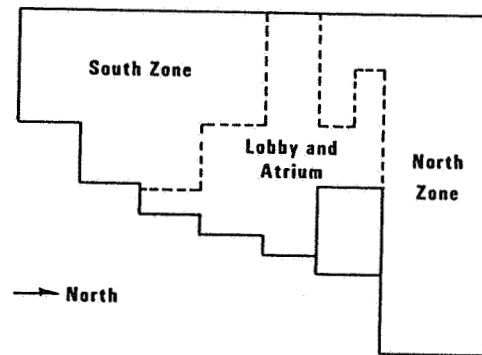
Figure 3. Schematic and Photograph of Federal Building in Springfield, MA

### SPRINGFIELD FEDERAL BUILDING Schematic of South Elevation

### SPRINGFIELD FEDERAL BUILDING Schematic of First Floor

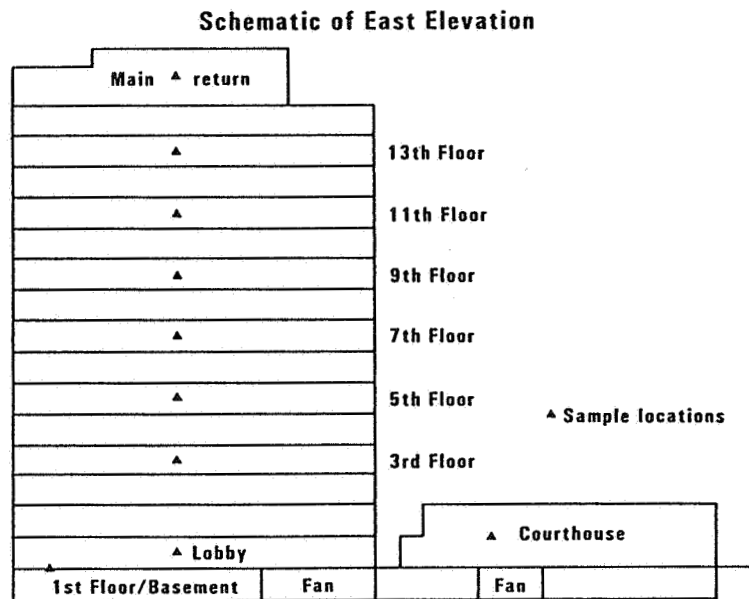
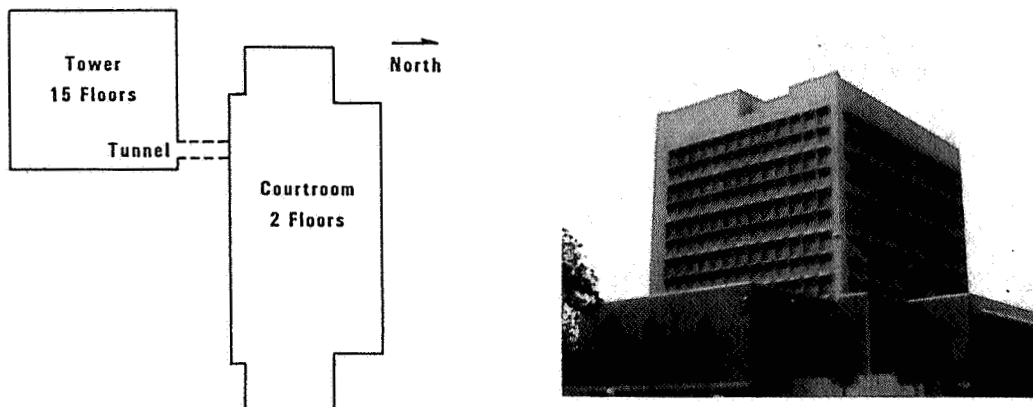
Figure 4. Schematic and Photograph of Federal Building in Columbia, SC

**COLUMBIA FEDERAL BUILDING**  
Schematic of Overhead View

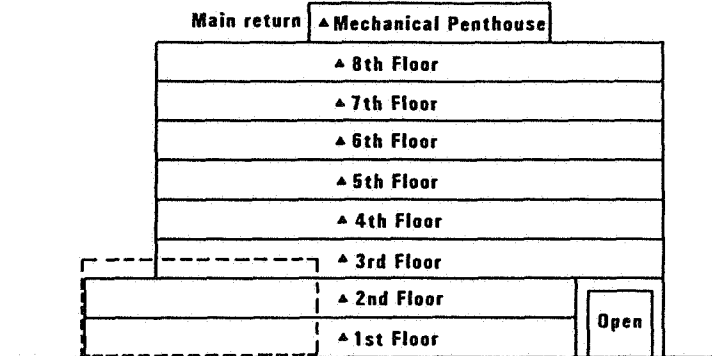
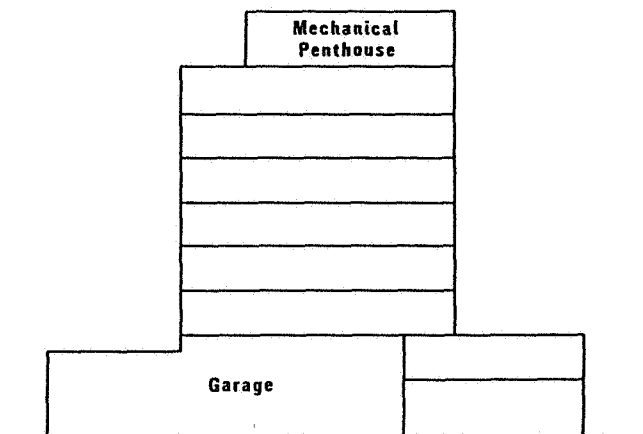
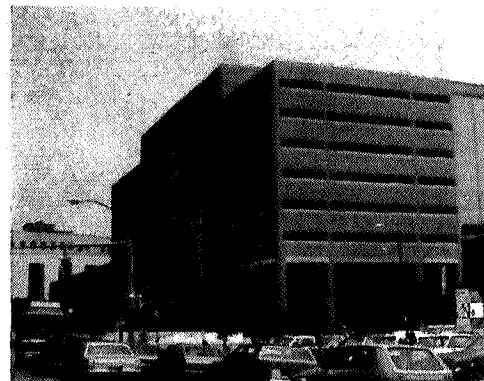
Figure 5. Schematic and Photograph of Federal Building in Norfolk, VA

# **NORFOLK FEDERAL BUILDING** **Schematic of West Elevation**

- ▲ Sample location
- Outline of outside garage on opposite side of building

# **NORFOLK FEDERAL BUILDING** **Schematic of North Elevation**

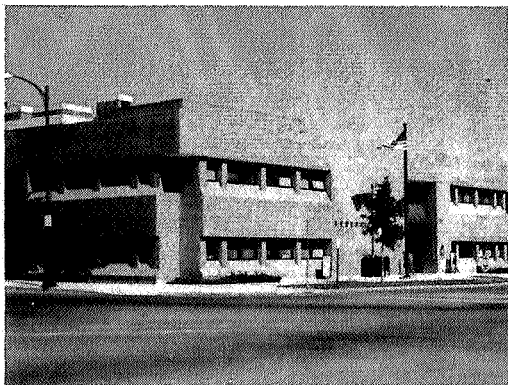
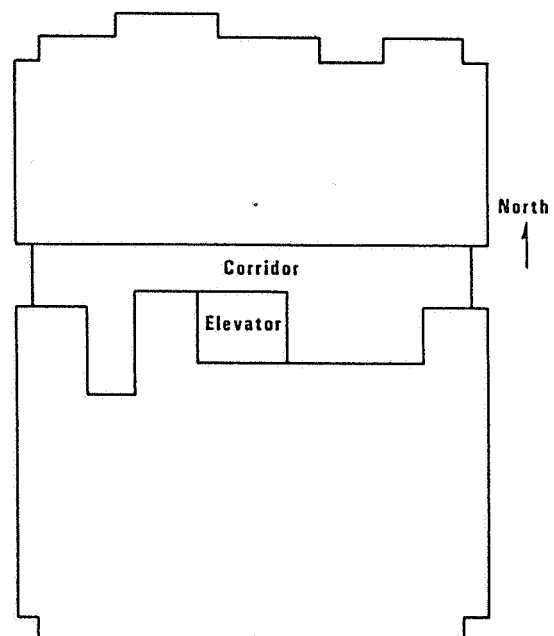
Figure 6. Schematic and Photograph of Federal Building in Pittsfield, MA

**PITTSFIELD FEDERAL BUILDING**  
**Schematic of West Elevation**

**PITTSFIELD FEDERAL BUILDING**  
**Schematic of Overhead View**

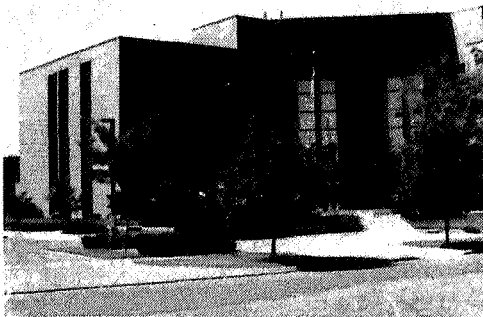
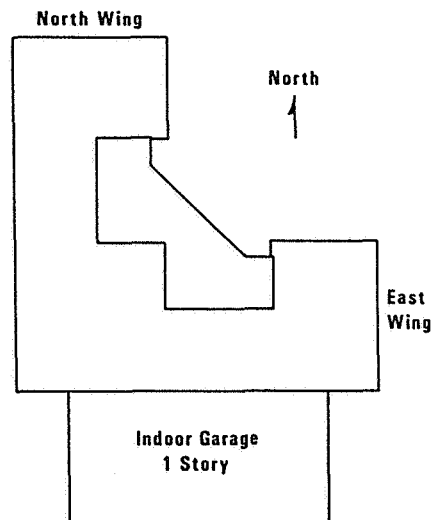
Figure 7. Schematic and Photograph of Federal Building in Huron, SD

# **HURON FEDERAL BUILDING** **Schematic of East-West Building Section**

▲ Sample locations

"North" Wing	Mechanical Penthouse		"East" Wing
	North return ▲	East return ▲	
4th Floor north ▲			▲ 4th Floor east
3rd Floor north ▲			▲ 3rd Floor east
2nd Floor north ▲			▲ 2nd Floor east
1st Floor north ▲			▲ 1st Floor east

# **HURON FEDERAL BUILDING** **Schematic of Overhead View**

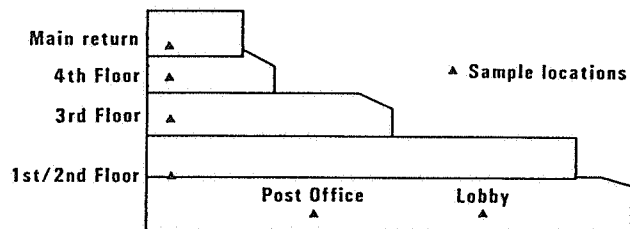
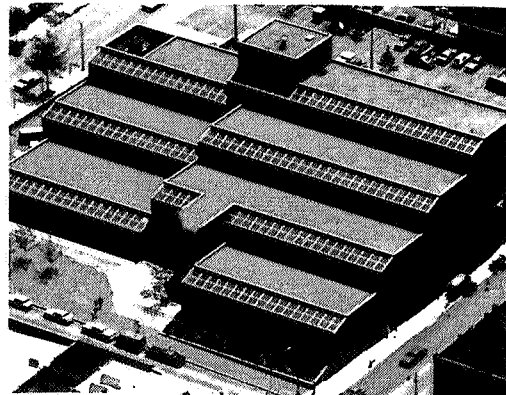
Figure 8. Schematic and Photograph of Federal Building in Ann Arbor, MI

**ANN ARBOR FEDERAL BUILDING  
Schematic of First Floor**

**ANN ARBOR FEDERAL BUILDING  
Schematic of East Elevation**

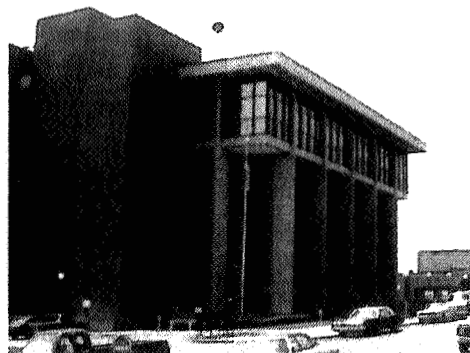
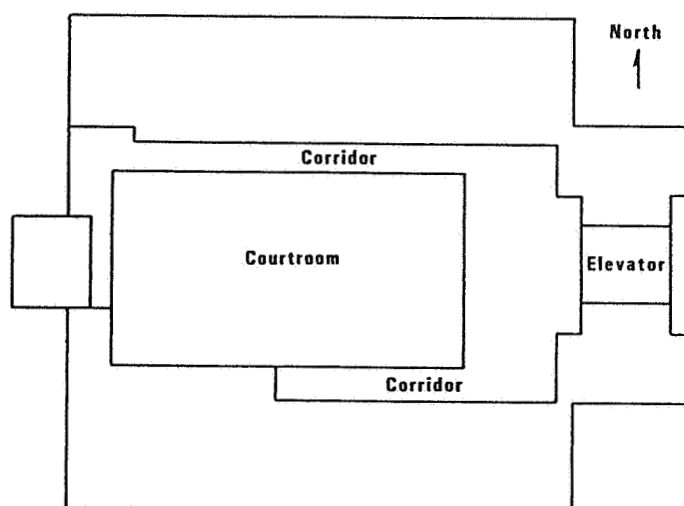
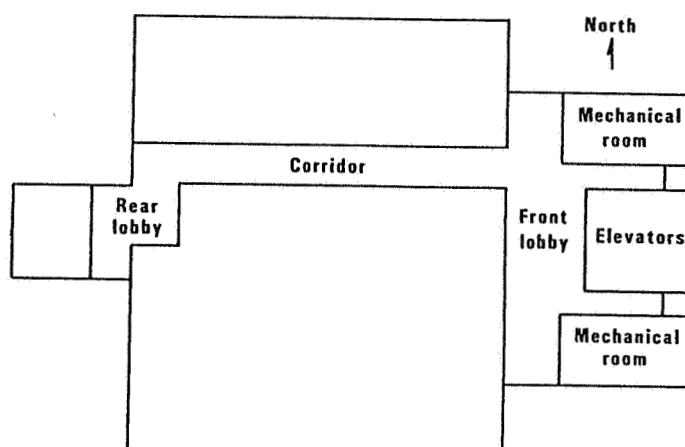
Figure 9. Schematic and Photograph of Federal Building in Fayetteville, AR

**FAYETTEVILLE FEDERAL BUILDING**  
**Schematic of North Elevation**

Elevator room		▲ Sample locations	Courtroom fan
Mech room	▲ 5th Floor	Courtroom ▲	
Mech room	▲ 4th Floor		
Mech room	▲ 3rd Floor		
Mech room	▲ 2nd Floor		
Mech room	▲ 1st Floor

**FAYETTEVILLE FEDERAL BUILDING**  
**Schematic of Fifth Floor**

**FAYETTEVILLE FEDERAL BUILDING**  
**Schematic of First Floor**

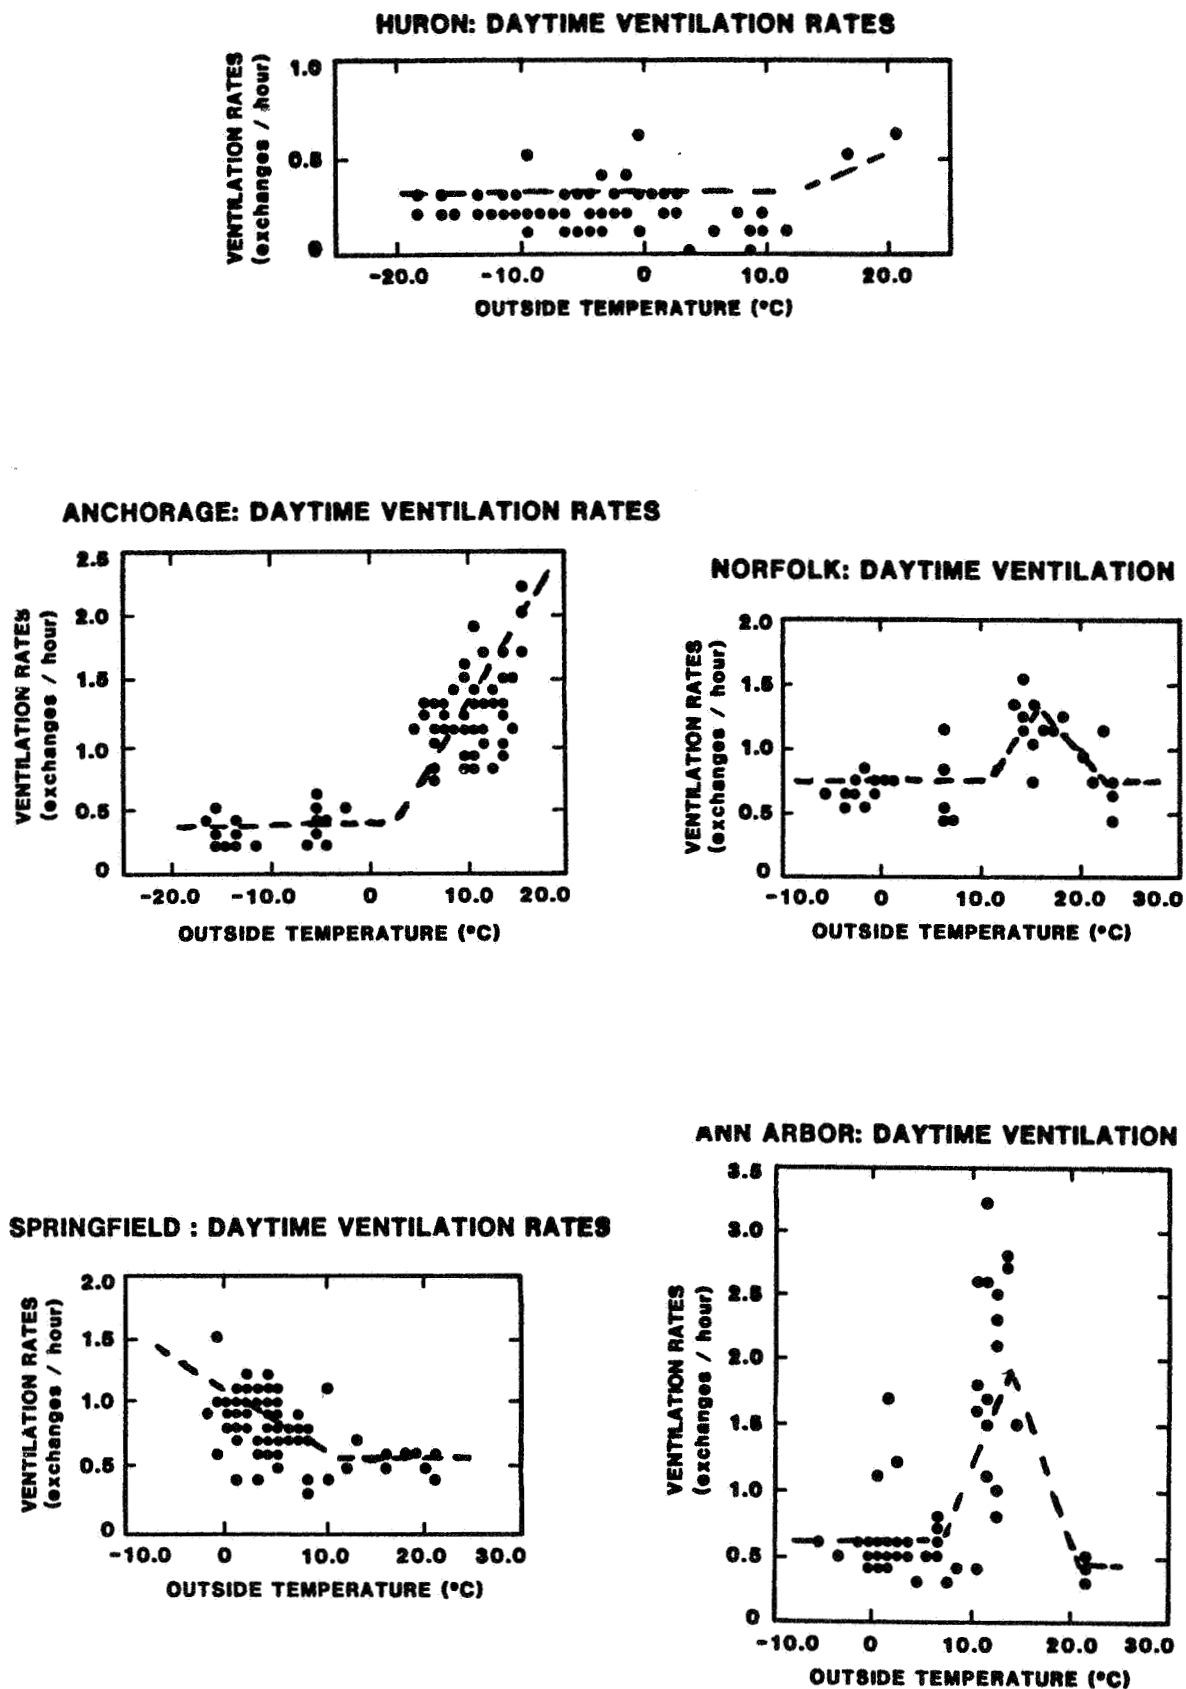
Figure 10. Ventilation Rates Versus Outdoor Temperature for Various Office Buildings

The results of these measurements are summarized in tables 3 to 10 and figures 10 to 12. The data has been categorized in the ventilation rates experienced during occupied periods, infiltration rates for wind speed less than 2.5 M/S and infiltration rates for wind speed greater than 2.5 M/S. Tables 3 to 10 give the average air exchange rates for various temperature bins. A study of the data in figure 10 and tables 3 to 10 show three distinct patterns in the ventilation rates in the eight buildings. The building in Huron shows little change in the ventilation rate during occupied periods over all

temperature bins with the possibility that the ventilation rate raises for the temperature bin 10 to 20 °C. The building in Anchorage shows this raise in temperature clearly. The buildings in Norfolk and Ann Arbor have low ventilation rates at both low and high temperatures with increasing ventilation rates in the temperature bin 10 to 20 °C. This increase is due to use of outdoor air of cooling of the building. The building in Springfield has a fairly constant ventilation rate in the temperature bin 10 to 20 °C and an increasing ventilation as the temperature decreases. This is probably due to the increase in infiltration as the temperature decreases for this building (figures 11 and 12). These trends in the data are indicated by the dotted lines in figure 10. The minimum ventilation rates for these buildings are given in table 11. As can be seen by examining the data, some of these building under certain weather conditions violate these minimum ventilation rates.

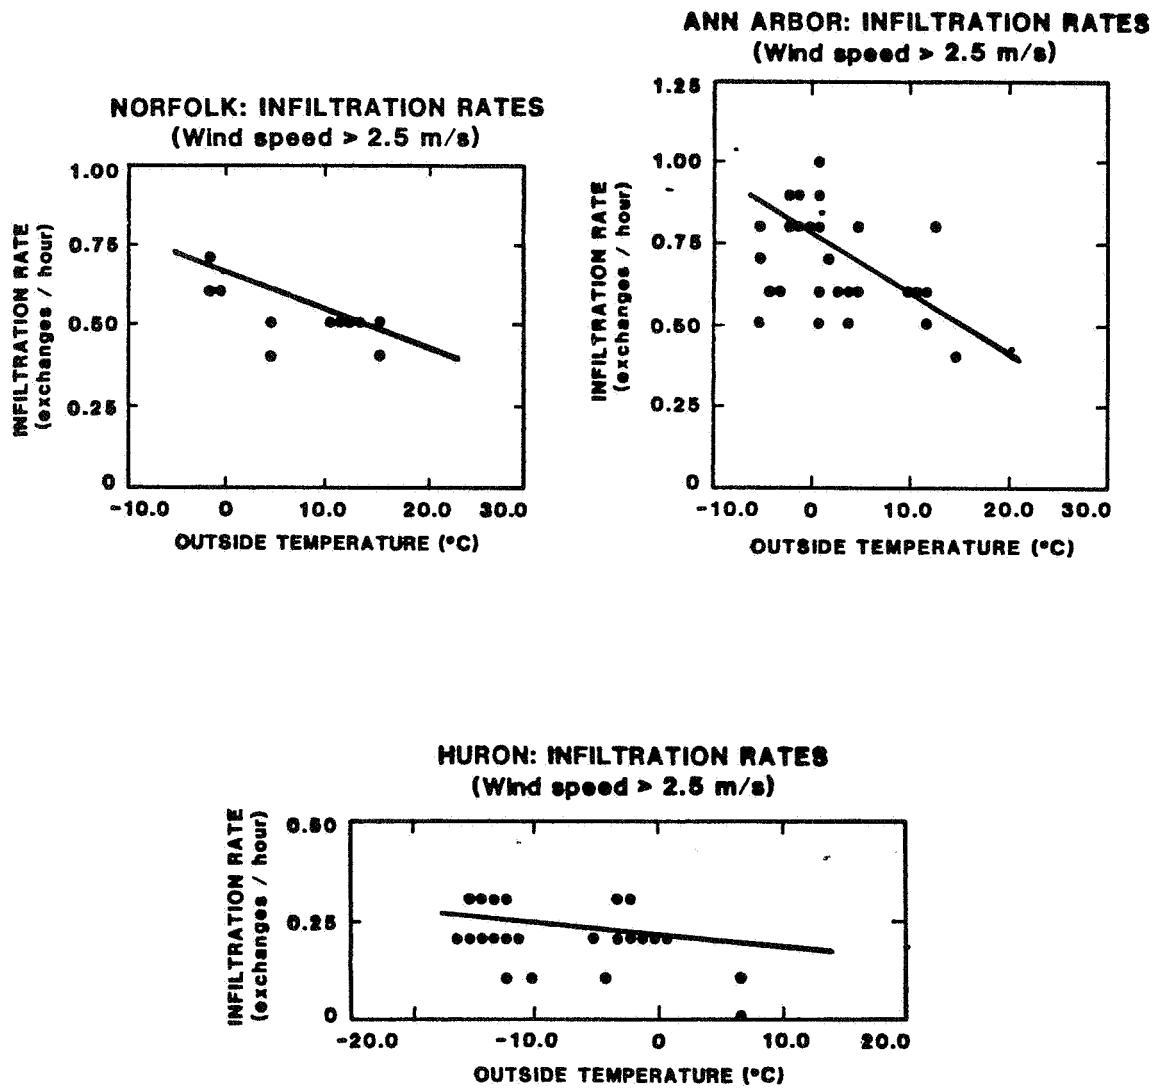
Figure 12. Infiltration Rates Versus Outdoor Temperature for Speed Greater Than 2.5 M/S

The air infiltration rates for some of the buildings are show in figures 11 and 12. In general, though there is considerable variation in the data, it can be seen that lower exterior temperatures produce higher air infiltration rates and higher wind speeds produce higher air infiltration rates. Fitting a regression line to the data in figures 11 and 12 produce the following relationships between the temperature and air infiltration rates:

Wind Speed Greater Than 2.5 M/S

Norfolk:

$$I = 0.64 - 0.0085 T_{out} \quad r^2 = 0.60$$

Ann Arbor:

$$I = 0.80 - 0.0115 T_{\text{out}} \quad r^2 = 0.15$$

Huron:

$$I = 0.24 - 0.0021 T_{\text{out}} \quad r^2 = 0.07$$

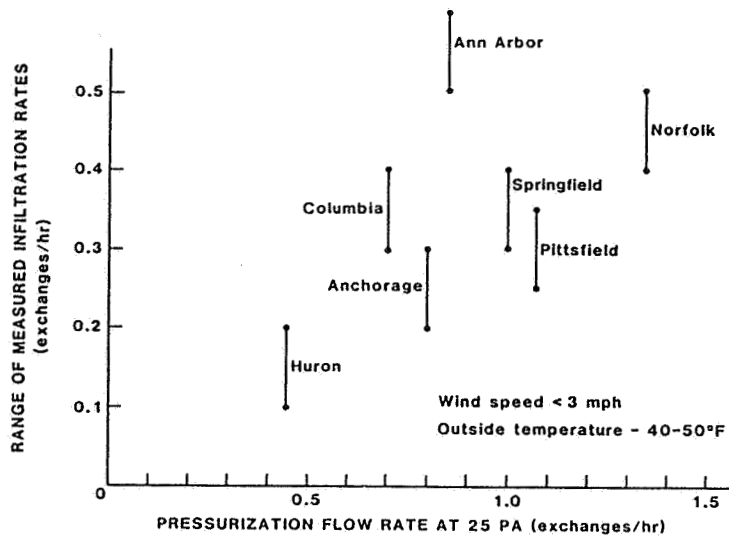
Figure 13. Correlation of Air Infiltration Rates Versus Induced Air Exchange Rates at 25 Pa

From the data in table 12, it can be seen that there is correlation between the pressurization measurements and the tracer gas test results. Bearing in mind that the tracer gas results are preliminary and made only under approximately the same weather conditions, infiltration rates have been plotted against pressurization results in figure 13. The correlation between the two measurements

appears to be fairly strong. The slope of a line passing through all the points is roughly 0.5. If one adjusts the 25 Pa flows to 50 Pa flows using the rough correction factor of 1.5, then the slope of infiltration against 50 Pa flow is about 1/3. This compares to the slope for residential buildings which is about 1/20.

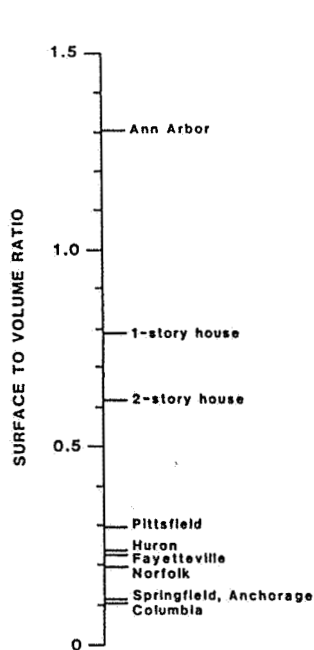
Figure 14. Distribution of Surface to Volume Ratio Among Federal Offices and Residences

In comparing the pressurization test results of the federal buildings to each other and to residential buildings, the important factor of surface to volume ratio arises. Figure 14 shows the surface to volume ratios (S/V) for the federal buildings and two sample homes. The 1-story house is assumed to have a 120 M<sup>2</sup> square floor area and 2.5 M ceilings. The 2-story home also has a square floor plan with 100 M<sup>2</sup> on each floor and a 5 M building height. We see in the figure that the large sizes of the federal buildings generally lead to lower values of S/V than for homes. The Ann Arbor building is an exception due to its particular design.

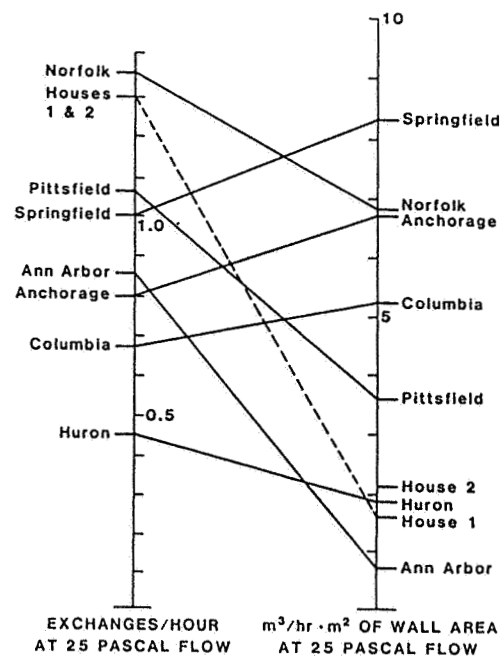
Figure 15. Pressurization Test Results Comparison of Ranks

One may adjust the pressurization test results in table 12 to take into account the different values of S/V among the buildings. Table 12 gives the 25 Pa leakage rate in building volumes per hour. This number divided by S/V, yields the 25 Pa flow rate in m<sup>3</sup>/hr per m<sup>2</sup> of exterior surface area. This second flow rate is more of a measure of "construction quality" than the first flow rate. Figure 15 compares these two measures of leakiness. The vertical scale on the left shows the 25 Pa flows in exchanges per hour for the seven federal buildings and the two sample houses (2.0 exchanges/hr at 50 Pa, extremely tight). The vertical scale on the right shows the 25 Pa flows in m<sup>3</sup>/hr-m<sup>2</sup> as discussed above. We see that in moving from exchanges/hr to m<sup>3</sup>/hr-m<sup>2</sup> the tightness ranking of the buildings changes significantly. Also, the spread in the leakage values using the second measure is larger than the spread in exchanges per hour. The most significant change occurs in the Ann Arbor building which is of average tightness as measured by exchanges per hour but is the tightest building in terms of m<sup>3</sup>/hr-m<sup>2</sup>. Thus, the Ann Arbor building has the tightest construction per m<sup>2</sup> of wall area, but its design leads it to appear relatively leakier than many of the other buildings as measured by the flow in exchanges per hour.

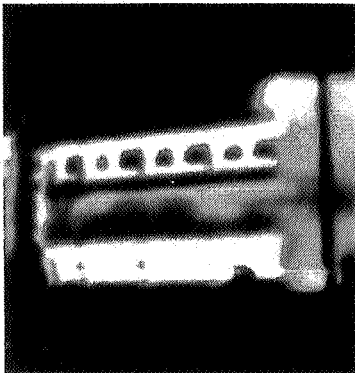
Pittsfield - Air Penetration  
in Wall

Figure 16. Sample Thermograms Showing Air Leakage Sites in  
Office Buildings

show the location of several classes of air infiltration sites in these buildings. These are summarized in table 13. Figure 16 shows some examples of the thermograms produced. A more complete discussion the the results of the thermographic surveys can be found in references 3 and 4.

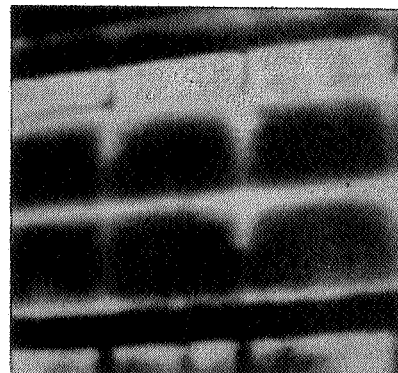
Ann Arbor - Air Penetration  
at Wall-Floor Joint

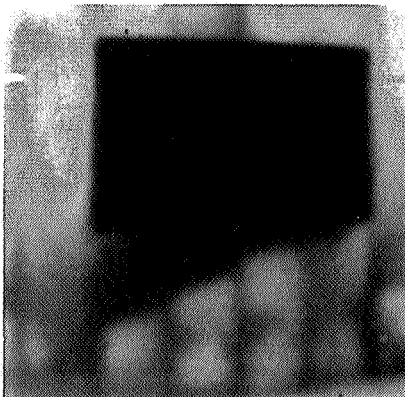
Columbia - Interior  
Air Penetration  
from Window
