# TESTING A METHOD FOR THE EVALUATION OF THE AIRTIGHTNESS OF VENTILATION SYSTEMS IN EXISTING BUILDINGS

P. Barles<sup>1</sup>, X. Boulanger<sup>2</sup>, S. Buseyne<sup>2</sup>

### Example of detailed results: Middle School building

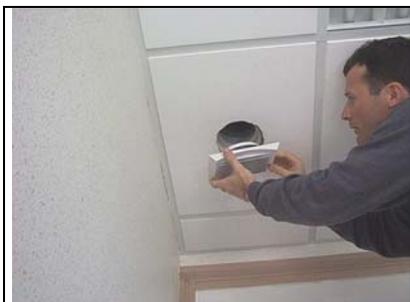
<p>Picture 2: Removing an exhaust air terminal device (exhaust ATD)</p>	<p>Picture 3: Connection between a flexible duct and a rigid duct</p>	<p>Picture 4: Terminal part for the exhaust ATD connection</p>

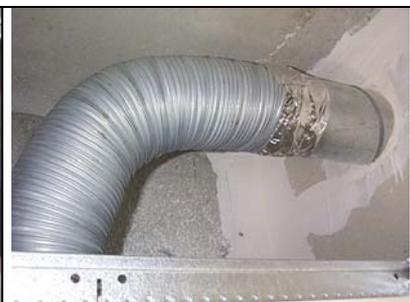
- For sealing the exhaust ATD, small balloons were used, without any difficulty;
- The links between flexible ducts and rigid ones (on the terminal parts of the ductwork) appeared not to be very airtight ; one reason is the lack of specific connection component;

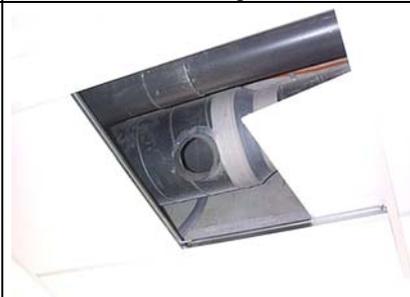
- One open connection duct was found inside a coffered ceiling (125 mm diameter); it was then sealed with a special cap;
- Some connections between exhaust ATD were visibly not airtight at all; (these terminal defaults are not taken into account in the global network leakage evaluation, because the small balloons were placed downstream)

<p>Picture 5: Preparing the small balloons to close up the exhaust ATD</p>	<p>Picture 6: "open duct", which was discovered inside the coffered ceiling</p>	<p>Picture 7: Smoke test for leakages visualization; here, the connection is well mounted and airtight</p>

It seems that the poor quality of the airtightness of the ventilation system is often due to the terminal parts of the ductwork; further investigations on another multi-family building revealed strong defaults (see picture n°8, below) which led to higher leakages values. Bad airtightness is also due, in some cases, to major errors like an open duct without any ATD (see picture n°6, above); a visual inspection before coffering the ceiling would allow to avoid such a mistake.

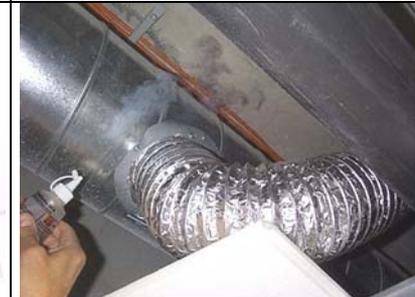
- The links between the main ventilation duct and the secondary ducts were airtight, due to the use of tape and mastic (no leakage could be visualised with the smoke test) ; also along the main duct, the connections between duct components (deviations, reductions) were visibly airtight;

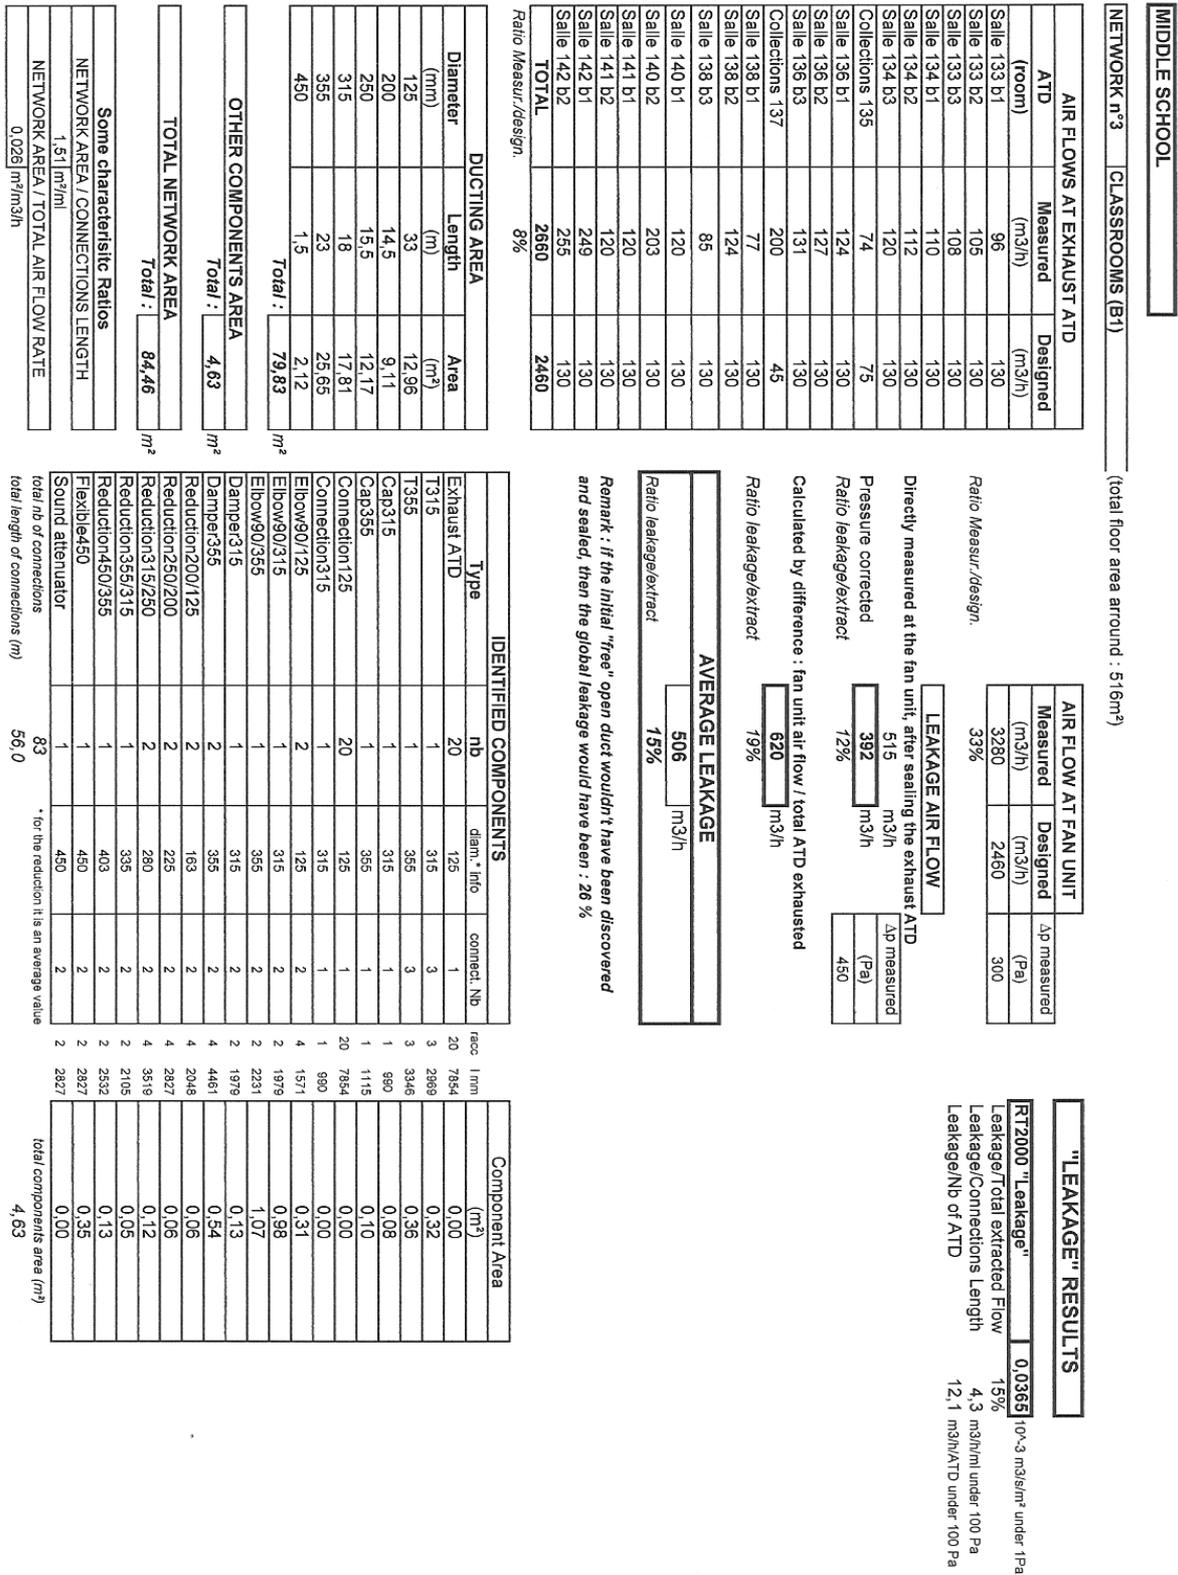
The ductwork leakage is expressed in m<sup>3</sup>/h and also, according to the French regulation, in 10<sup>-3</sup>m<sup>3</sup>/s/m<sup>2</sup> under 1 Pa. Other ratios are calculated, for example “leakage/total extracted air flow rate”.

Figure 1: Detailed results for the network n°3, in the Middle School

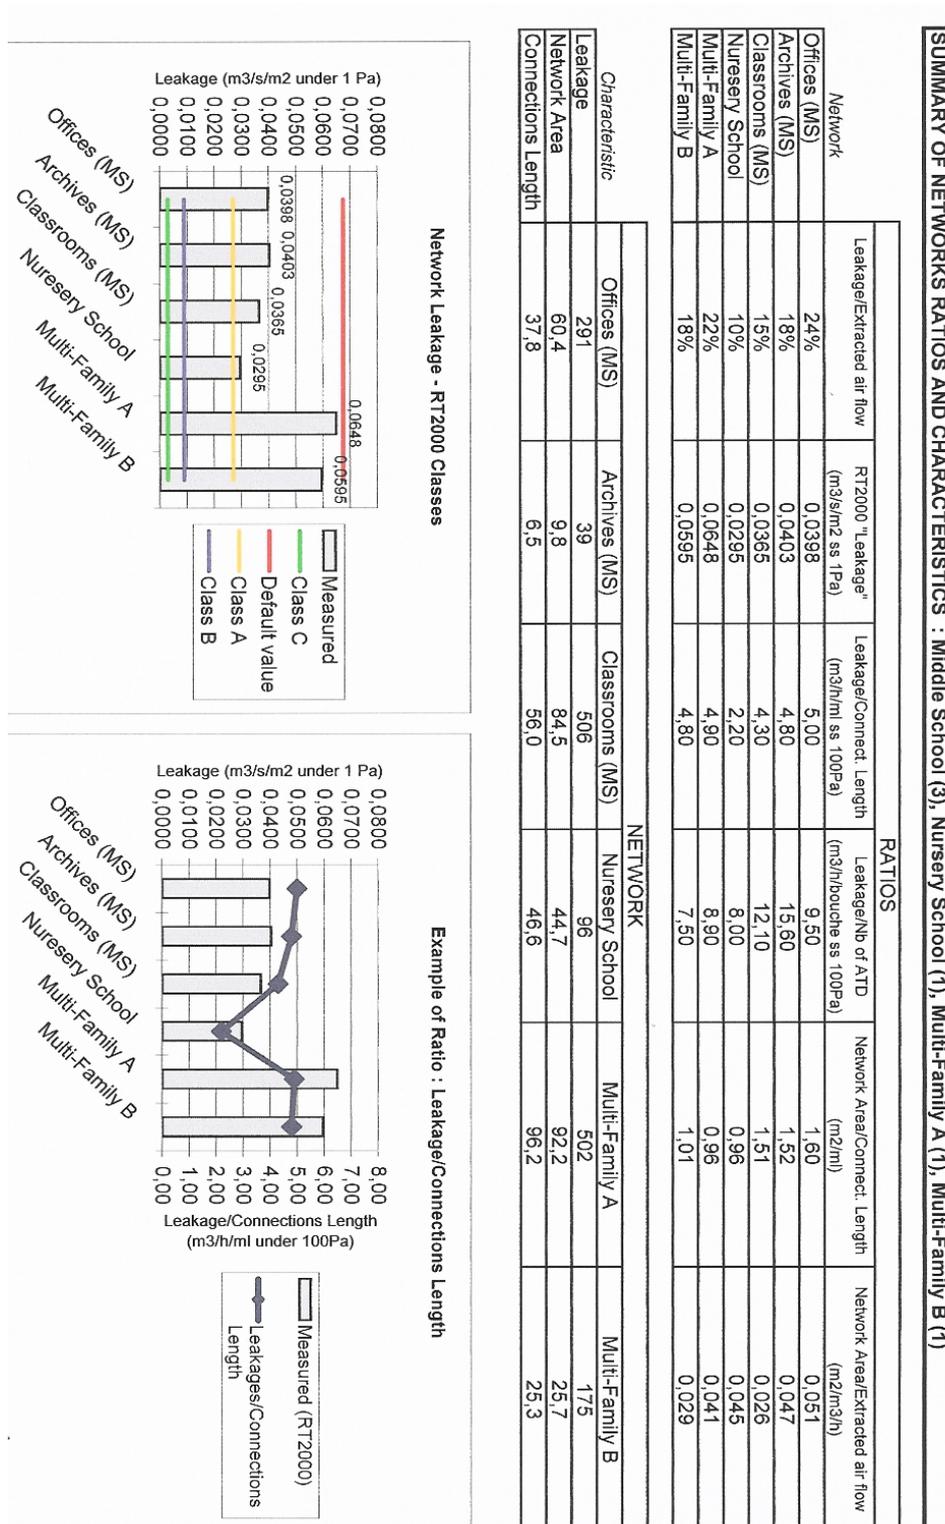
Different ratios are presented, and also, on the graphs, the situation of the different systems by comparison with the leakages classes according to the French regulation.

Figure 2: Tables and graphs, showing the leakages and the characteristics of the 6 ventilation networks which were studied: Middle School (3), Nursery School (1), Two Multi-family Buildings (2)

None of the tested ventilation ductworks fulfilled the Class A requirements for leakages, according to the new French regulation RT2000. Leakages values were comprised between Class A and the default value (the default value is 2,5 higher than the Class A). For the two multi-family buildings the airtightness of the ventilation system was comparable, and close to the default value, according to RT2000; both cases were significantly worth compared to the others.

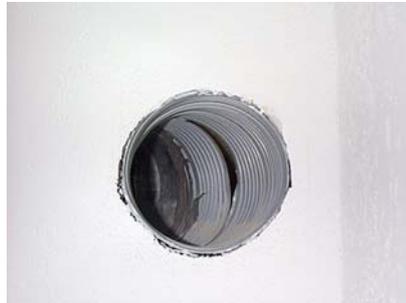
Picture 8: (Multi-Family Building) Connecting duct (flexible) with a strong leakage (the ATD has been removed, it was directly – and bad – mounted on the connecting duct)
