# **BLOWER DOOR TESTS (EN 13829) FOR QUALITY ASSURANCE: GETTING AIR-TIGHT BUILDINGS IN RETROFITTING, TOO**

**Sigrid Dorschky**

*BlowerDoor GmbH, Energie- und Umweltzentrum, D-31832 Springe, Germany*

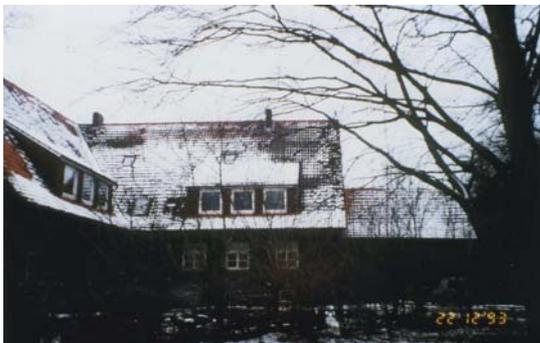
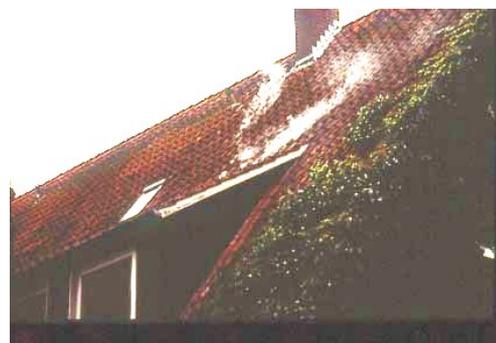
Figures 1+2: Thawed snow and the appearance of fog at 50 Pa pressurization show how air is flowing at the internal walls, beam ceilings and attic areas, and that there are energy losses in spite of the 200 mm insulation thickness.

The first measurements of airtightness on an old German building (1920) were carried out as early as 1989 at the energy and environmental center e-u-z, Springe. The faults that we know to be typical were observed: During the development of a large attic storey apartment at the beginning of the 1980s, an insulation thickness of 200 mm and more was installed. At the time, this was revolutionary, but the creation of airtight joints was not given any consideration. The result was that the occupants complained about the difficulty of keeping their rooms warm when the cold, east winter wind blew against the broad side of the house. When the wind was strong, granulated cork trickled out of the beam sealing; when the weather was particularly cold, condensed water dripped into the bathroom and kitchen from the surrounds of the skylight windows. The radiator against the jamb wall of the house once froze. The thawed snow always made it very easy to see from the outside how warm air was flowing out along the joints to the beam ceiling and the interior walls. With 50 Pascal pressurization, artificial fog emerged from exactly these points.

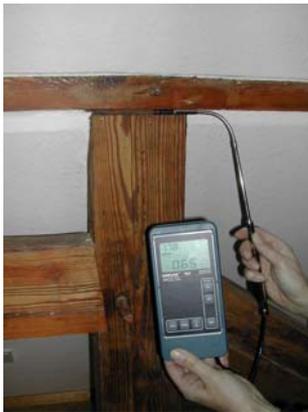
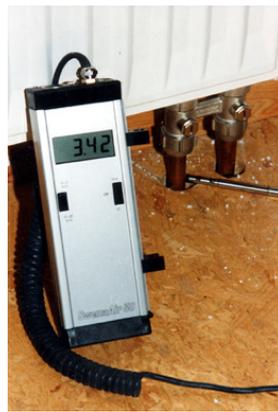
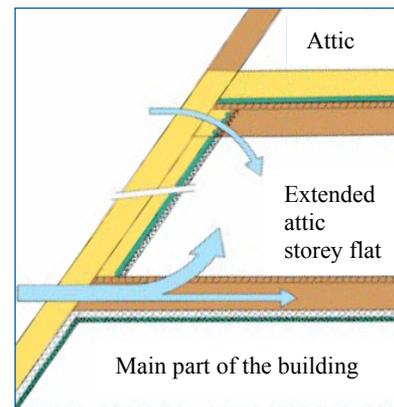
Figures 3,4,5: Draughts at the joint between post and center purlin (0.65 m/s); flow through the ceiling (air flow rate at the ceiling opening 3.4 m/s) due to incomplete airtight layer at the ceiling joint

The overall airtightness of the extended attic storey apartment could not be measured, since an adequate differential pressure could not be reached: With an open BlowerDoor fan with a flow capacity of approx. 8000 m<sup>3</sup>/h [3], and with an apartment volume of approx. 500 m<sup>3</sup>, this means that  $n_{50}$  is greater than 16 h<sup>-1</sup>. By comparison, the limit value for buildings with window ventilation in the Hessian Promotion Program for Low-Energy Houses [4] was  $n_{50} \leq 3$  h<sup>-1</sup>. The reason for this extremely high value is to be found on the one hand in the absence of an airtightness concept for the attic storey, and on the other in the leaks to the main part of the building underneath. Both of these types of leakage are typical for attic storey extensions, even today.

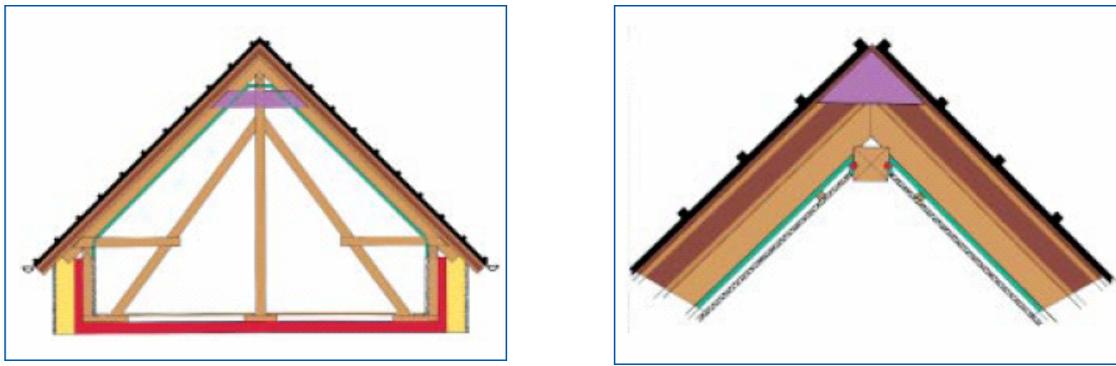
Figures 5+6: Original design offered by the static engineer to reinforce the ridge purlin for the rafters: penetrating shackles which cannot be easily, economically and permanently sealed ... and the alternative that was built: triangles at the tips of the locking rafters outside the airtight layer, attached along the ridge purlin

The static engineer almost made nonsense of this plan again: due to the planned doubling of the rafters (Agepan webbed beam AS 160), each pair of rafters was to be reinforced in the center by two shackles nailed to the side - this would have resulted in 36 new holes! This imposition was discovered just in time before obtaining the quotation. The solution was to fasten the Agepan beams above the ridge purlin by means of triangular boards - without penetration.

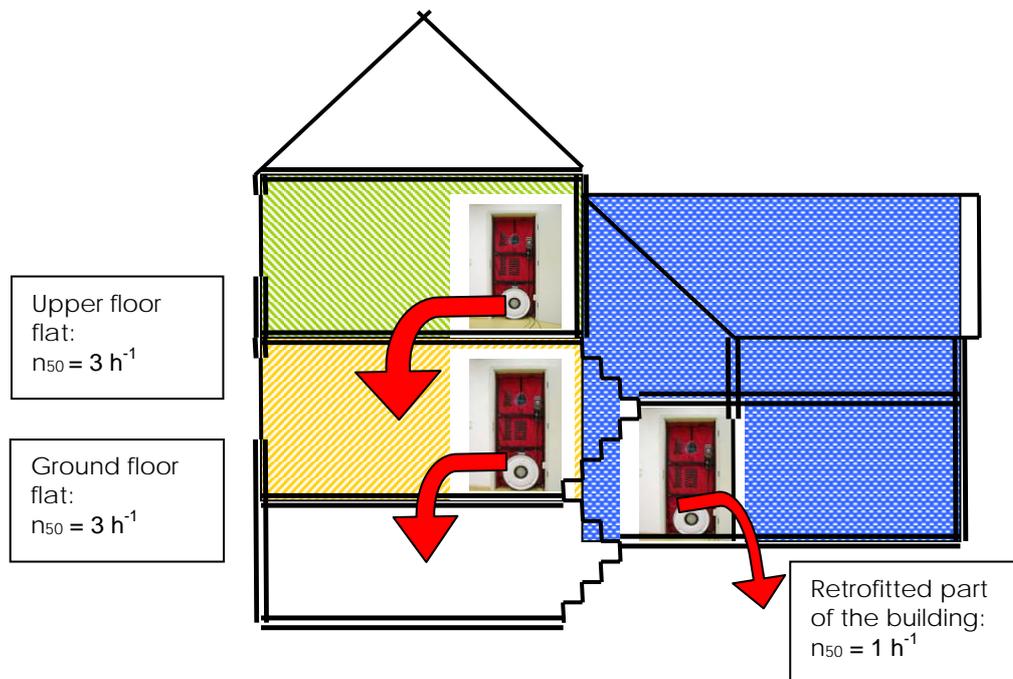
Figure 7: Guard Zone Measurement with 3 BlowerDoor systems to determine the air permeability of the improved part of the building (and at the same time for the unchanged part of the building, consisting of two apartments)

Using Guard Zone (or Deduction) Measurements with two BlowerDoor systems, of which one was mounted in an external door and the second was mounted in the apartment doors, it was possible after several series of measurements to confirm an  $n_{50}$  value of  $1.2 \text{ h}^{-1}$ , with a scatter of 10%. In a further Guard Zone Measurements with three BlowerDoor systems built into the external door and into a window in each apartment, it was finally possible to determine a value of about  $1 \text{ h}^{-1}$  for the extension. A great success, even if the ambitious target was not entirely reached!
