IEQ Direct Reading Instruments – Myths and Realities

Georgi Popov, PhD **Tsvetan Popov, PhD**

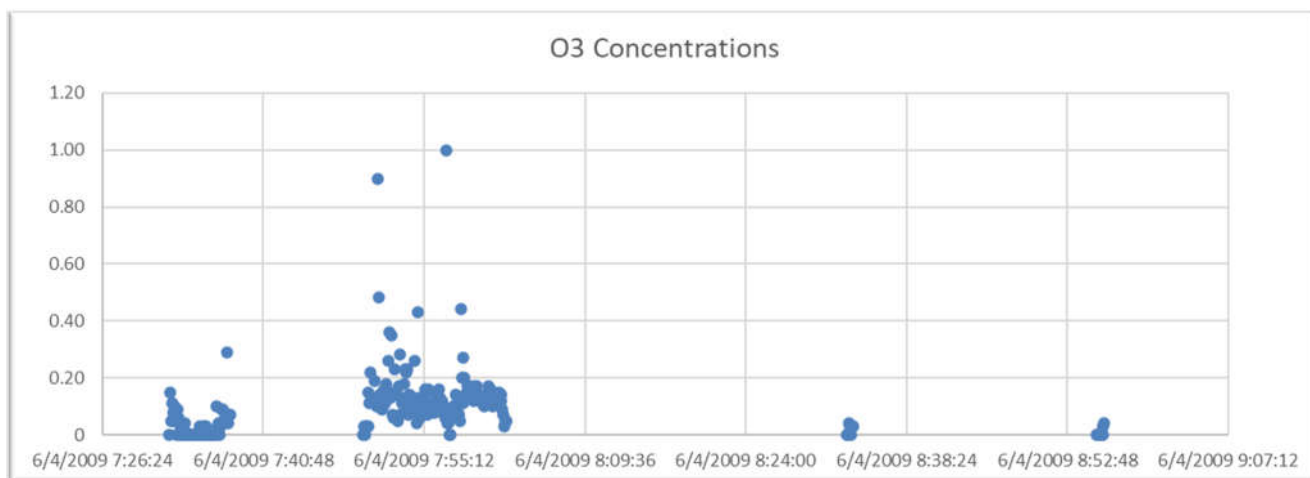
Direct reading measurement systems were used to test the air. The tests showed the presence of trace concentrations of VOC's, Chlorine, Ammonia, Formaldehyde, and noticeable concentration of Ozone. It is a common perception that O₃ direct reading instruments would display exact concentration based on the instrument's 30 seconds response time. It turned out that some O₃ sensors are affected by VOCs, Chlorine, and outer pollutants. At the time of the survey, O₃ concentration significantly spiked during constant documents printing. However, it was estimated that approximately 50% of the measured O₃ concentration could be attributed to the cleaning of office surfaces with alcohols and bleach (Chlorine). An example of a time plot using O₃ sensor data is shown in Figure 2.

Figure 2 Time plot using O₃ sensor data.

Additional O₃ samples were collected utilizing traditional IH methods. Subsequent laboratory analysis showed that the actual O₃ concentration was <0.036 ppm. However, one of the disadvantages of traditional sampling methodology is that the assessor will not be able to see the spikes in concentrations. Therefore, it is always advisable to perform both direct reading instruments and traditional testing to compare the results.

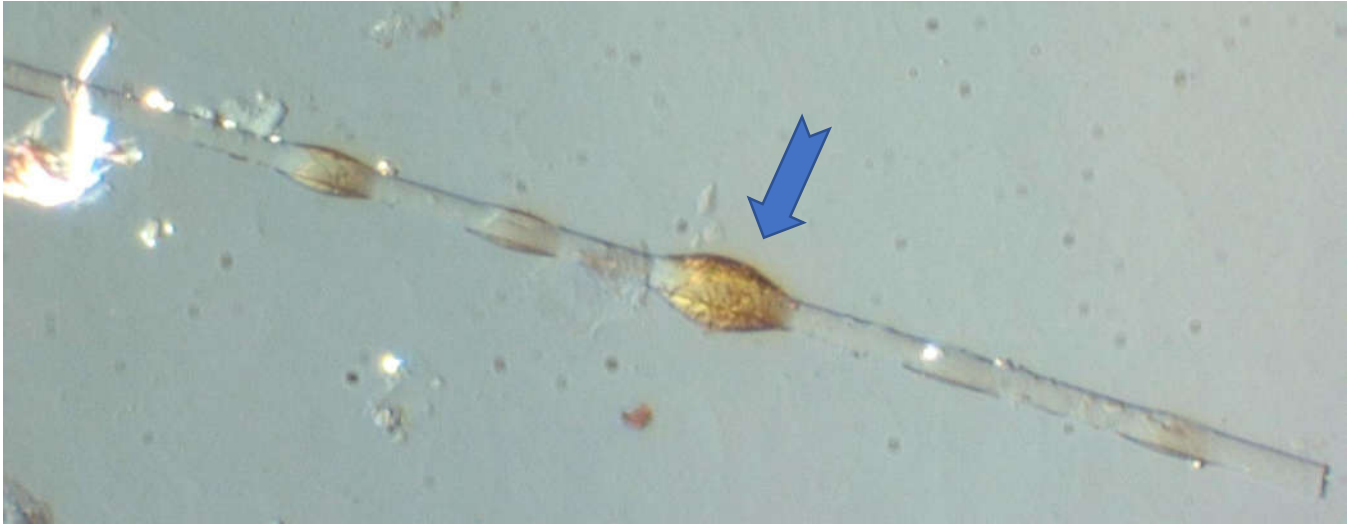
monitoring device. While US OSHA currently has a permissible exposure limit (PEL) for airborne particulates not otherwise regulated (PNOR), which includes fibrous glass, the agency does not have a specific PEL for the fiberglass. However, the ACGIH recommended airborne exposure limit is 1 fiber/cubic centimeter (cc). Relying only on a dust monitoring system, an industrial hygienist may easily miss the fact that some of these fibers are smaller than 2.5 μm in size. Additional concern may be phenol-based formaldehyde binders commonly used in batt fiberglass insulation and flooring materials. An example of aldehyde binder on fiberglass fiber is presented in Figure 3.

Figure 4 Yellow Acoustic Ceiling Tile Glass Fiber (source: MicrolabNW).

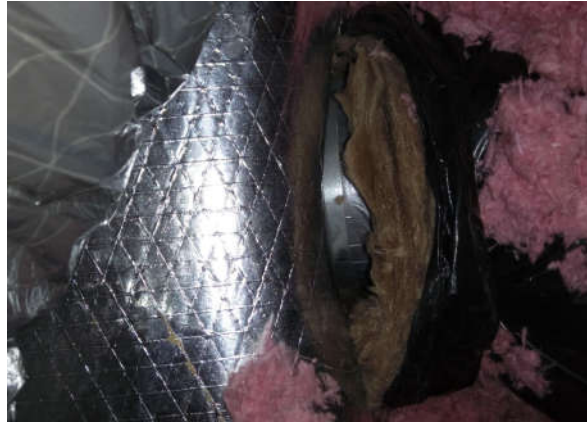
As mentioned earlier, due to renovation efforts, a new flex duct was installed above the ceiling tiles. The flex duct contains significant amounts of fiberglass and aldehyde binder. A closer look will reveal that the flex duct was not even fitted properly allowing introduction of loose fiberglass fibers to be introduced in the air stream due to duck leakage. Please see depiction on Figure 6 for details.

Figure 6 New flex duct was installed above the ceiling tiles
The installation technician decided to shorten the flex duct and installed the supply air close to the return air grille without realizing that such arrangement does not provide the proper ventilation rate. Ventilation rates can be easily assessed with direct reading instruments as well. Some of these instruments are combined with CO and CO₂ sensors. Ductwork pressure testing should have been performed to determine how well ducts are constructed to prevent air leakage. An experienced IEQ professional would have addressed insufficient ventilation, duct sealing and elevated CO₂ levels. However, such a variety of direct reading instruments are not always readily available. In the above-mentioned scenario, measurement of single parameters would probably lead to wrong conclusions.
