# THE USE OF BUILDING OWN VENTILATION SYSTEM IN MEASURING AIR TIGHTNESS

## ABSTRACT

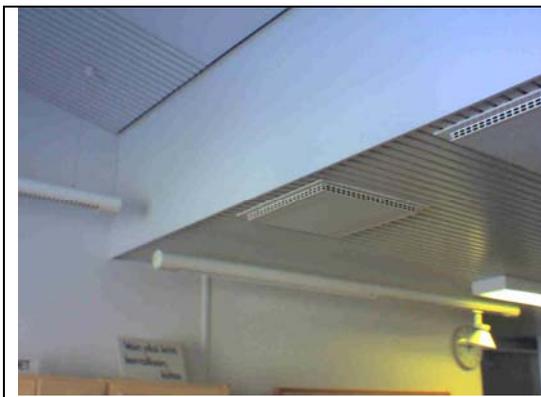
Figure 1. Ventilation duct, inlet to the library

Indoor thermography showed the problems in the library – the surface temperature of ventilation ducts all over the way were low (4 – 5 °C) and the temperature of supplied air was 14 °C (18 °C recommended as minimum). Figures 1 and 2 show the situation in the ceiling – the surroundings of the supplied air duct were cold and also some extremely low surface temperatures in rear part of the library, where the works space of librarians are situated. In the shower room the surface temperatures were below 0 °C at lowest (the outdoor temperature had been very low in the night), which means that there was a risk of condensation and structural damages. The radiators seemed to work properly, and except some leaks from window weather-strip and spotty low surface temperatures in the junction of exterior wall and ceiling. There was no possibility to reach -50 Pa pressure difference using the exhaust fan – by the maximum capacity (100 %) the negative pressure drop was -31 Pa. This indicated leaks. Figure 3 shows the air leak curve. Air leak number must be evaluated using the equation of the curve. N50 was approximately 7 - 8 l/h (changes/hour) which is a very poor result. The acceptable value, taking into account the age of the building and structures could be 2 – 3 l/h at 50 Pa. The eligible value should be 0,5 – 1 l/h at 50 Pa. It was very probable that without very exhaustive repairs it would be difficult to achieve a proper level of air tightness. The actual level of air tightness caused significant uncontrolled leakage air ventilation which will increase the consumption of heating energy. In generally, the library part of the building was very leaky – one reason for that could be the renovation which was carried out in 2007 was not properly done.

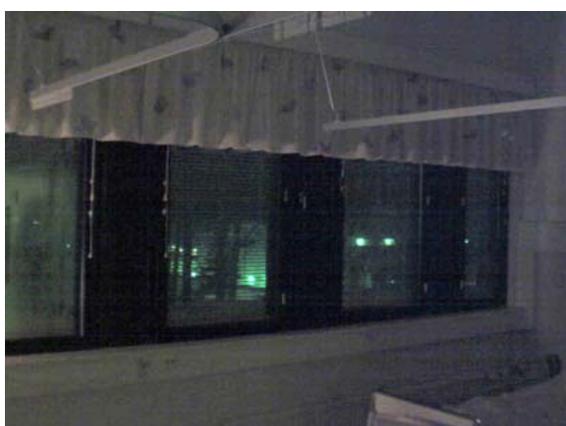
Figure 7. Windows of a sickroom

Figure 6 shows the air tightness curve and results. Air leakage number  $n_{50}$  was 1,9 1/h (changes/hour), which is excepted result but not acceptable if the question would be about a new hospital. The main leaky points were the windows (figures 7 and 8). Because the patients in health centers are mainly elderly people (in this case old long-term or chronic patients), the indoor conditions should be best possible; if there is draft in the rooms, it will be compensated by increasing indoor temperatures, which will increase also energy consumption.

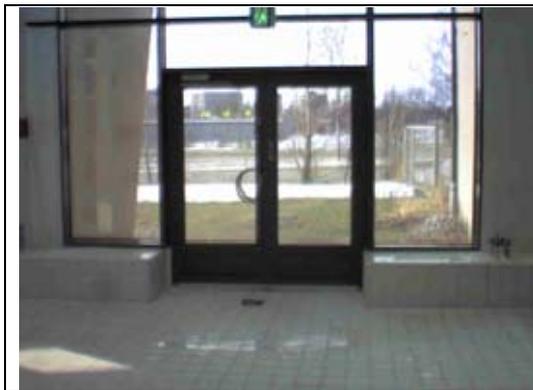
Figure 8. Entrance door of pool unit

Thermal scanning was made both indoors and outdoors before pressurization and during depressurization. Figures 8 – 11 show some of the located leak patterns under depressurization.

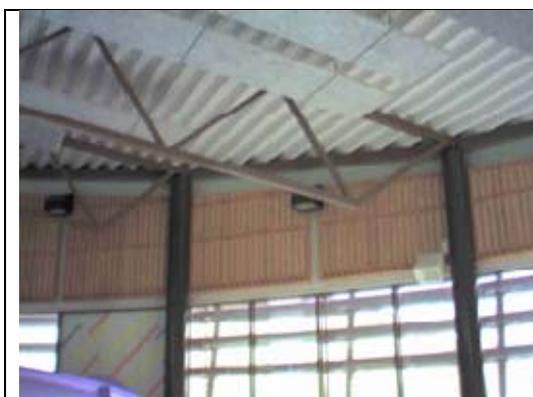
Figure 10. Ceiling of spa

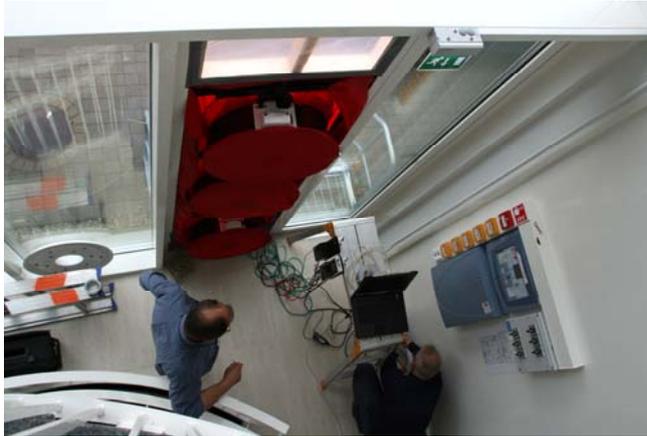
Figure 13. Blower-door

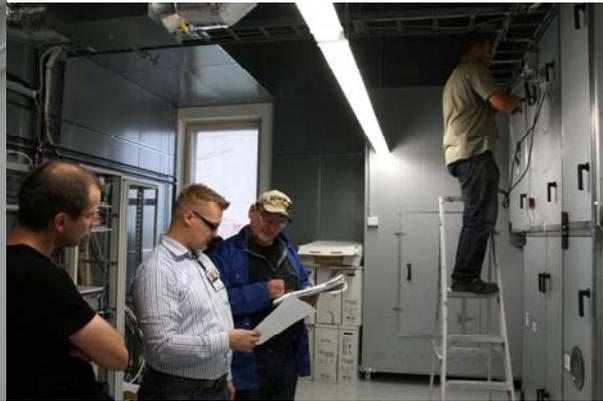
Figure 14. Measurements over the exhaust fan
