Szymanski M., Gorzenski R., Mroz T.: Air tightness of buildings in Poland
Poznań University of Technology

1. Aquapark, Poznan

AIVC 3rd TightVent Workshop on Building and Ductwork Airtightness, Washington DC, April 18-19, 2013

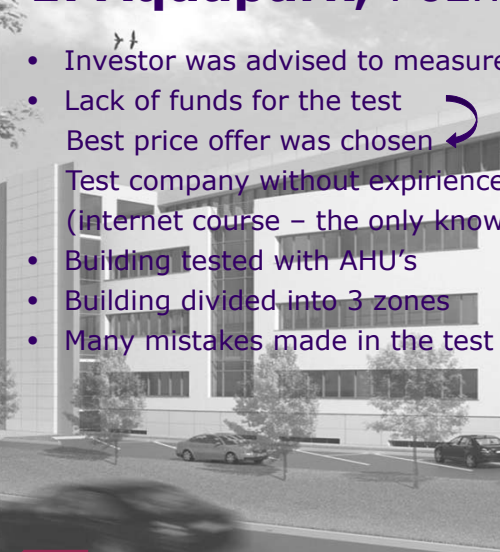
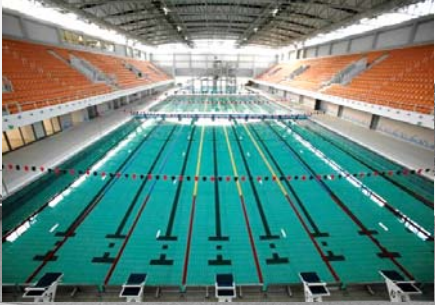
- Investor was advised to measure airtightness of whole building
- Lack of funds for the test
 Best price offer was chosen
 Test company without experience
 (internet course – the only knowledge, theoretical)
- Building tested with AHU's
- Building divided into 3 zones
- Many mistakes made in the test

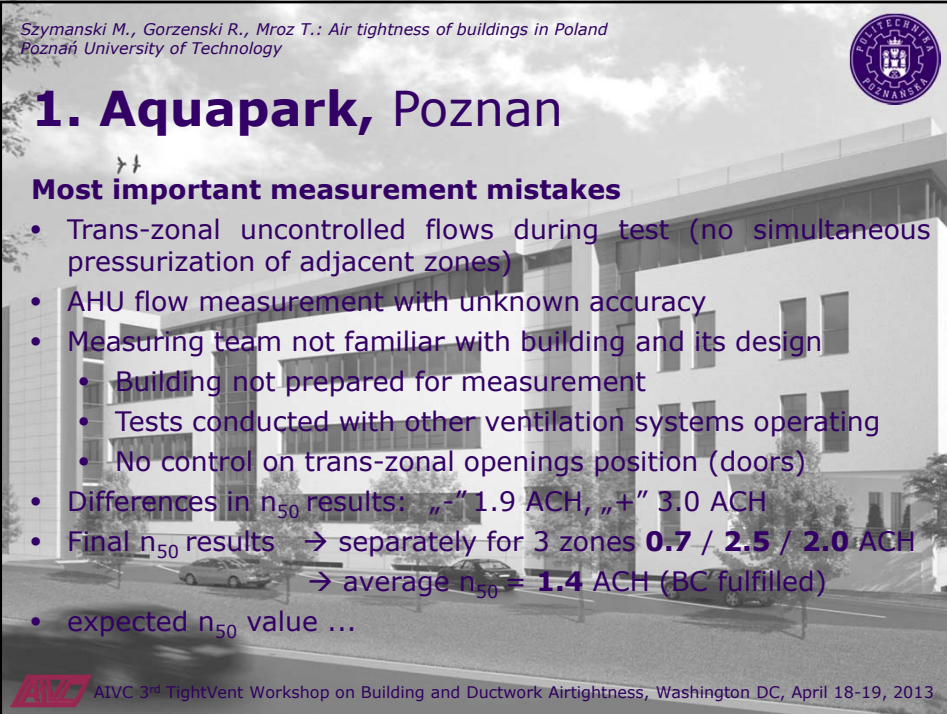
- Trans-zonal uncontrolled flows during test (no simultaneous pressurization of adjacent zones)
- AHU flow measurement with unknown accuracy
- Measuring team not familiar with building and its design
 - Building not prepared for measurement
 - Tests conducted with other ventilation systems operating
 - No control on trans-zonal openings position (doors)
- Differences in n_{50} results: „-“ 1.9 ACH, „+“ 3.0 ACH
- Final n_{50} results → separately for 3 zones **0.7 / 2.5 / 2.0 ACH**
→ average $n_{50} = \mathbf{1.4 ACH}$ (BC fulfilled)
- expected n_{50} value ...

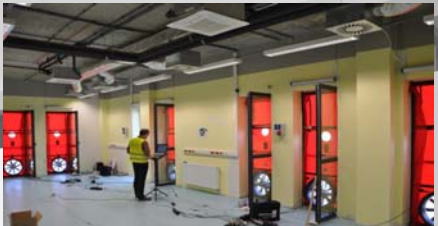
- 6-fan set provided for the test
- 2 fans were sufficient
- $n_{50} = 0,31 \text{ ACH}$
- Another result of quality control was also 48% reduction of primary energy demand for heating and DHW (measured in the 1st year of operation) EP_{H+W}

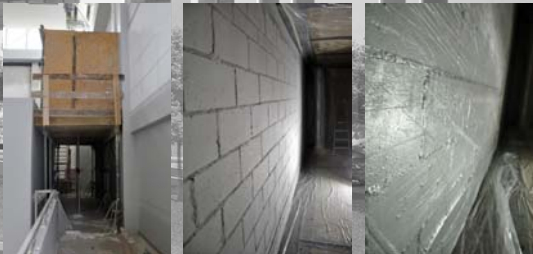
- to avoid condensation of water vapour inside the walls → wall permeability measurement was performed (q_{50})
- wall not plastered from inside and outside, thermally insulated from outside (mineral wool and facade panels)
- test box attached to tested wall surface $18 \text{ m}^2 \approx 200 \text{ ft}^2$
- comparative measurement with & without foil from inside at overpressure conditions
- $q_{50} = 0,5 \text{ m}^3/(\text{m}^2 \cdot \text{h})$
- expected value for unplastered wall
