EXPERIENCES IN THE AIRTIGHTNESS OF RENOVATED TERTIARY EXEMPLARY BUILDINGS IN THE BRUSSELS CAPITAL REGION

2 CASE STUDY 1: EUROPEAN FOUNDATION HOUSE

3 CASE STUDY 2: POLICE OFFICE TRITOMAS

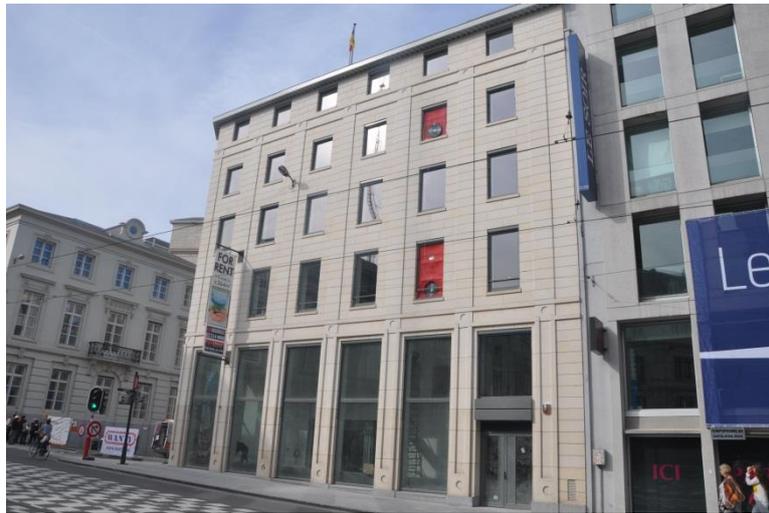
Figure 1: Façade of the EFH building during an airtightness measurement

It was decided to maintain the existing façade of natural white stone (see Figure 1) and the existing concrete structure, including the roof structure. Windows and doors were replaced. In order to obtain the targeted energy performance, the existing 6 cm of mineral wool wall cavity insulation were insufficient and internal insulation had to be added. 20cm of insufflated cellulose were added and an interior finishing of a wooden panel and plasterboard was applied. Extensive research was done on thermal bridging and hygrothermal effects, which were reported by Roger France (2013). More details can be found in Table 1 below.

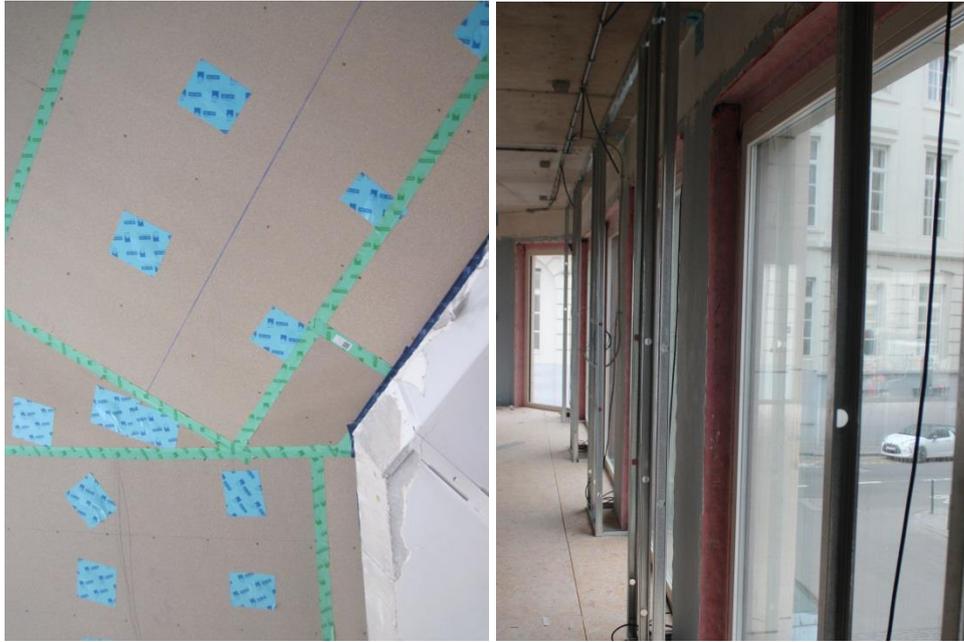
Figure 2: Airtightness tapes on the panel joints - Figure 3: Membranes around window frame edges

Airtightness measures taken were taping of joints of panels (Figure 2), use of airtight membranes around the new windows (Figure 3), the implementation of a motorized ventilation grill in the elevator shaft (Figure 4). An intermediate airtightness test has been realised in an upper corner of the building using a temporary wall, which gave the opportunity of testing both exterior wall and roof (Figure 5). These elements are illustrated in the photographs below. As a conclusion of this intermediate and partial testing, it was found that the airtightness membranes around the window frames were able to minimize infiltration, only minor infiltrations in the corner joints were experienced. It was also shown that the bored holes to screw the metal studs to the concrete did not endanger the airtightness. It was difficult to quantitatively predict the airtightness of the building, given the presence of the (not entirely airtight) temporary wall and its temporary joints with walls and roof. In Belgium, airtightness is usually quantitatively characterized as a n_{50} value, which is the measured infiltration rate (in m^3/h) at a pressure difference of 50 Pa between interior and exterior divided by the interior heated volume (in m^3) of the building. As this worst case intermediate testing yielded a n_{50} value of about $1 \text{ (h}^{-1}\text{)}$ for a building part with several types of walls, corners and joints, it was deemed possible to obtain the same value for the rest of the envelope.

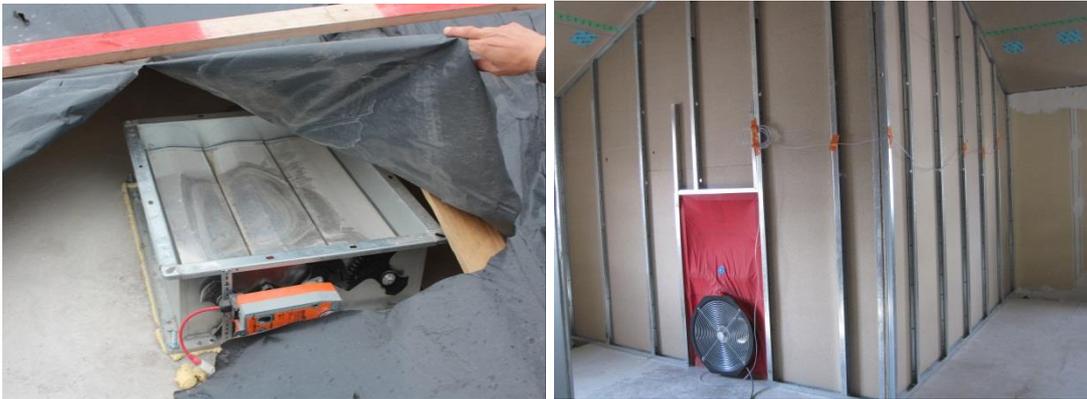
Figure 4: Motorized grill for ventilation shaft - Figure 5: intermediate testing in a corner of the top floor

The final figure of the finished building yielded a n_{50} value of $0,91 \text{ h}^{-1}$, which is considerably better than the $1,5 \text{ h}^{-1}$ originally put forward as a target by the design team during the Exemplary Building competition stage. Given the availability of intermediate results, the influence of certain elements can be estimated. Firstly, the effect of the motorized grills in the elevator shaft can be estimated. These grills are opened whenever there is a need for ventilation in the elevator shaft (elevator movement, rising temperatures, smoke evacuation), but in general they are closed. This is a considerable reduction of infiltration compared to the standard grills which are opened all the time. During the test, the motorized grills can be closed according to the technical guidelines for airtightness testing within the framework of energy performance legislation (Three Belgian Regions, 2013). During one of the intermediate tests, the grill was tested in opened state. At that moment, the blowerdoor was unable to build up the necessary 50 Pa for official testing, and only about 30 Pa was reached at an maximal airflow through the blowerdoor of about $8000 \text{ m}^3/\text{h}$. After closing the grill with a membrane, the measured airflow at 50 Pa was about $6600 \text{ m}^3/\text{h}$. Assuming a square root dependency of airflow to pressure difference, the influence of the motorized grills on the n_{50}

value is $0,3 \text{ h}^{-1}$, corresponding to an airflow of $1800 \text{ m}^3/\text{h}$ at 50 Pa . This proves the importance of this kind of device to achieve airtight buildings.

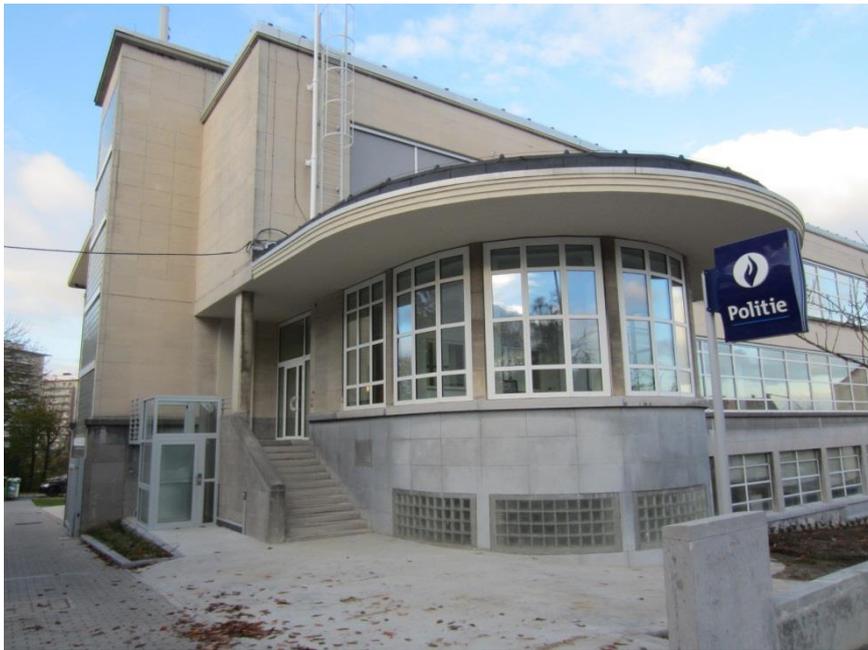
Converting a former telephone exchange building into a modern and sustainable police station, was the challenge of the Tritomas project. Given the modernist architecture, which can be considered as part of Brussels architectural patrimony, the choice was made to maximally preserve the building's exterior, shown in Figure 6. More details of the building are listed in Table 1.

Figure 6: Entrance of the Police Office Tritomas

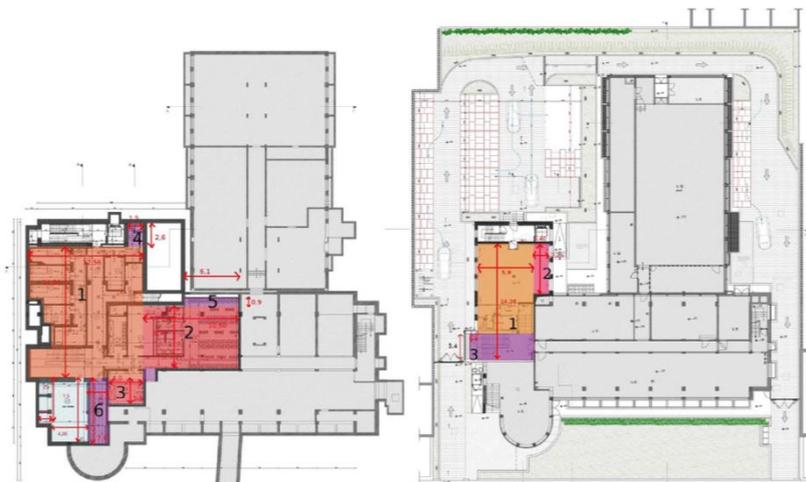
Figure 7: Underground floors (left -2, right -1), coloured zones are part of the renovation project, taken from the test report (Delire et al., 2013)

The technical measures to come to an airtight building were very similar to the first case study, with the use of internal insulation, new windows provided with airtight membranes, ... Particular to this project, was the fact that part of the existing building was not touched during the renovation project, moreover, this was in use throughout the construction works by another user (grey zones in Figures 7 and 8). As a consequence, in order to establish good airtightness for the police station, not only external building envelope, but also internal walls and doors had to be airtight. In this project, an intermediate airtightness test was performed on one level (on the first floor, red zone in Figure 8) in order to check the façade concept (internal plasterboard finishing) and its joints. At the end of the project, a measurement was performed on the entire project.

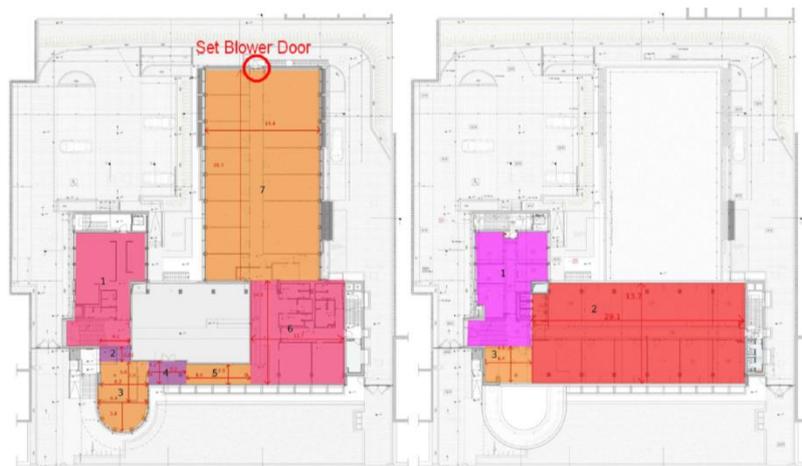
Figure 8: Building floors (left ground floor, right +1), coloured zones are part of the renovation project, taken from the test report (Delire et al., 2013)

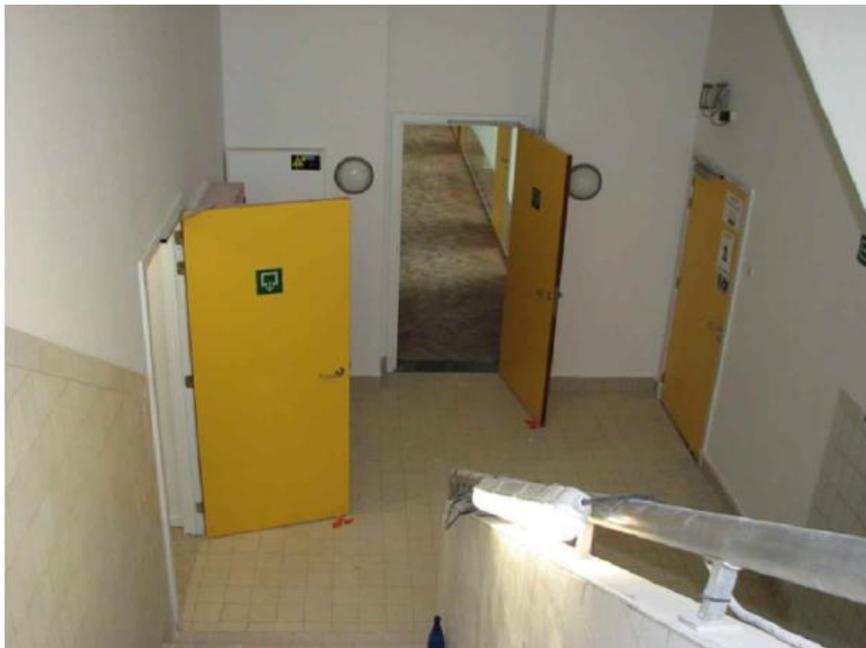
Figure 9: Opened and closed internal doors on the first floor, taken from the test report (Delire et al., 2013)

The result of the intermediate test showed clearly that the applied concepts of façade insulation and window-wall joints for the tested floor were sound, yielding a n_{50} of 0,73 for the tested volume. However, during the testing of the entire building, interaction with the untouched building volume influenced the results. Indeed, during the testing, all doors within the tested volume were opened to enable internal air circulation during the test, and doors to the untouched volume were closed, as shown in Figure 9. As the previous case study showed, doors can influence the airtightness to an important extent. Even when care is taken during selection and installation of the doors – most of the doors were escape exits and had to comply to fire regulations as well – some infiltration losses are inevitable. Given the complex geometrical interface between the tested volume and the untouched volume and the number of doors, the final result of $1,08 \text{ h}^{-1}$ is a very good result, compared to the initial target of 1.5 h^{-1} .
