# AIRTIGHTNESS OF BUILDING PENETRATIONS: AIR SEALING SOLUTIONS, DURABILITY EFFECTS AND MEASUREMENT UNCERTAINTY

Wolf Bracke<sup>\*1</sup>, Nathan Van Den Bossche<sup>1</sup>, Arnold Janssens<sup>1</sup>

*1 Ghent University  
Jozef Plateaustraat 22  
9000 Gent, Belgium*

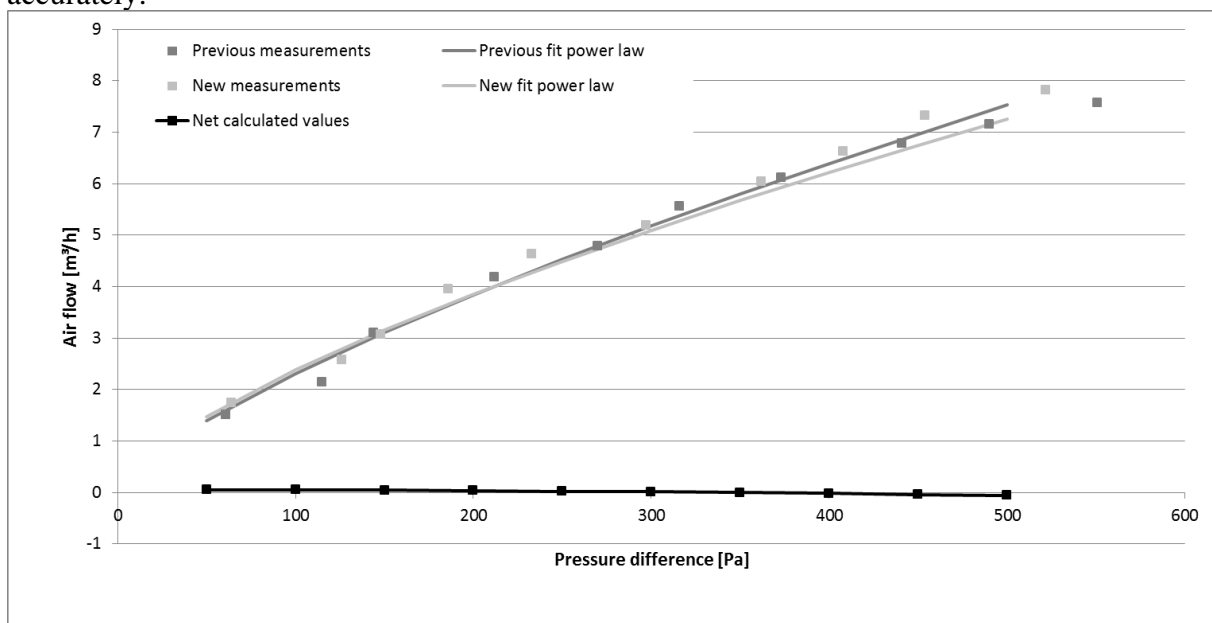
Figure 1: Measurement principle and calculation of net leakage (2 x EPDM gasket Ø 75 mm)

The penetrations tested in Figure 1 are almost perfectly airtight. The power laws fitted through the measurement points of the previous and the new measurement cross each other, meaning the test setup is unable to measure the difference between both measurements accurately.

The results of the 75 mm PVC pipe penetrations are shown in Table 5. Again, tape and PUR show similar results and perform worse than the gasket. The net air leakage rate for the gasket calculated at 50 Pa is higher than the leakage rate at 250 Pa, and for 500 Pa, a negative result is calculated. Because the gasket is almost perfectly airtight, the difference between both measurements could not be quantified by the test setup and subtracting both fitted power laws rendered these physically impossible results. The power laws and calculated net leakage are visualised in Figure 1.

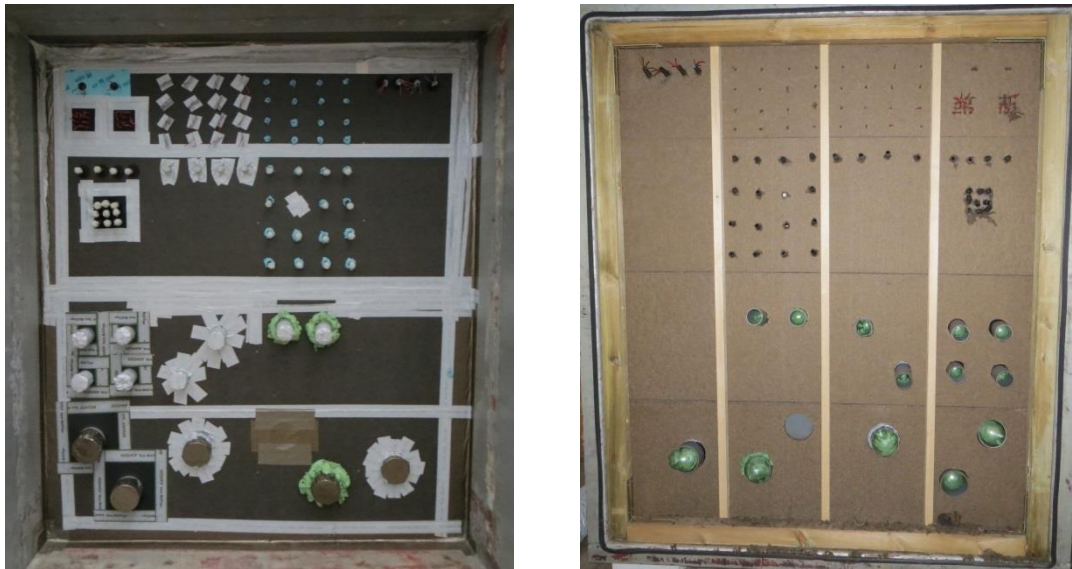
Figure 2: Wood-frame wall with different air sealing solutions in steel test rig

Figure 2 shows the tested wall with different penetration diameters and sealing solutions. The wall is connected airtight to the test rig using butyl-aluminium tape and the joints between the different fibreboards are also sealed to minimize extraneous air loss and resulting measurement uncertainty.

The tests were executed on a full-scale setup built in a steel test rig. A wood-frame wall of 228 cm by 196 cm was built consisting of a framework and exterior sheathing of 18 mm bituminous impregnated fibreboard. As the fibreboard contains more bitumen than most similar products, it does not only act as a rain screen, but also as an additional air barrier next to the interior barrier and provides enough structural stiffness to avoid the need of OSB sheathing on the interior side. To make an abstraction of the real-world situation, the use of OSB panels and interior insulation was omitted in the test setup.

Four different penetration diameters were tested: 4 mm (single electrical cable), 20 mm (ribbed conduit pipe for electrical cables), 75 mm (PVC pipe) and 130 mm (PVC pipe). The openings for the different penetrations were respectively 6 mm, 22 mm, 85 mm and 140 mm. Every case was sealed using three different methods

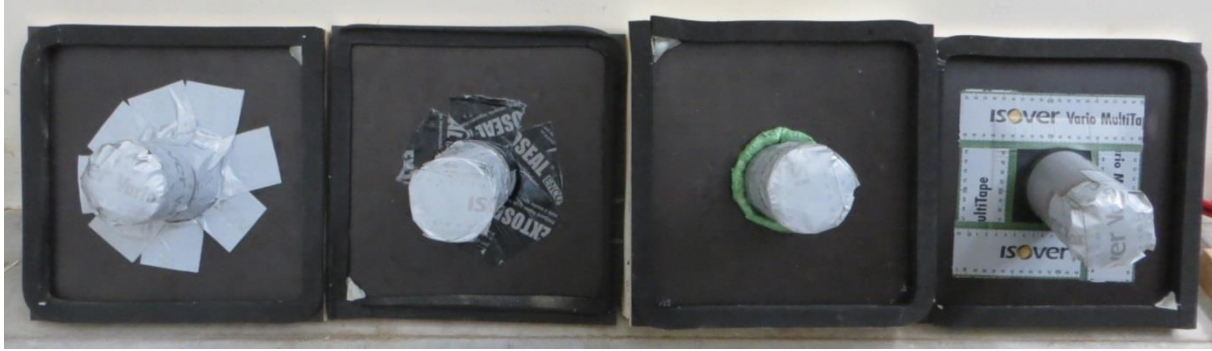
Figure 4: Test specimens: tape (1), tape (2), PUR, gasket

Four specimens were built to test different methods to seal a 75 mm PVC pipe wall penetration in a 90 mm opening.

- PUR: PUR foam was sprayed in the gap (7,5 mm wide) between the PVC pipe and the wall element. Plywood with an epoxy coating was attached to a PUR foam board to provide enough thickness for the expansion of the sprayed PUR.
- gasket: An EPDM gasket with an opening of 55 mm was pulled over the PVC pipe and taped to the plywood.
- tape (1): The PVC pipe is sealed to the plywood using pieces of tape. The tape is designed to seal the 2-dimensional joints of vapour retarder membrane and consists of a reinforced PE membrane and an acrylate adhesive.
- tape (2): The PVC pipe is sealed to the plywood using pieces of tape. The elastic tape is designed to seal difficult corners and 3-dimensional connections and consists of an elastic PE membrane and a butyl rubber adhesive.

The net air leakage of the different specimens is shown in Table 7, together with the extraneous leakage through the test setup. Contrary to the results from setup 1, the specimen with sprayed PUR foam showed the lowest air leakage, followed by the specimen with the elastic butyl tape. The leakage through the EPDM gasket is relatively higher but in absolute value it is still negligible. The penetration with reinforced, rigid tape is clearly the worst solution. Only 1 test was conducted, as additional leakages were created during the 5 min tests at 50, 250 and 500 Pa.

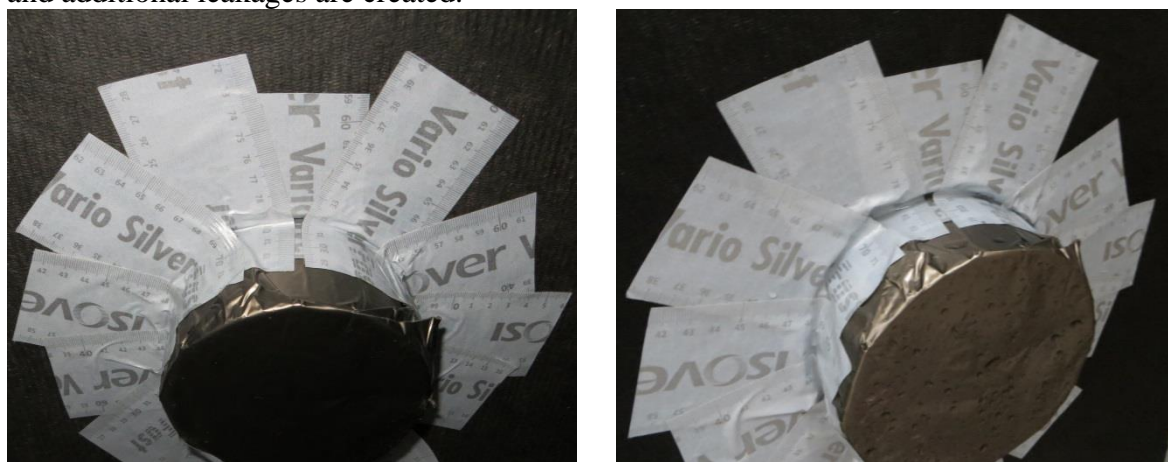
Figure 5: Durability effects taped PVC pipe: before and after water tightness testing

No tapes were detached from the surface of the fibreboard as a result of the large amounts of sprayed water, but the impact of the pressure pulsations on the taped PVC pipes was clearly visible. As Figure 5 illustrates, the pipes are pressed through the opening in the fibreboard, and additional leakages are created.

The use of standard airtightness tape, which is designed to seal joints between panels, is not recommended to seal 3-dimensional connections such as building penetrations. As the tape is very rigid, it is unable to follow the shape of the pipes and large leakages can arise. Air and water tightness tests showed these connections can be very tight, but most of the times they result in large air leakage rates. Furthermore, the use of rigid tape in this situation is very sensitive to mechanical impacts and cannot be regarded as durable.
