FIELD MEASUREMENT TESTING OF AIR TIGHTNESS – EXAMPLE
FROM A HOSPITAL PROJECT IN SWEDEN

University Hospital in Linköping Sweden

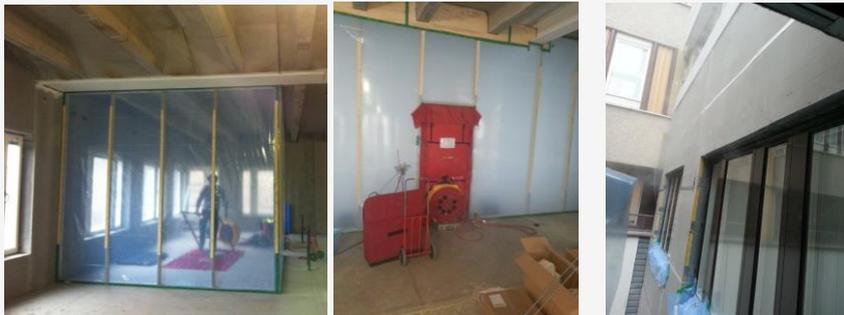
- Spot checks, temporary box, smoke machine

- 1) Spot-checks of parts of the building envelope, for example a floor divided into parts by temporary stud walls with plastic film
- 2) Measurement of building parts
- 3) Measurement of a whole floor and techniques to identify leakage sources with smoke machine and infrared camera

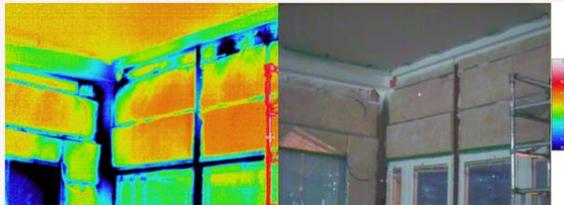
- Testing of a whole floor

Date	Floor nr	Envelope area	Pressure in test (Pa)	Leakage flow (l/s)	Air permeability at 50 Pa (l/s, m ²)
2014-02-09	15	2267	-50	930	0,41
