# Feedback on installation, maintenance, and aging of mechanical humidity-controlled ventilation exhaust units

## ABSTRACT

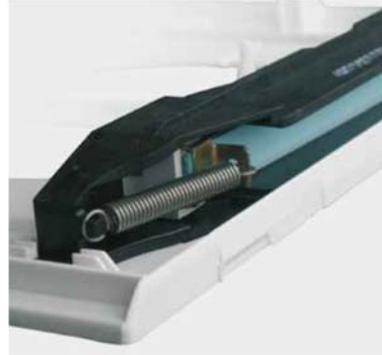
Figure 3: Close-view on the humidity sensing strip

The working principle of the hygroscopic devices is based on a calibrated nylon strip which acts as local humidity sensor and actuator. The strip is connected to a shutter which controls the cross-section of the device, hence the airflow crossing it.

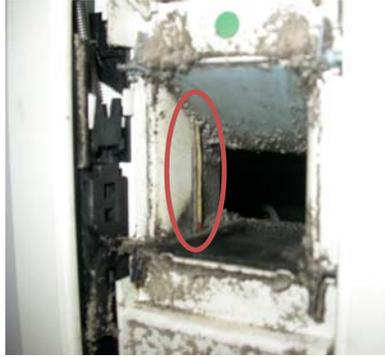
- 14% (5 out of 33 units) of the collected exhaust units were found with damage, either due to voluntary modifications by the occupants (e.g. blocking of the shutter), or to wrong re-assembly after maintenance.
- These degradations concern 36% (4 out of 11 dwellings) of the apartments.

Figure 5: Shutter blocked open with a match

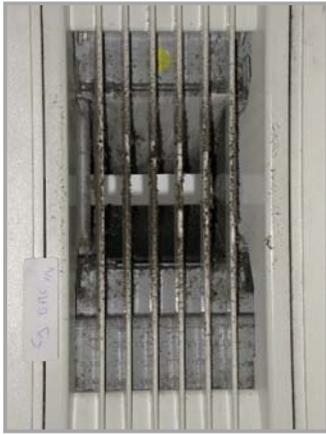
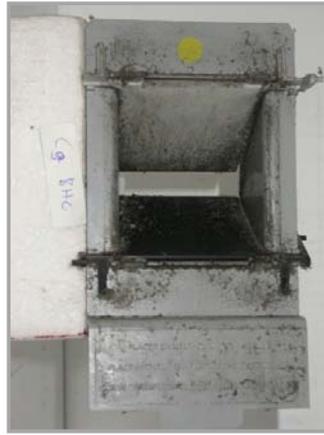
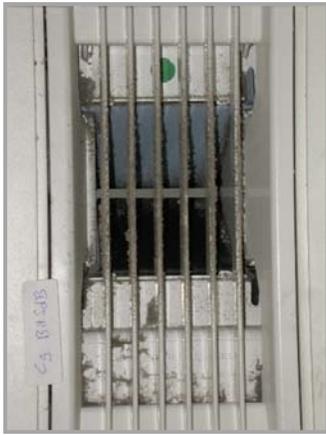
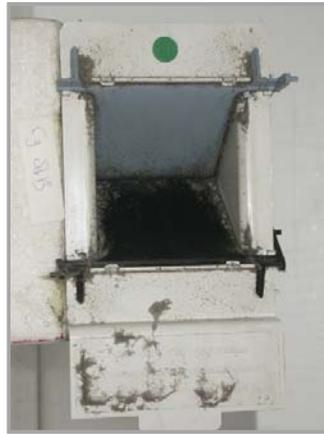
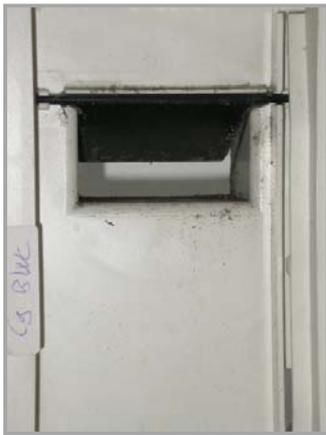
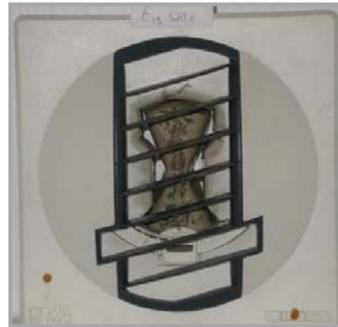
1. 11% (4 out of 37 units) of the exhaust units were considered to have received sufficient maintenance. Devices in this category presented aspects such as given in Figure 8 to Figure 13 or cleaner.

Figure 8: Kitchen humidity-controlled exhaust unit, with protection grid

Figure 9: Kitchen humidity-controlled exhaust unit, protection grid removed

Figure 10: Bathroom humidity-controlled exhaust unit, with protection grid

Figure 11: Bathroom humidity-controlled exhaust unit, protection grid removed

Figure 12: Fixed (not humidity-controlled) exhaust unit

Figure 13: Self-adjusting exhaust unit

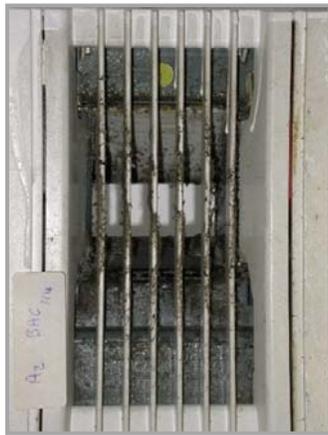
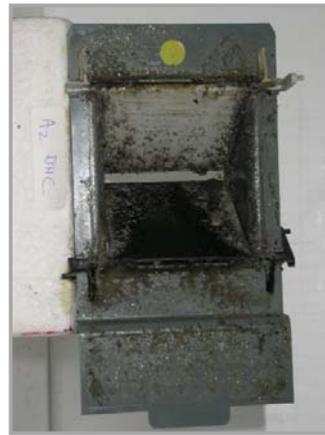
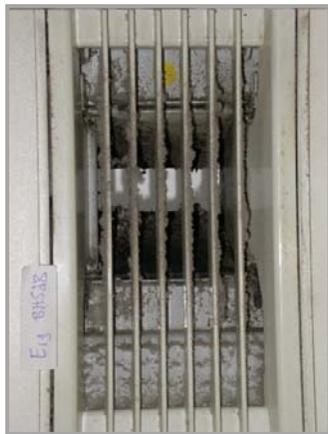
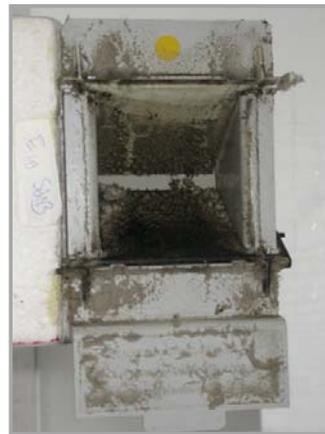
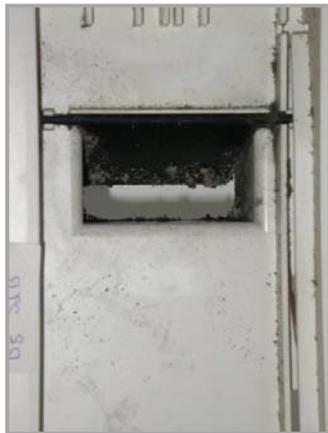
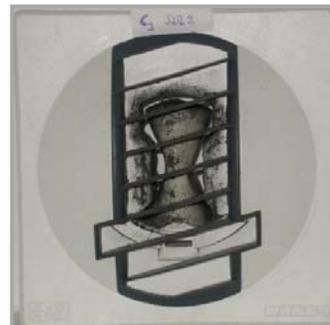
2. 43% (16 out of 37 units) of the exhaust units were considered to have received insufficient maintenance. Devices in this category presented aspects similar to devices shown in Figure 14 to Figure 19.

Figure 14: Kitchen humidity-controlled exhaust unit, with protection grid

Figure 15: Kitchen humidity-controlled exhaust unit, protection grid removed

Figure 16: Bathroom humidity-controlled exhaust unit, with protection grid

Figure 17: Bathroom humidity-controlled exhaust unit, protection grid removed

Figure 18: Fixed (not humidity-controlled) exhaust unit

Figure 19: Self-adjusting exhaust unit

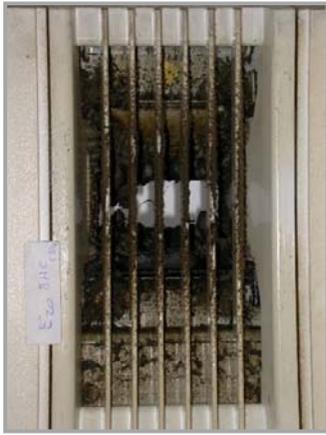
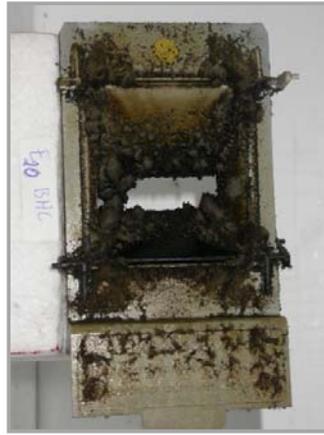
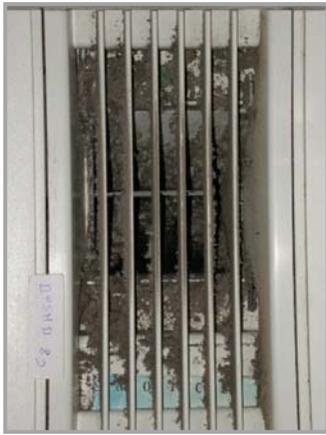
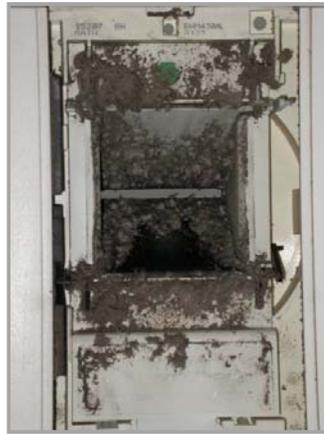
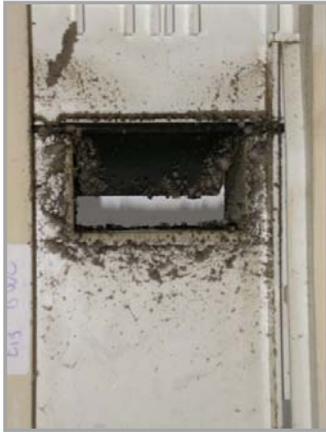
The nature of the accumulated dirt is also categorized: on one hand, dirt found on the exhaust units in the kitchens is thick and oily, because cooking activities generate volatile grease. On the other hand, the dirt found on toilet and bathroom units is generally dry and fibrous.

3. The remaining 32% (12 out of 37 units) of the exhaust units were excessively dirty (absence of maintenance). Devices in this category presented aspects such as shown in Figure 20 to Figure 25.

Figure 20: Kitchen humidity-controlled exhaust unit, with protection grid

Figure 21: Kitchen humidity-controlled exhaust unit, protection grid removed

Figure 22: Hygroscopic bathroom exhaust unit, with protection grid

Figure 23: Hygroscopic bathroom exhaust unit, protection grid removed

Figure 24: Fixed (not humidity-controlled) exhaust unit

Figure 25: Self-adjusting exhaust unit

In this section, we study the performance of non-degraded exhaust units which have received little to no maintenance as presented on Figure 20 to Figure 25.

As a first example, the curve obtained for the kitchen exhaust device from Figure 20 and Figure 21 has been plotted in dark brown on Figure 26. The dirt on this unit was thick and greasy, which is typical of dirt accumulated in kitchens. The curve's hysteresis is seen on every hygroscopic device; it is due to mechanical clearances. The initial tolerance envelope is shown in dark brown on the graph.

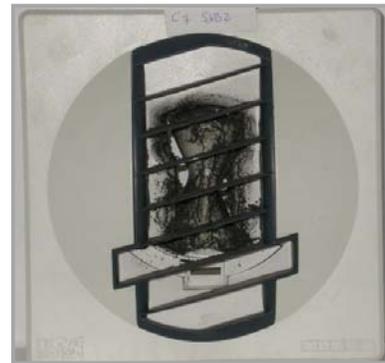
Self-adjusting exhaust units have been characterized following the same process. The test curves of a moderately dirty (Figure 28) and an excessively dirty (Figure 29) self-adjusting exhaust units are shown below.

The bold red curve represents the theoretical behavior, while fine red curves show the measured behavior on the new devices. Orange curves represent the measurements on the device as-collected (i.e. still soiled), when the blue curves show the same measurement after the unit had been cleaned.

Figure 28: Test curves for a moderately dirty self-adjusting unit

In the examples above, self-adjusting exhaust units show a high sensitivity to maintenance: the average airflows are reduced by 55 % of the nominal value in the case of moderate maintenance, and 65 % of the nominal value in the case of insufficient maintenance. Once properly maintained, the measured airflows are close to the original values.
