# Improvement of the acoustical performance of mechanical ventilation systems in dwellings: a case study

Samuel Caillou<sup>\*1</sup>, Arne Dijckmans<sup>1</sup>

*1 Belgian Building Research Institute (BBRI)  
Avenue P. Holoffe 21  
Limelette, Belgium*

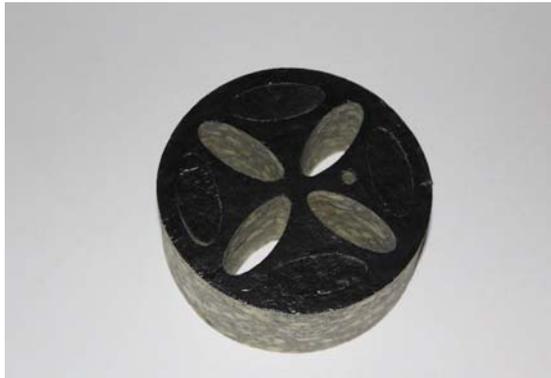
Figure 1: Foam sound attenuator initially used behind the ATD of the living room.

The foam sound attenuators (Figure 1) behind the ATD's of the living room were probably used to reduce the noise level coming from the fan and the ductwork and probably also to limit the noise transfer between different rooms connected to the same duct part. However, such foam sound attenuators can cause higher pressure drop in the ductwork. In the first step, these foam sound attenuators have been removed.

The use of the foam sound attenuators situated behind the ATD of the living room could theoretically attenuate some noises coming from the ducts of these ATD. However, the removal of these foam sound attenuators in step 1 (together with a new adjustment of the air flow rates at the ATD) allowed to reduce drastically the noise level in the living room, but also in other bedrooms connected to the same fan but not equipped of such foam sound attenuators. This can be explained by the high pressure drop generated by these foam sound attenuators. The removal of these components leads to a lower pressure drop in the ductwork, as evidenced by the decrease of the electrical power absorbed by the ventilation unit at the same time. The reduction of the pressure drop by the removal of these components can have two positive impacts on the acoustical performances. First, these components themselves probably generated noise because of the airflow through them. Second, the lower total pressure drop in the ductwork allowed decreasing the fan speed (to obtain the same flow rate) and thus decreasing the noise generated by the fan itself. This can be confirmed by the reduction of noise also in the 3 bedrooms which were not equipped with such foam sound attenuators.

Some small sound attenuators to be placed behind the air terminal devices, such as foam components, have to be used carefully because the additional generated pressure drop can have a more negative impact on the acoustic performances than the theoretical attenuation of the component.

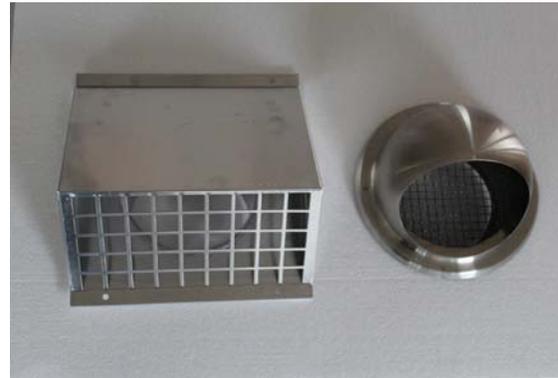
Figure 2: Comparison of the externally mounted air transfer devices before (right) and after (left) optimisation in step 2.

The second improvement was the replacement of the externally mounted air transfer devices used for the intake of outdoor air and the exhaust of air outside the building. The components initially mounted in the façade have been replaced by components with a larger area (Figure 2). The calculated pressure drop through these components for the nominal flow rate (300 m<sup>3</sup>/h) was 21 Pa for the new component compared to 117 Pa for the component initially used, i.e. 5 times lower.

The replacement of the externally mounted air transfer devices in the façade in step 2 showed also an improvement of the acoustic performances in all the rooms. This replacement was also associated with a decrease of the pressure drop generated by these components, as also demonstrated by the decrease of the electrical power absorbed by the ventilation unit at the same time. The pressure drop 5 times lower for the new component compared to the initial one (calculated based on the manufacturer data) can be explained by the larger free section for the airflow in the new one compared to the initial one, as evidenced in Figure 2. In this case, the decrease of the pressure drop applies centrally for the fans (and not locally), allowing also decreasing the fan speed.

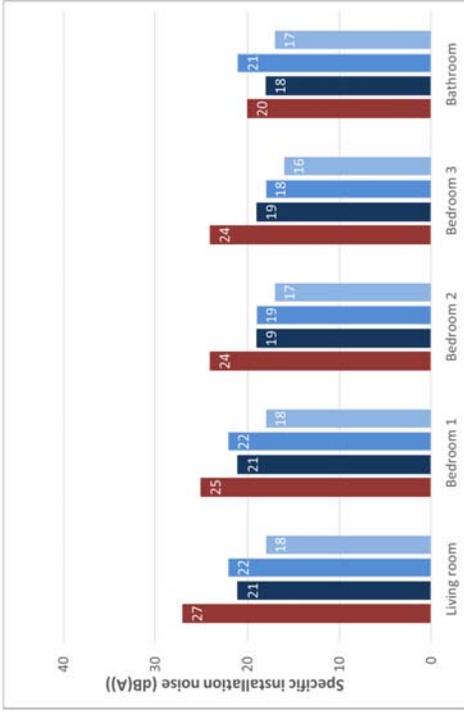
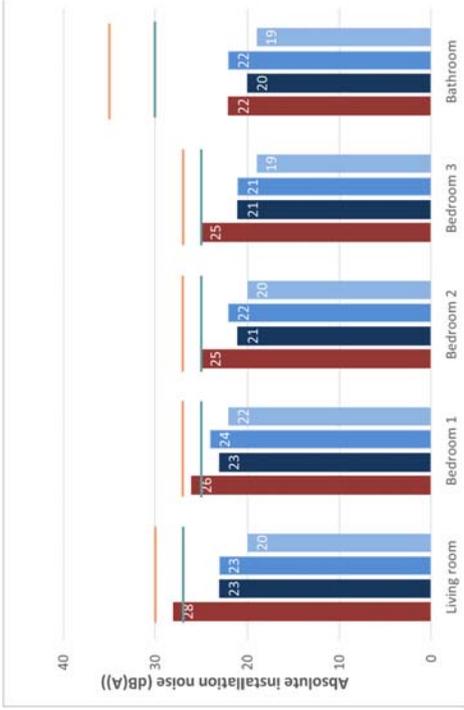
Figure 4: Standardized service equipment sound pressure levels without (left) and with (right) background noise correction for the initial situation and after optimisation step 1, 3 and 4 (step 2 was not measured) for fan setting 3 (nominal setting, above) and for fan setting 2 (below). The requirements of the standard NBN S 01-400-1 are indicated in orange (normal acoustic comfort) and in green (enhanced acoustic comfort).

The standardized service equipment sound pressure levels have been measured for the initial situation and after optimisation step 1, 3 and 4 (step 2 was not measured) and compared to the requirements of the Belgian standard NBN S 01-400-1 (Figure 4). The specific service equipment noise levels have also been calculated by correcting the measured service equipment sound pressure levels for background noise according to clause 8 of ISO 16032 [7]. The background noise was measured when the ventilation system was switched off.

For the initial situation and nominal fan setting, the noise levels largely exceeded the requirement of the Belgian standard for normal acoustic comfort in all the rooms, except in the bathroom that was conform. For example, the noise level in the living room was 42 dB compared to the maximum allowed 30 dB; in the bedrooms the noise levels were between 39 and 40 dB compare to the maximum allowed of 27 dB.

After each optimisation step, the noise levels were decreased in the different rooms. For example after step 1, the noise levels were lowered by 7 dB in the living room and by 5 to 8 dB in the different bedrooms. After step 4, the noise levels in the different rooms were all conform the requirement of the Belgian standard for normal acoustic comfort and even for enhanced acoustic comfort in the living room, bedroom 1 and the bathroom.

For fan setting 2, the noise levels were lower compared to fan setting 3 and were conform the requirement for normal acoustic comfort in all the rooms for the initial situation as well as after optimisation. Due to the lower ventilation noise levels for fan setting 2 (especially after optimisation), the measurements were generally influenced by background noise. For these low noise levels, the specific installation noise levels better represent the noise coming from the ventilation system and give an upper limit of the service equipment sound pressure levels. For fan setting 3, background noise was only an issue after optimisation step 4.

After step 3 and the above-discussed optimisations, the noise levels had been improved compared to the initial situation but remained too high in some rooms, especially the living room, bedrooms 1 and 2. The specific installation noise level in bedroom 3 was significantly lower (27 dB) compared to those in the other rooms (30 to 32 dB). Bedroom 3 was the only room connected to a duct part equipped with a primary sound attenuator.

In step 4, a primary sound attenuator has been added to the duct part delivering the living room, bedroom 1 and bedroom 2. Moreover, an additional sound attenuator has been installed to further protect the main bedroom 1. Between step 3 and step 4, the noise levels decreased by 5 dB in the living room and 4 dB in bedroom 2, demonstrating the significant positive impact of a primary sound attenuator. The noise reduction was even higher, by 9 dB, in bedroom 1, because of the additional sound attenuator in this room.
