Comfort at hospital reception desks

R.M.J. Bokel*. P.J.W. van den Engel, A.M. Eijkelenboom, M.A. Ortiz Sanchez

Delft University of Technology

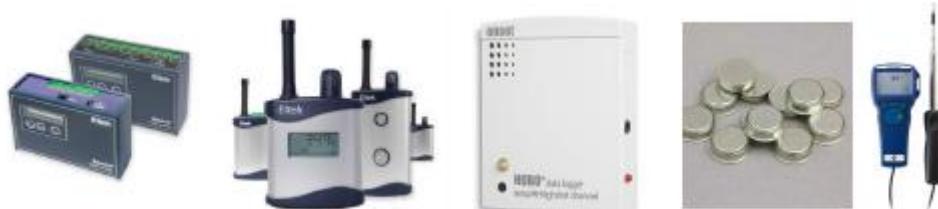
Figure 1: Equipment Eltek Squirrels, Hobo Dataloggers, I-buttons and air velocity meter, images from the producers.

Eltek Squirrels, HOBO dataloggers, I-buttons and EXTECH air velocity meters were used to measure the temperature, the relative humidity the air velocity and the CO₂ concentration, see figure 1. The researcher's nose was used to track and identify any interesting smells at the reception desk and in the surrounding areas. The outdoor temperatures of the nearest airport were taken from the KNMI website. The perceptions of the people from the reception desk were investigated using a questionnaire and additional small talk. The questionnaire consisted of questions about personal characteristics and thermal comfort.
