EXTERNAL INSULATING SHUTTERS IN ENERGY CONSERVATION HOUSES - descriptions and experiences from three low-energy houses at Hjortekær, Denmark

Thermal Insulation Laboratory
Technical University of Denmark
November 1982

report no 129

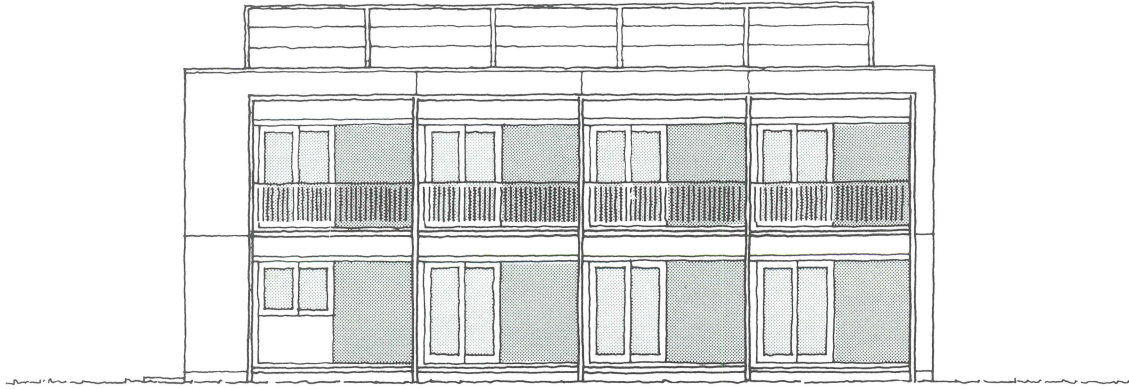
Figure 6. House F. Operation of external shutters.

South aspect

Gross floor space	176.1 m ²
Volume	349.2 m ³
Area of window and door openings *) of these south facing:	31.04 m ² 26.88 m ²
Corresponding transparent area of these south facing:	19.81 m ² 18.66 m ²
Area of shuttered openings **) of these south facing:	26.88 m ² 26.88 m ²
Corresponding transparent area of these south facing:	18.66 m ² 18.66 m ²

*) Ground floor and first floor
 **) Of this 1.44 m² is a well insulated parapet (top drawing, to the bottom left)

Ground floor

The shutters in house F slide horizontally on the south aspect as indicated in Figure 6. It should be noticed that the windows of the house are primarily oriented to the south. They are all triple glazed (sealed units in reinforced plastic frames). The shutters are operated automatically, all working simultaneously controlled by a time switch. A manually controlled switch at each window allows separate operation of each shutter. This is a prototype system developed by the Department of Mechanical Technology, AMT, at the Technical University of Denmark.

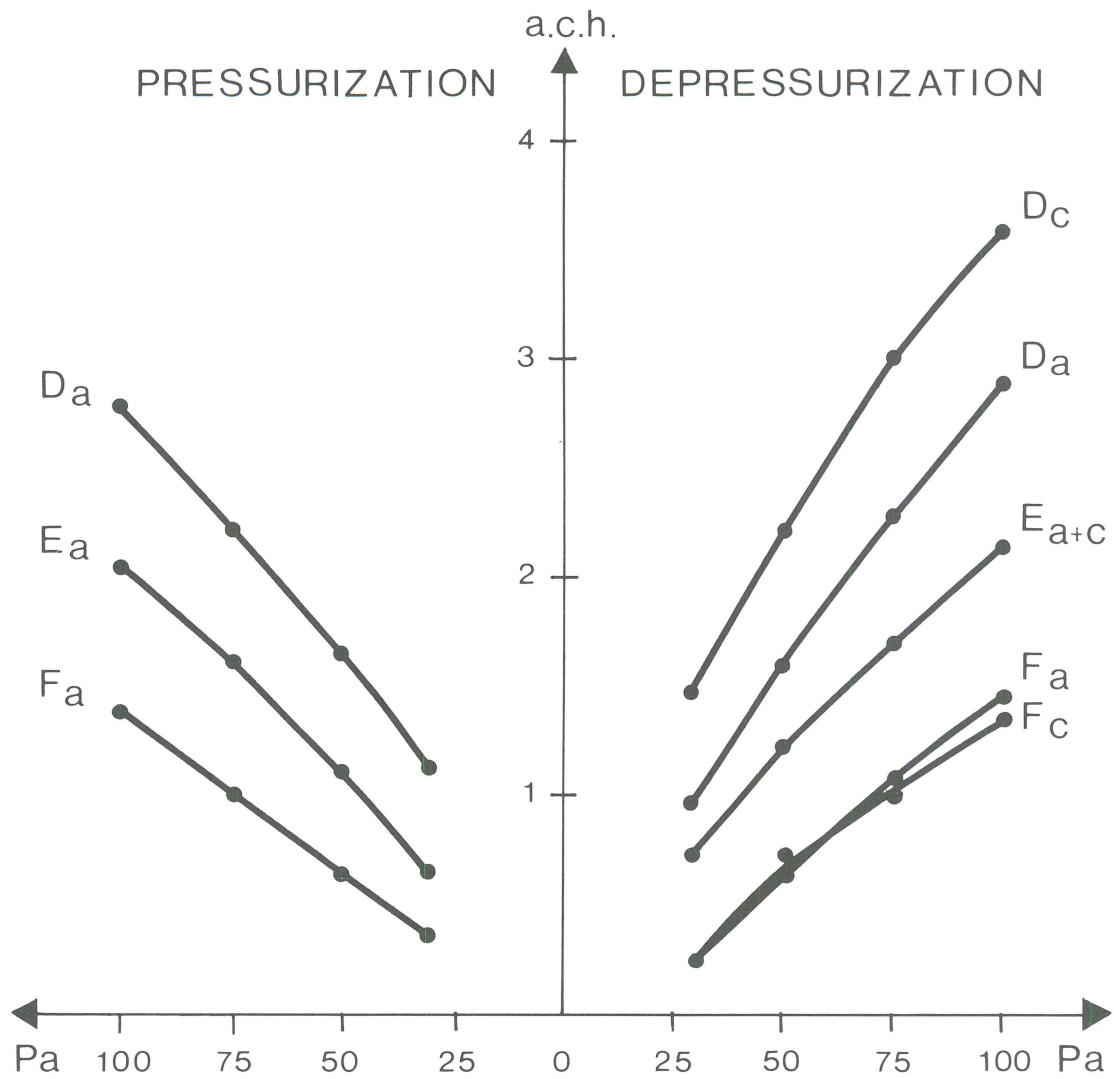
Figure 10. Measured air change rates illustrating extremely good air tightness performance of insulating shutters.
