What's Being Built Out There? Performance Tests on 100 New Homes

by Arnie Katz

■ PERFORMANCE TESTS ON 100 NEW HOMES

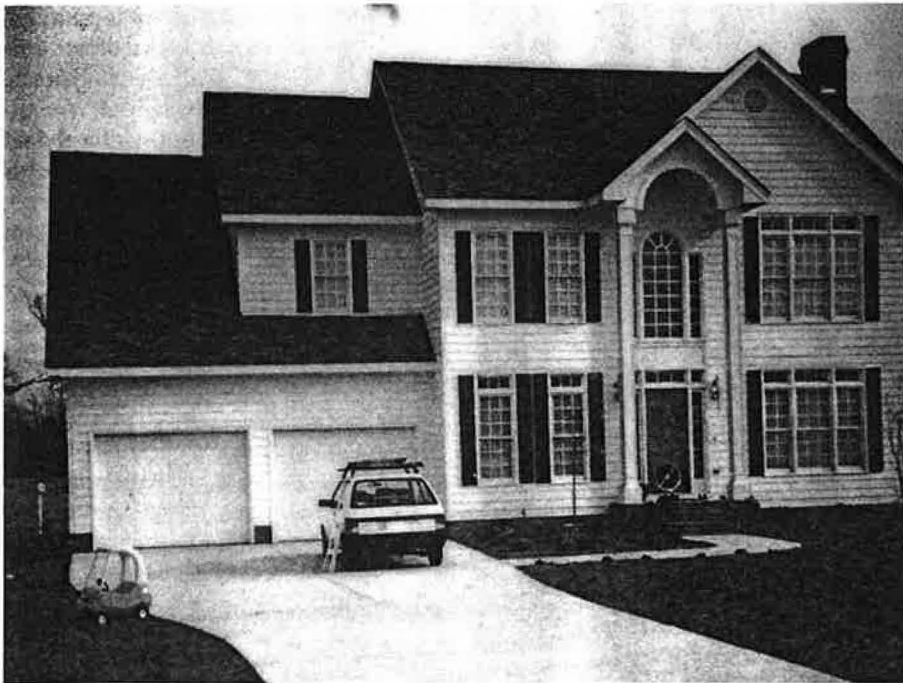
A blower door used for pressure testing is visible in this home from the Advanced Energy study.

We performed a standard depressurization test with a blower door to measure whole-house airtightness. Only 1 house out of the 100 had an ACH₅₀ of under 5, while 20 houses had an ACH₅₀

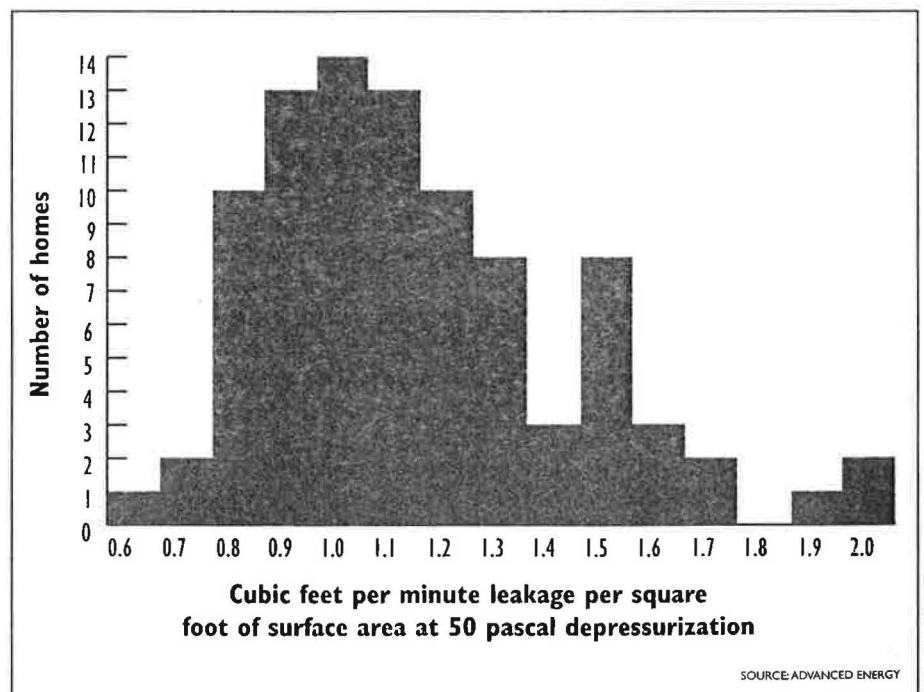
Figure 1. Distribution of homes at different leakage rates, as determined from blower door tests.

of over 10. We calculated CFM₅₀/ft² of exposed interior surface area (gross wall, floor, and ceiling area) for the 51 all-electric homes. This looks more directly at leakage in relation to potential leakage area and takes the volume of the house into account. These homes had a median 0.44 CFM₅₀/ft² of surface area. The tightest was 0.19 CFM₅₀/ft², while the loosest was 1.46 CFM₅₀/ft².

Only 3 houses out of 51 (6%) met our whole-house air sealing target. The median house was about 50% leakier

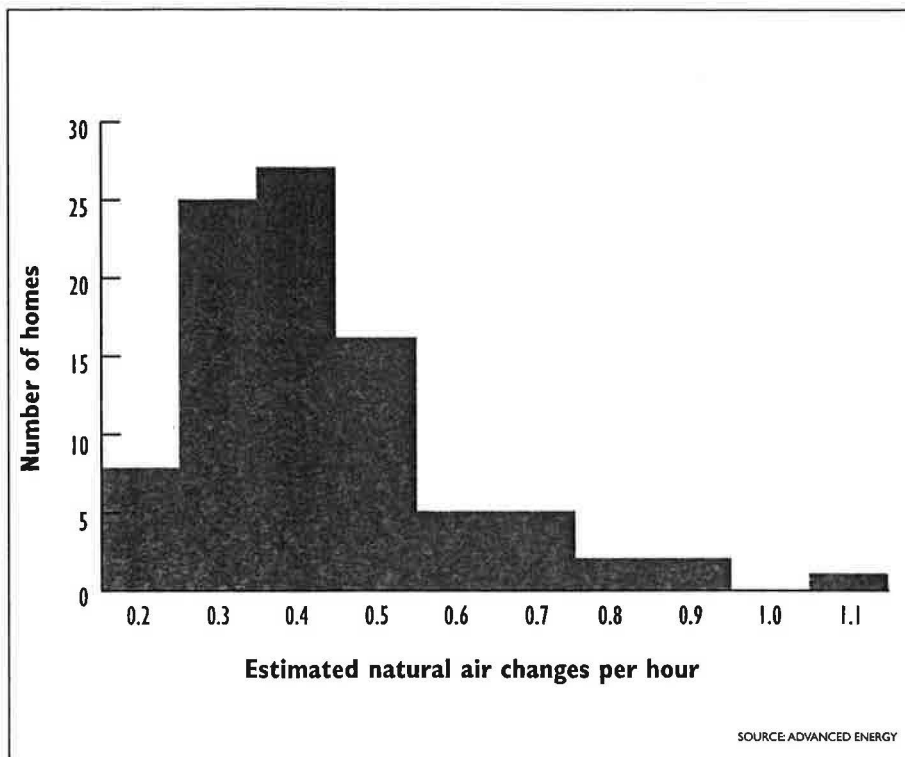
Figure 2. Distribution of homes at different natural air change rates, converted from blower door leakage data.

On the other hand, they may be too tight to count on natural ventilation. ASHRAE recommends that homes with estimated natural infiltration rates of less than 0.35 ACH should have mechanical ventilation. Nineteen out of 100 houses—nearly 20%—fell into this range. Our methodology for estimating natural infiltration, however, may have overestimated infiltration. Tracer gas testing of 23 homes indicated that a much higher percentage are below 0.35 ACH. If this outcome is supported by more extensive testing, it would suggest that substantially more houses may need mechanical ventilation. Only one of the 100 houses had a whole-house ventilation system.

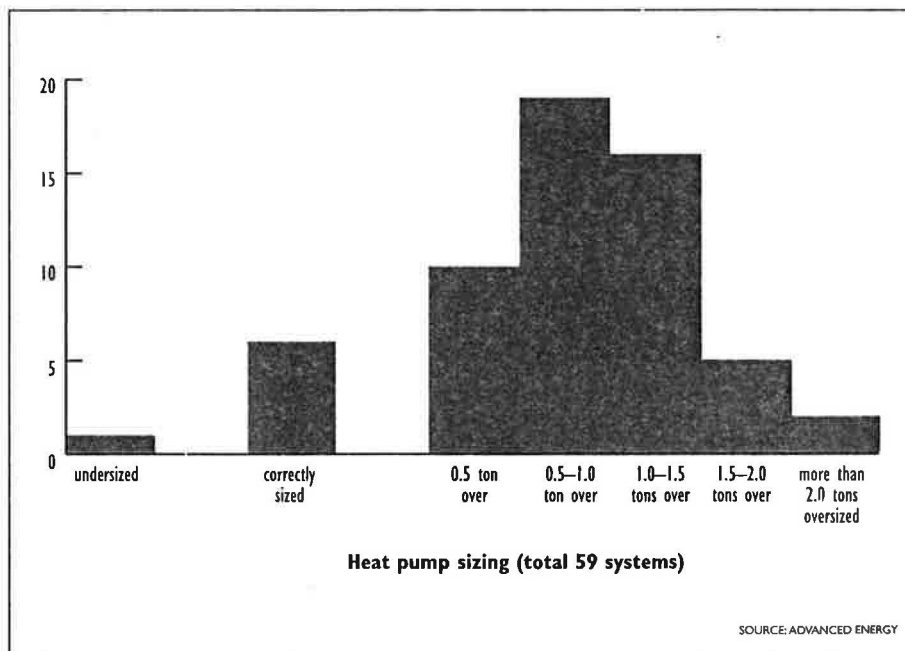
Figure 3. Distribution of homes with undersized, correctly sized, and oversized heat pumps.

the unit installed in each house and used ACCA *Manual S* to determine proper sizing guidelines. Specifically, *Manual S* says, "If heat pump equipment (air-source or water-source) is installed in a warm climate or moderate climate, the total cooling capacity should not exceed the total cooling load by more than 15 percent."

Unfortunately, out of 59 heat pumps, only 6 lived up to this standard. One was undersized. The remaining 52 units, or 88% of the heat pumps, were oversized. Median oversizing was 0.81 tons, with the most oversized unit rated to provide an extra 2.3 tons of cooling. Oversized air conditioning equipment tends to be noisy and suffers from short-cycling. Short-cycling can cause moisture buildup and a major loss of efficiency (see "Bigger Is Not Better: Sizing Air Conditioners Properly," *HE* May/June '95, p.19).

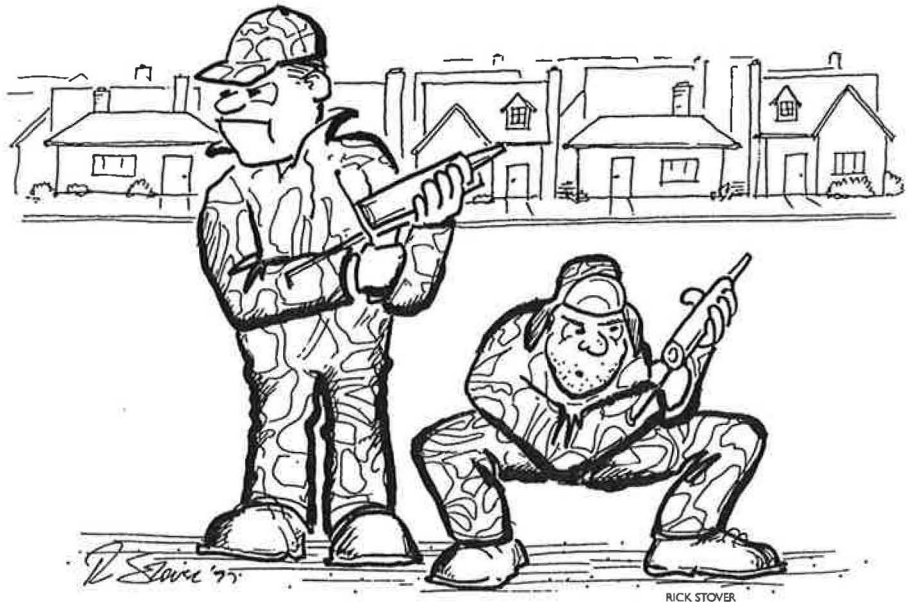
Duct hunting season.

We came upon several instances of catastrophic duct failure—ducts that were totally disconnected. We found this condition in both attics and crawlspaces. In one case, a homeowner told us she had complained about lack of heating and cooling to the master bedroom for nearly a year. Each time she called the contractor sent someone out, found no problems, and determined that the system was working fine.

While checking crawlspace insulation, we found a supply duct lying on the ground under the master bedroom. The bedroom was in the far corner of the house, far from the crawlspace access door. With major ductwork between the access door and the dead duct, the only way to find the disconnection was to slither on the ground like a snake, with barely enough clear-
