AIR POLLUTION AND NATURAL VENTILATION IN AN URBAN BUILDING: A CASE STUDY

Vina Kukadia, James Pike and Martin White

Building Research Establishment Ltd, Garston, Watford, WD2 7JR

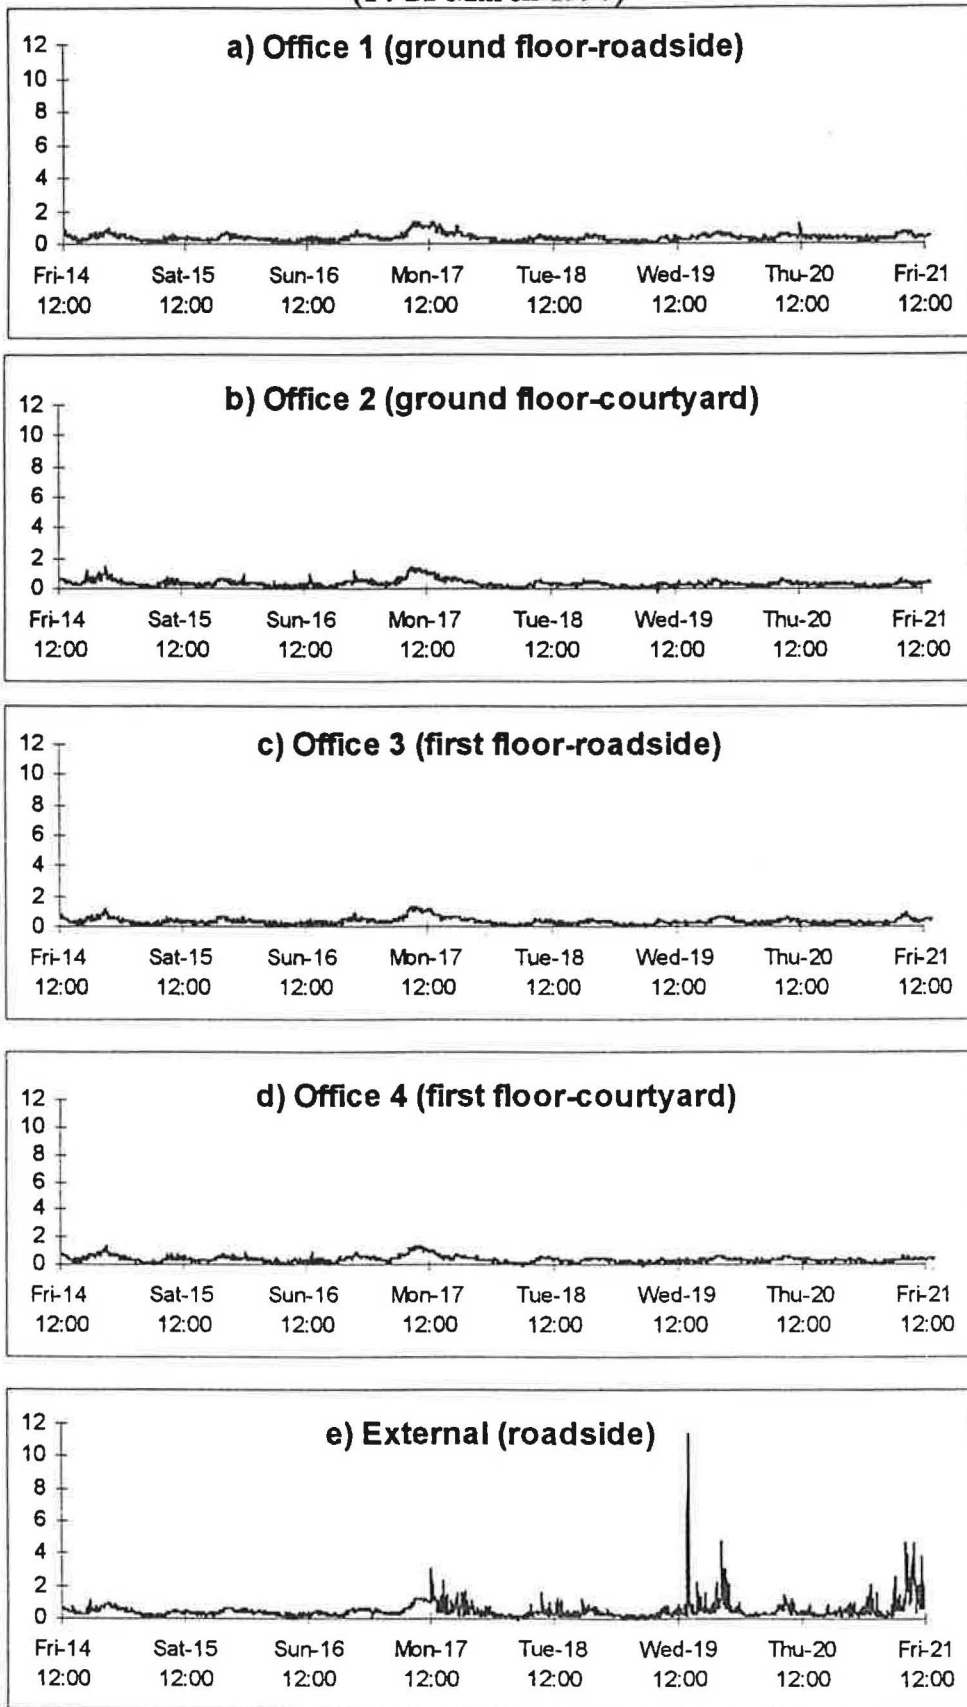
Figure 4: Carbon monoxide concentrations (ppm) vs Time of day (14-21 March 1997)

Figures 4(a-e) show the internal and external (measured at one point on the roadside) concentrations of CO within the four offices monitored. As expected, all the offices show very similar contaminant levels because of the common air intake from the courtyard side. Low external CO levels measured over the weekend period indicate little vehicular activity in comparison with the working week. During certain periods of the working week, relatively high CO concentration peaks occurred externally reaching levels of about 12 ppm. Comparison of the contaminant levels measured inside the offices with external measurements taken at a single point on the roadside indicate that these high contaminant peaks were reduced considerably and did not occur inside any of the offices monitored. Even office 3, outside which the external measurements were carried out, does not show these peaks, indicating little pollutant infiltration through the fabric of the building.

When outside CO concentrations were very low (less than 0.5ppm) the internal levels often exceeded external roadside levels. It is possible that contamination levels were higher on the courtyard side in these cases or that the building retained the contaminant dispersing it slowly whilst the external concentration dispersed more rapidly. However, since the external measurement point was not in the courtyard near the inlet to the offices monitored, it is not possible at this stage to make any firm conclusions on the quality of the air on this side of the building. In fact these studies show that a single external measurement point is not fully representative of the overall exposure levels experienced around the building and highlights the need to carry out a range of lateral and vertical measurements externally on both sides of the building. Nevertheless, it is clear that by using supply air from the courtyard side the high concentration peaks of CO (12ppm) in the external environment appear to have been reduced to values around a mean of about 0.3 ppm inside the building. This is well below recommended air quality guidelines as given in Table 2.

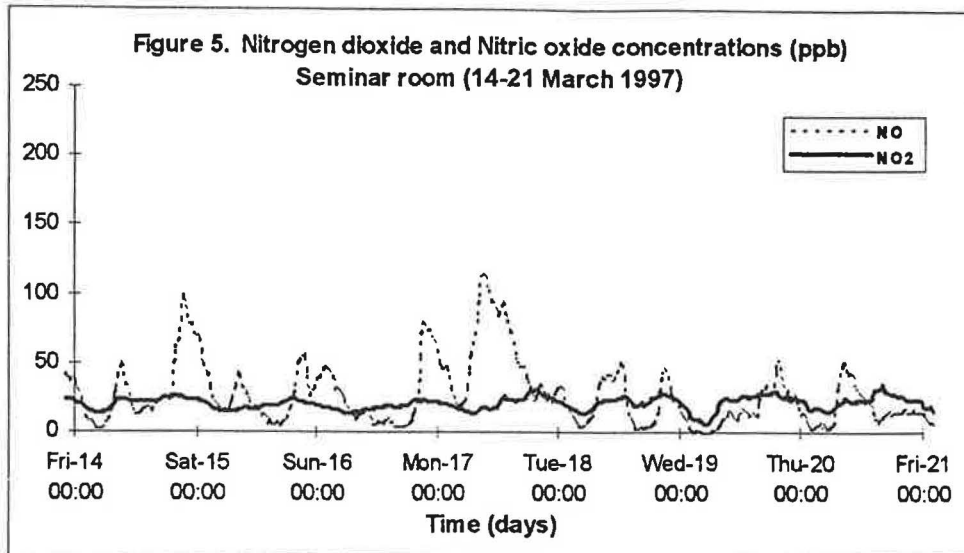
The measurements of nitrogen dioxide (NO₂) and nitric oxide (NO) are shown in Figure 5. Due to practical constraints only internal measurements could be made and it is not therefore possible to make any comparison with concurrent external concentrations. However, comparison of hourly concentration means of these pollutants with standard air quality guidelines (Table 2) shows that levels were low in the building. In general, NO₂ is a product of a variety of combustion processes including traffic. However, there were no other known sources of NO₂ in the area apart from the road traffic on the High Street. It can therefore be assumed that the low levels measured in the building indicate that air intake from the courtyard side away from the road traffic gave acceptable concentrations.

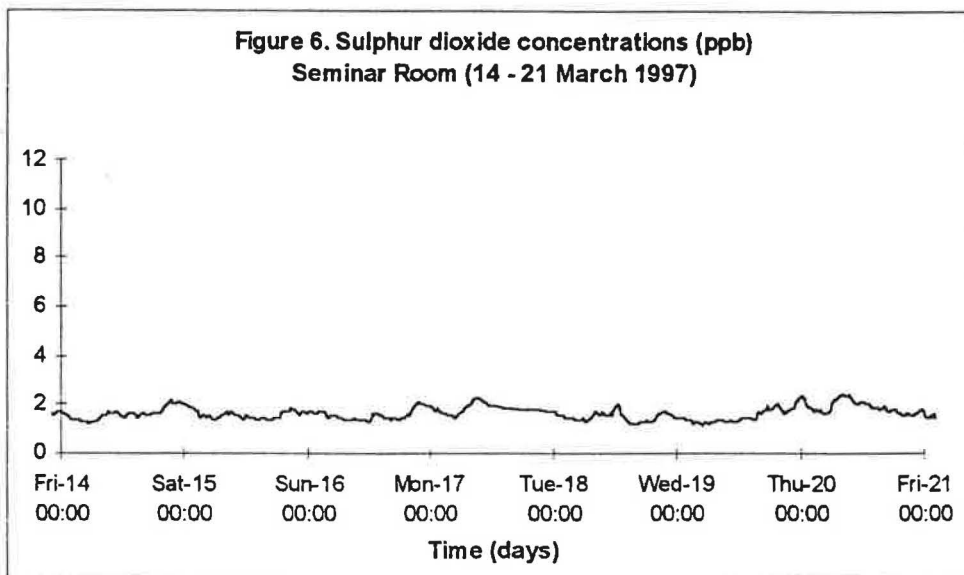
Internal levels of SO₂ (Figure 6) are typical of levels found in previous studies (2,3) and were below recommended air quality guidelines. This is as expected, since in general, external trends of SO₂ concentrations in London show that background levels have decreased by almost 60% since 1970 and by 45% since 1980 (7). This is largely attributable to the relocation of power stations away from city and urban areas and the growing use of natural gas and lower sulphur content fuel oils in combustion plant.

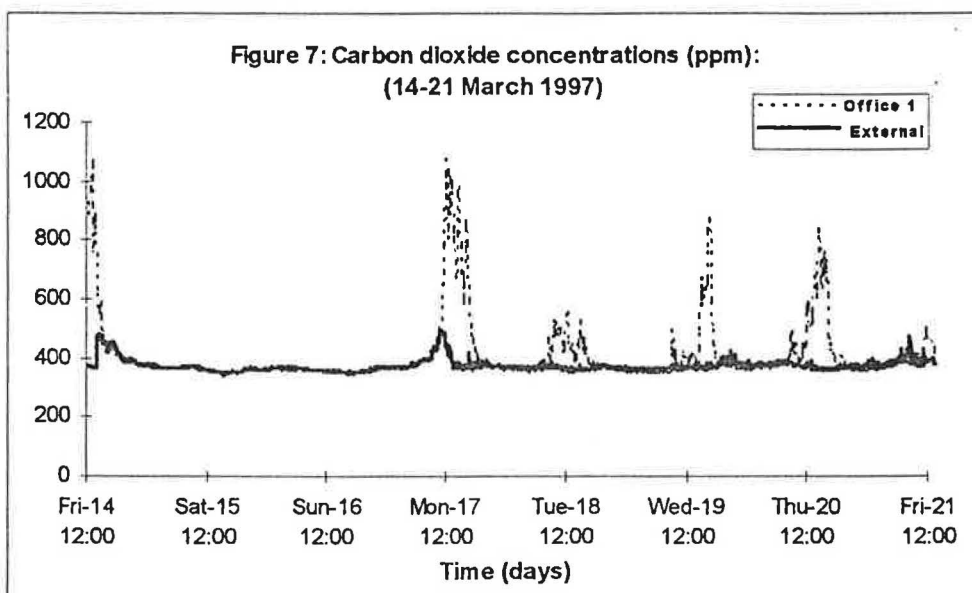
Increased levels of CO₂ within buildings are usually occupant generated. CO₂ results for office 1 are shown in Figure 7. These are typical of levels obtained in all the offices monitored. As expected, the high concentrations

(with peaks of about 1100 ppm) correspond to periods during the working week when the office was occupied. The levels reduced to a background of about 400 ppm during the weekend and at night. In general the occupancy in each room was variable on each day and this is shown by the varying degree of CO₂ levels. A background value of about 400 ppm is also seen in the external environment where there are no known sources and is in agreement with previous work (4).

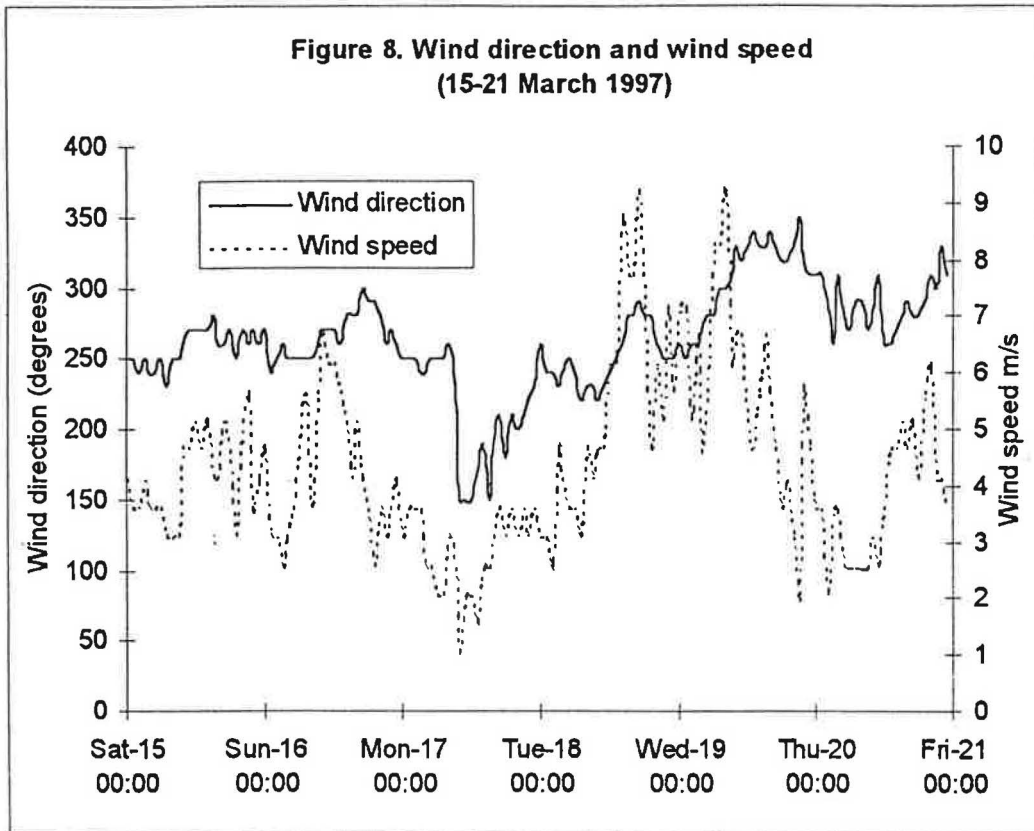
Wind speed and direction from the nearby Meteorological site are given in Figure 8. Wind speeds varied between about 1 to 9 ms⁻¹ over the monitoring period. Some initial analysis of wind speed and direction showed no simple relationship with the internal and external CO concentrations measured.
