An investigation of the infiltration characteristics of windows and doors in a tall building using pressurisation techniques

I C Ward and S Sharples

**Department of Building Science
Faculty of Architectural Studies
University of Sheffield
August 1982**

This report sets out the design and construction of pressure test rigs for use in windows and doorways in the Arts Building at Sheffield University. Results of tests on windows and doors in this building are presented which indicate that the building has suffered a considerable amount of fabric deterioration.

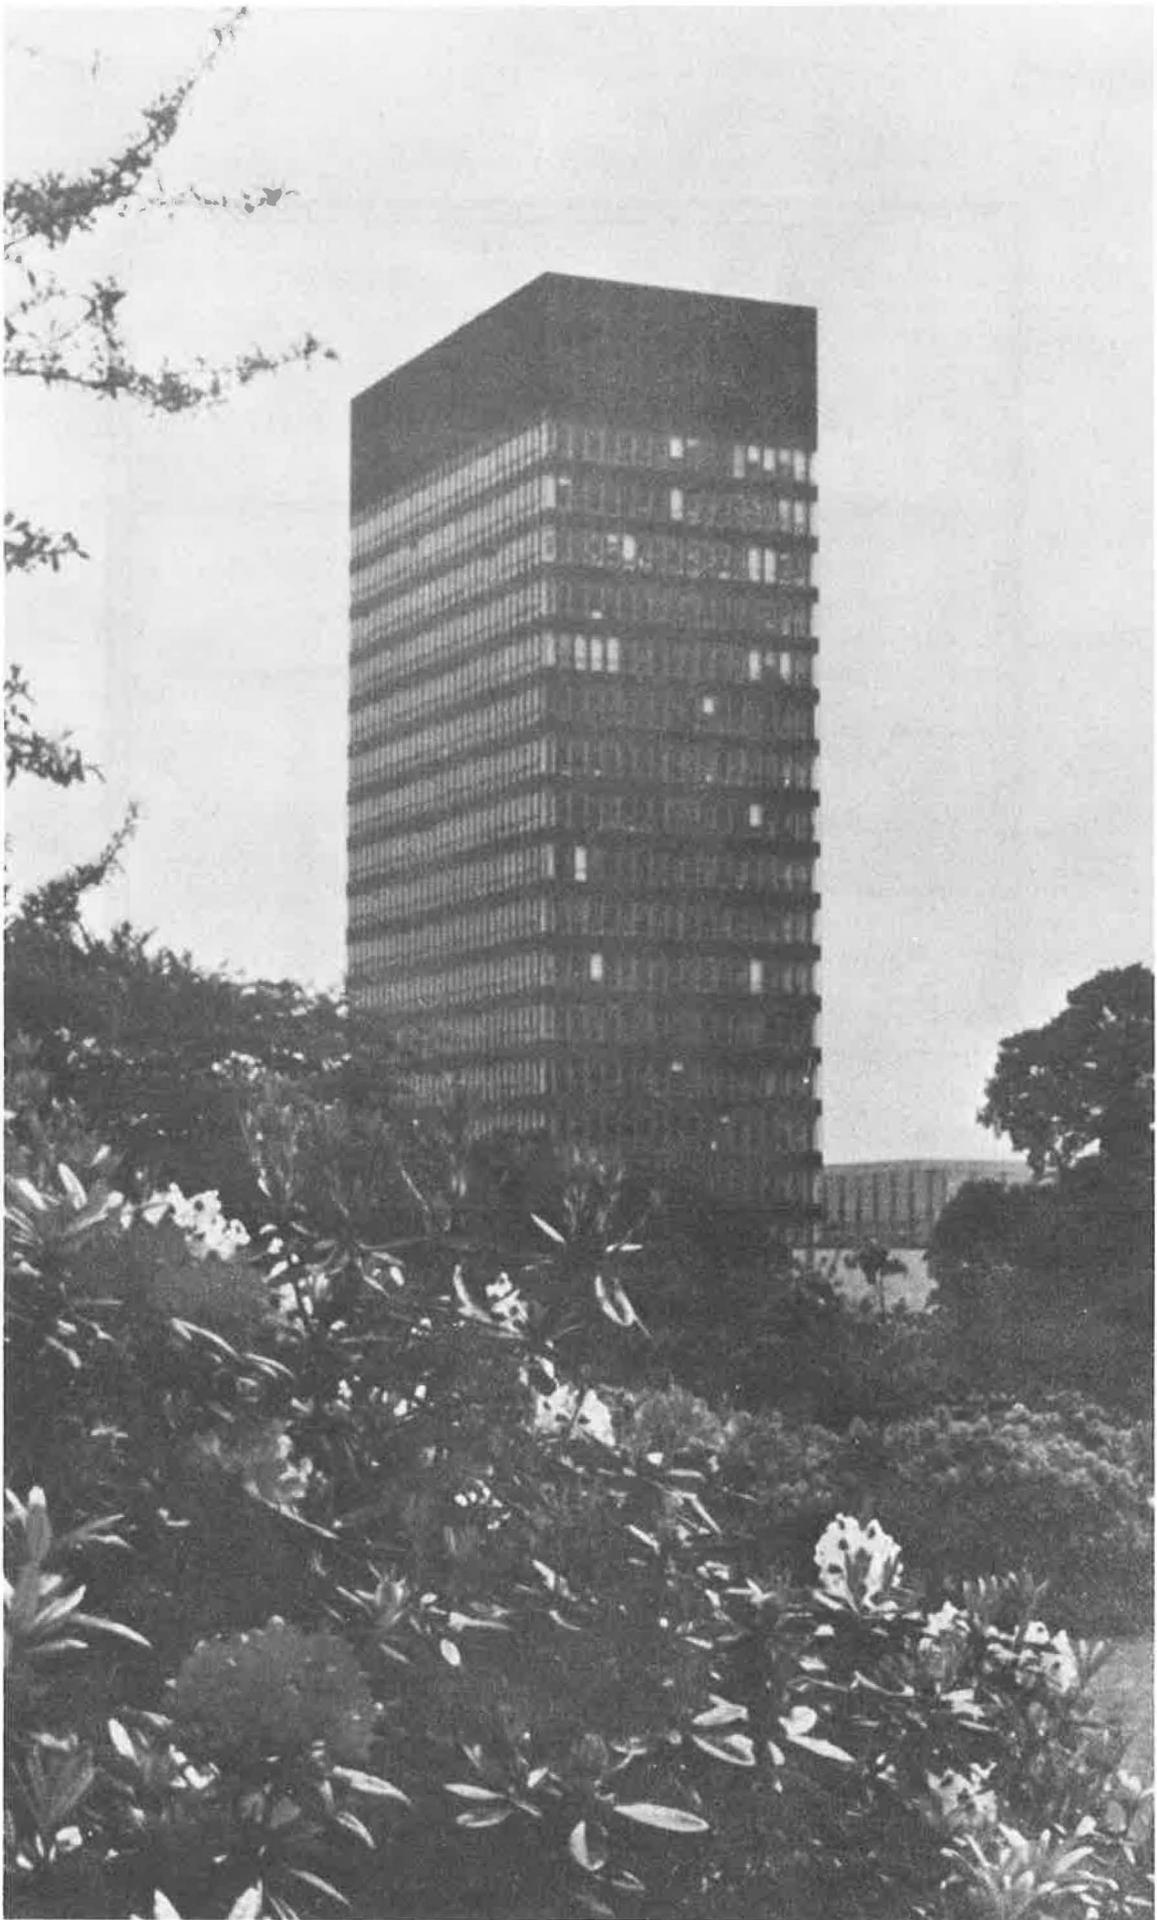
Plate 1: The Arts Tower

The Arts Tower at Sheffield University shown in Plate 1 is currently the subject of investigations into its energy performance.

The building has 19 floors and is 78m high with a glazing ratio of 60%. Figure No. 1 shows a typical floor plan from which can be seen that there is a high degree of partitioning and plenty of scope for air infiltration due to the large number of windows.

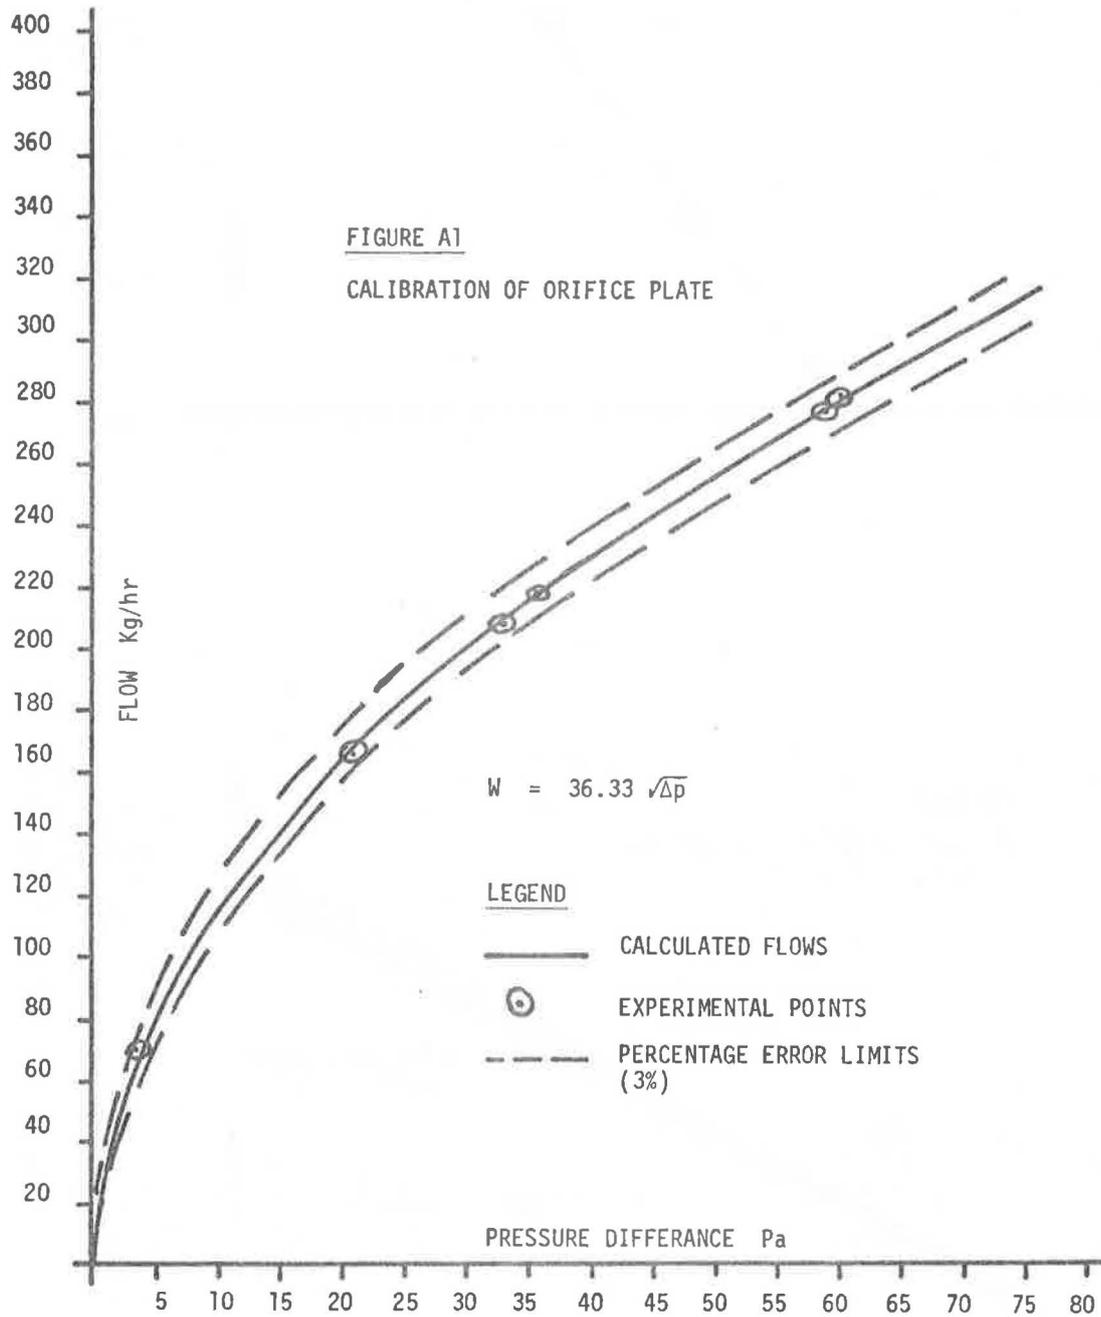
FIGURE A1
CALIBRATION OF ORIFICE PLATE

A check on the calculation procedure was carried out by means of a pitot tube traverse of the duct. Figure A1 shows the results of this check plotted on the same graph as the calculated performance.
