PROBE

13: Charities Aid Foundation

Natural ventilation, adiabatic cooling and passive solar architecture – the makings of an environmentally sound and low energy building. But has the headquarters building for the Charities Aid Foundation lived up to its billing?

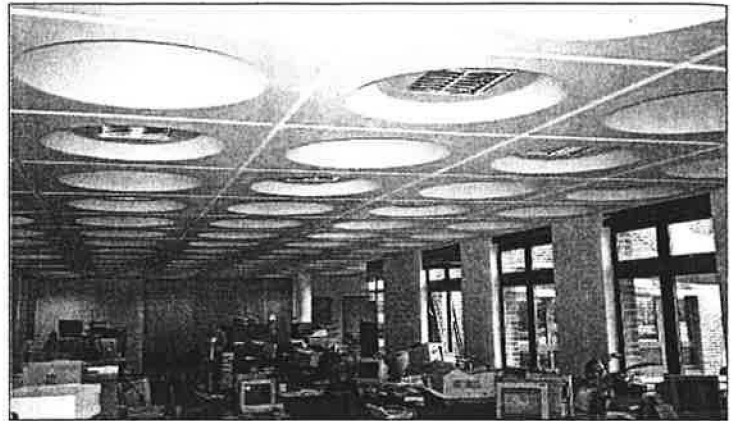
The offices at the CAF building feature an exposed concrete ceiling. Good for thermal balance but, without acoustic treatment, poor for noise control.

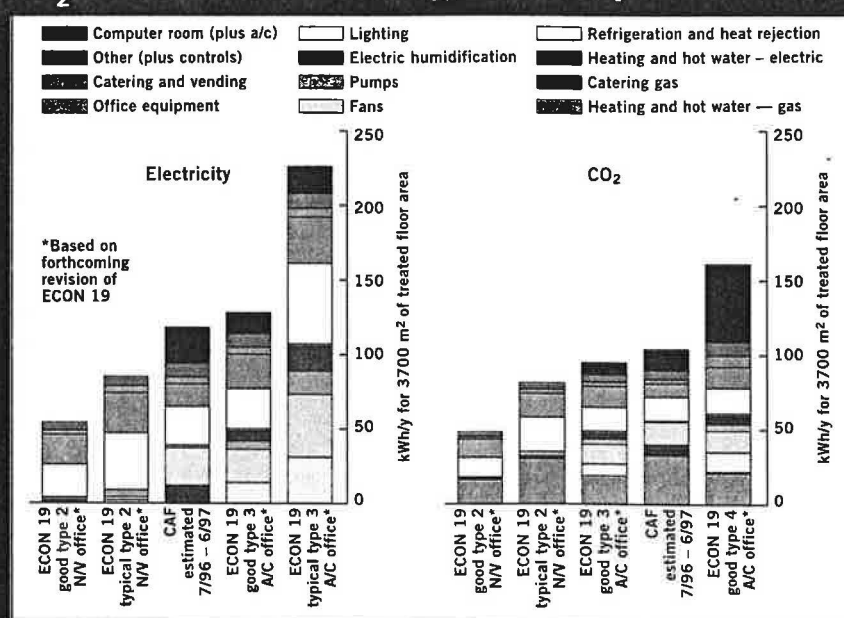
FIGURE 1: End-use energy breakdown at the Charities Aid Foundation building. Note that the conversion factors are: electricity 0.6 kg CO₂/kWh and gas 0.2 kg CO₂/kWh.

Annual electricity consumption between July 1996-June 1997 was 117kWh/m² of treated floor area, very close to the design estimate of 120 kWh/m². Figure 1 shows a detailed breakdown and compares it with a range of relevant benchmarks from the forthcoming edition of *ECON Guide 19*.

End-use breakdown: electricity

The CAF building consumes 11 kWh/m²/y of treated floor area for heating and hot water. This includes electric domestic hot water throughout the building, plus supplementary electric heating in the reception.

Refrigeration comes in at 1 kWh/m², including local on-demand cooling for the boardroom and training room. While the use of indirect evaporative cooling eliminates chiller consumption for office cooling, the occupant survey suggests that, in 1997, it was not very effective. This may need some investigation.

The CAF figures give an installed power of some 10 W/m² of mechanically-ventilated office area. Owing to moderate running hours, estimated at just under 3000 h/y, annual consumption is similar to the *ECON 19* good level for Type 3 air conditioned offices (typical levels are considerably higher) and below the design estimate of 30 kWh/m². However, occupants perceive the effectiveness of the

At 26 kWh/m², lighting energy consumption is at the good practice levels suggested in the new *ECON 19*. This is considerably less than those in the 1991 edition due to a low installed power density (12 W/m²) and lux levels between 350-400 lux.

At 17 kWh/m², office equipment consumption is below the typical level for a naturally-ventilated office, despite the high use of pcs. This is because the building is not quite up to capacity, and is also due to the fact that relatively energy efficient pcs and screens (95 W together) have been used.

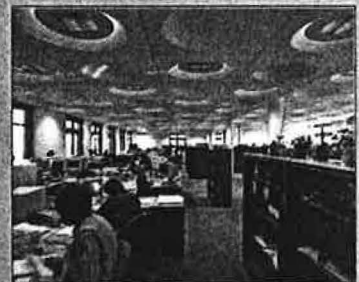
The project architect for the CAF building provided a high quality exposed ceiling-scape into which the services engineer integrated the lighting, but...

Considerable thought was applied to the design of the exposed concrete soffit which integrates lighting, air extract and structure, and helps to stabilise the internal temperature.

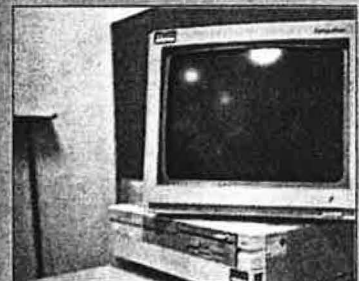
...the penalty has been glare problems on computer screens, and additional noise pollution from the untreated soffit.

On asking why, a common reply was that the ceiling lights caused headaches. One reason for this seemed to be that the louvres had different cut-off angles in different directions, causing distracting reflections in some computer screens. Interestingly, some local problems have been resolved by rotating fittings through ninety degrees.

Noise is the bugbear of the open-plan office. While the occupancy survey scores for the ground and second floors at the CAF are similar to the national benchmark, the first floor is significantly worse. People mentioned hearing remote conversations, banging doors, rain on the plastic rooflights and an inability to identify whether a ringing telephone was for someone in their workgroup or from some distance away. Like many passive solar buildings, the exposed concrete ceiling has no acoustic treatment.

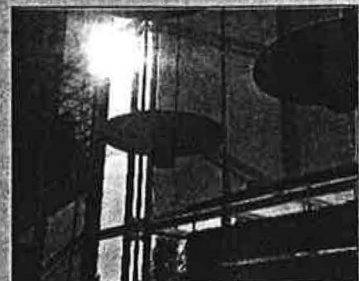
Sun glare into the reception area required a retrofitted sunblind.

The architect warned that blinds might be necessary, but it was decided to wait and see. In practice, the sun shone onto the desk from about 14.00h, with severe consequences both for glare and thermal comfort. Motorised internal roller blinds have now been added under manual control from reception.
