**LABORATORY INVESTIGATION  
AND FIELD MONITORING OF  
PRESSURE EQUALIZED  
RAINSCREEN WALLS**

**Richard Quirouette, B. Arch**  
Quirouette Building Specialists Ltd.  
18 Crispin Private  
Ottawa, Ontario, K1K 2T8

**Project No. J93r07e-4**  
**September 27, 1996**

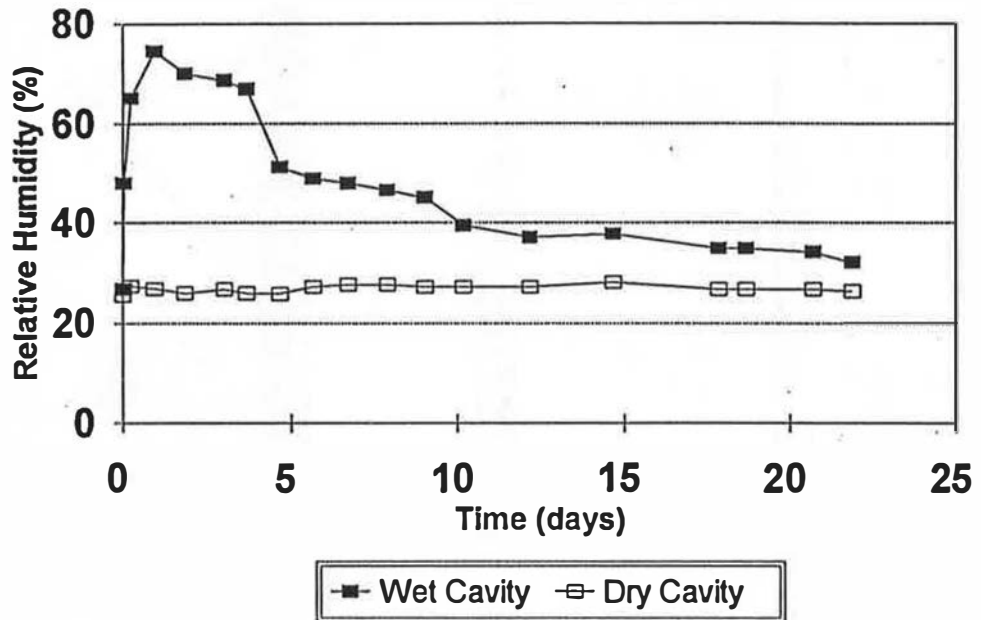
In figure 3 below, it can be seen that the relative humidity of the cavity rises sharply in the first few hours and is sustained for a few days. Then, the relative humidity tends to fall sharply at first and then gradually over about two weeks. The data for figure 3 was obtained by averaging the relative humidity results from 2 sensors, both near the bottom of the rabbet cavity just above the injected water. From the results obtained, it is clear that water in the cavity raises the relative humidity of the cavity air. But, it also shows that water in a closed cavity does not necessarily increase the humidity to 100%. Elsewhere, in the rabbet cavity, specifically the upper end and middle top parts, the humidity sensors recorded an increase in relative humidity but not as high as the lower sensors (see graph RH4 and RH5 of Appendix A).

**Figure 3 - Curtain Wall Rabbit Cavity  
Relative Humidity Observations**

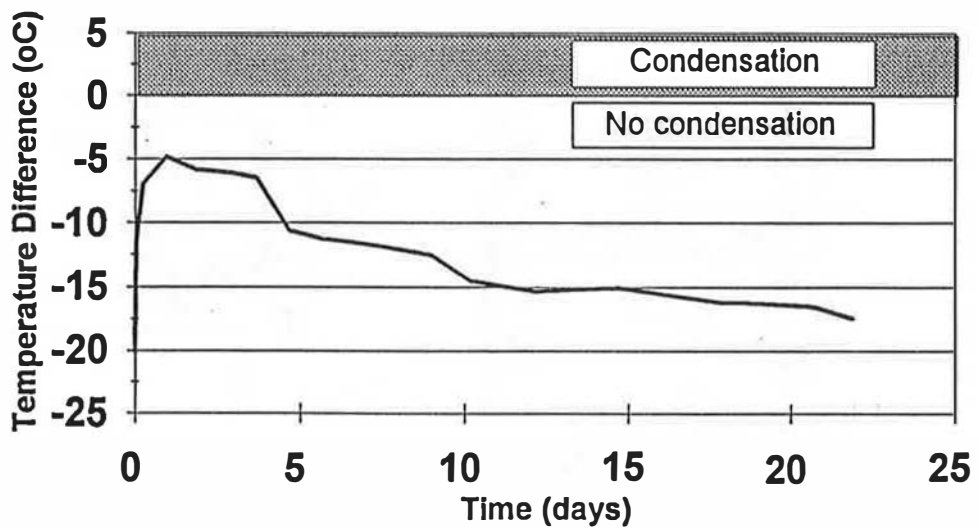
**Figure 4 - Curtain Wall Rabbit Cavity  
Dewpoint Temperature Analysis**

To better visualize the effect of water in the rabbet space, the temperature and relative humidity were converted to dewpoint temperature and compared to ambient conditions of the laboratory. In figure 4, the dewpoint temperature of the air in the rabbet cavity was subtracted from the ambient laboratory air temperature and plotted as a relative temperature difference. The dotted line at -20 °C indicates the temperature difference between the ambient temperature in the laboratory and the ambient dewpoint temperature. It is clear from the graph that 50 ml of water causes a distinct rise in the dewpoint temperature of the cavity air and that its decay can be related to moisture evaporation from venting.

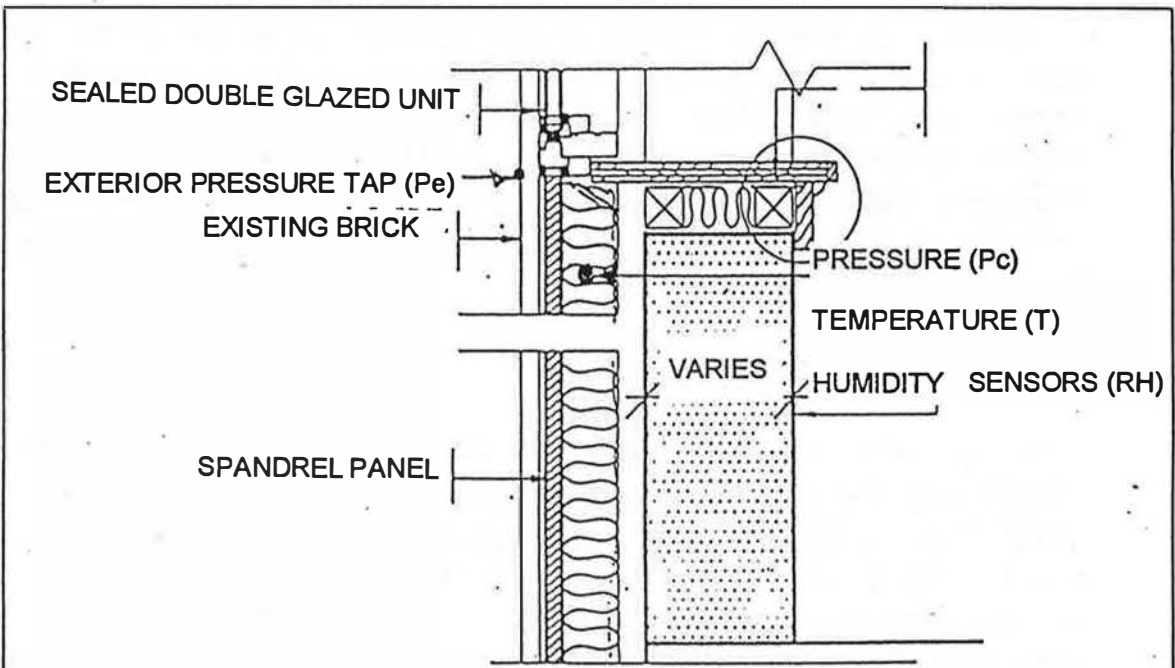
**Figure 6 - Location of pressure taps (Pe, Pc), temperature (T) and humidity (Rh) sensors.**

sealed glazing units. Figures 5 and 6 below illustrate the facade of the curtain wall and the location of the sensors within. Note that the curtain wall is joined to a brick wall along the jamb. The elevation shown is oriented to the North East.

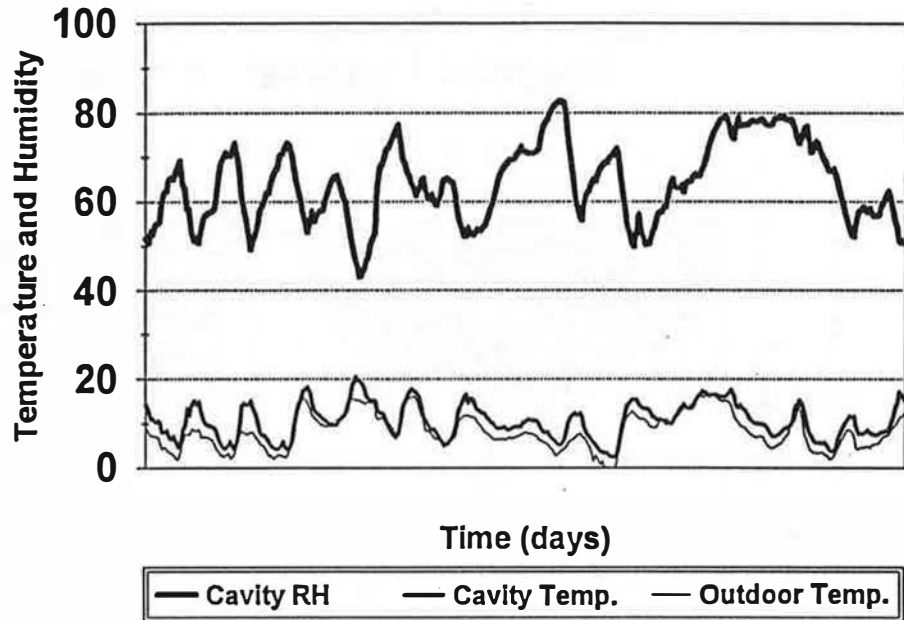
The relative humidity of the spandrel cavity air, the spandrel cavity air temperature and the outdoor temperatures were plotted on a graph for comparison and illustrative purposes (figure 8). It is noted that the spandrel temperature is above the outdoor temperature and that the relative humidity is moderately high but not at saturation (100%). It is also known from the weather records that there was considerable rain during this period and particularly on November 1 and 2. It is not particularly obvious from these observations if rain entered the cavity.

**Figure 8 - Cavity Relative Humidity, Cavity and Outdoor Temperatures**

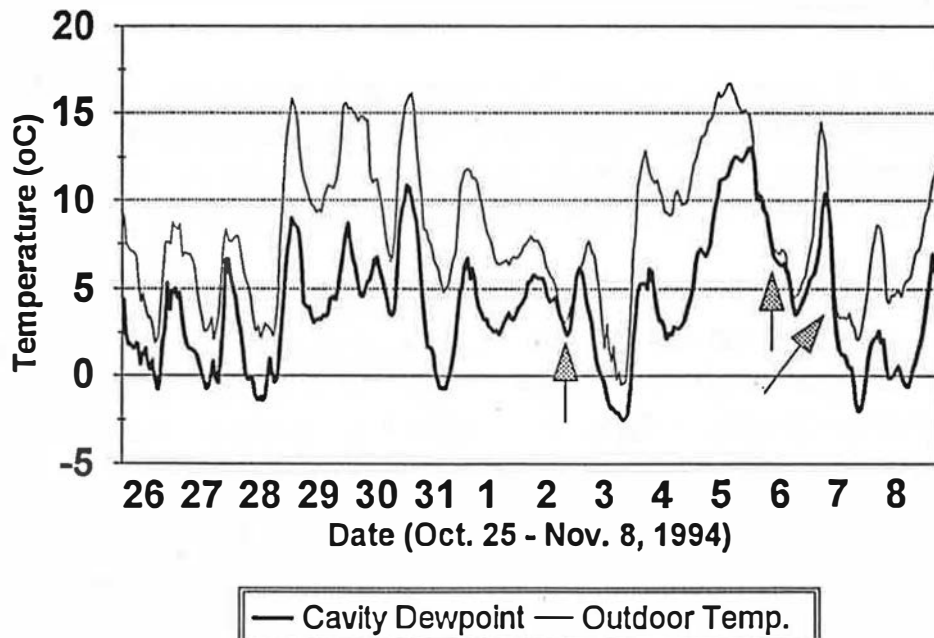
If the temperature and humidity data of the cavity are then converted to dewpoint temperatures and compared to the outdoor temperature we obtained a new plot (figure 9). This plot indicates that for the most part the outdoor and cavity dewpoint temperatures appear to follow each other without touching except in a few locations, see arrows on figure. When the dewpoint temperature of the cavity and the outdoor temperature are equal we expect that the inside surface of the spandrel glass is wetted by condensation.

**Figure 9 - Cavity Dewpoint Temperature and Outdoor Temperature**

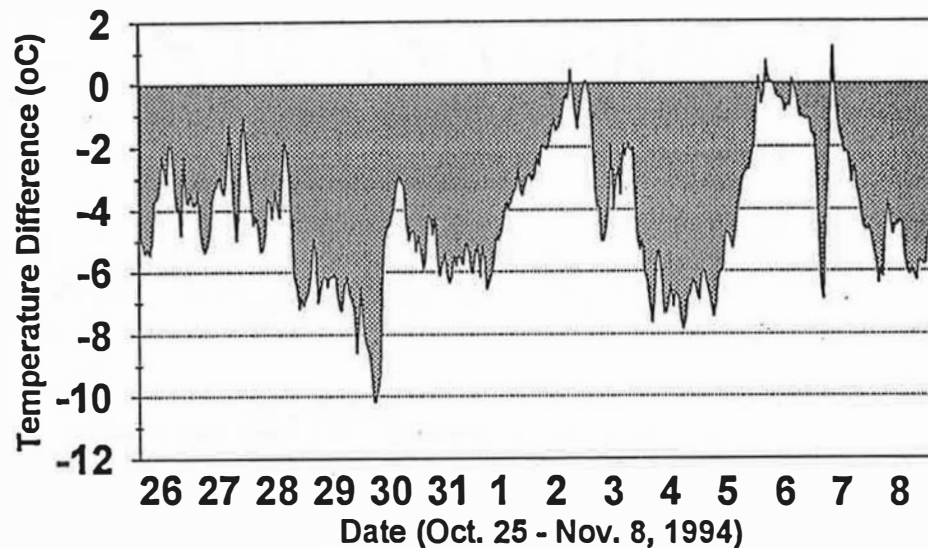
If a third plot is produced which examines the difference between the outdoor temperature and the cavity dewpoint we obtain a new plot (figure 10). In this figure, the difference in temperatures is wide with the exception of 6 small spikes where the dewpoint temperature exists temporarily above the outdoor temperature. This indicated that condensation was occurring. However, because the cavity dewpoint temperature dropped so rapidly, it is also believed that the cavity moisture conditions increased from the saturated outdoor air and not rain penetration. This is because, if wetting had occurred in the cavity, the condensation potential would have lasted considerably longer as was illustrated in the laboratory experiment.

**Figure 10 - Wetting and Drying Cavity  
Dewpoint Temperature Analysis**

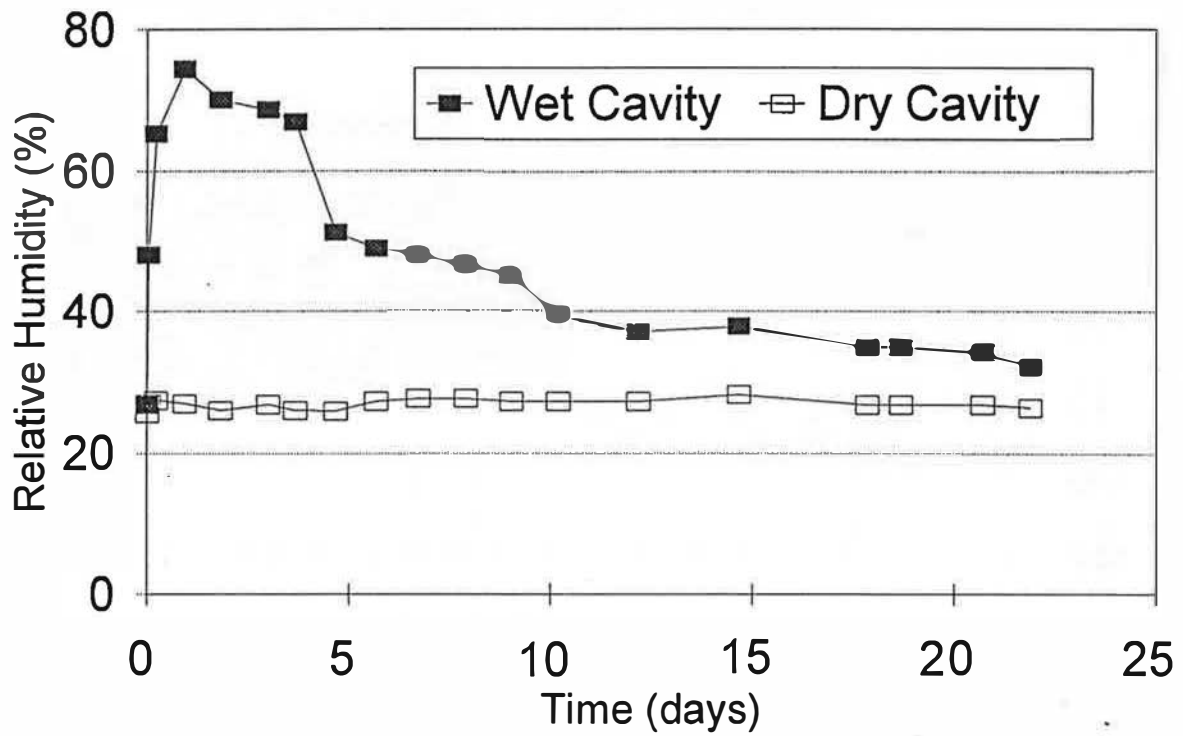
**Figure A1-Curtain Wall Rabbet Cavity**  
Relative Humidity Observations

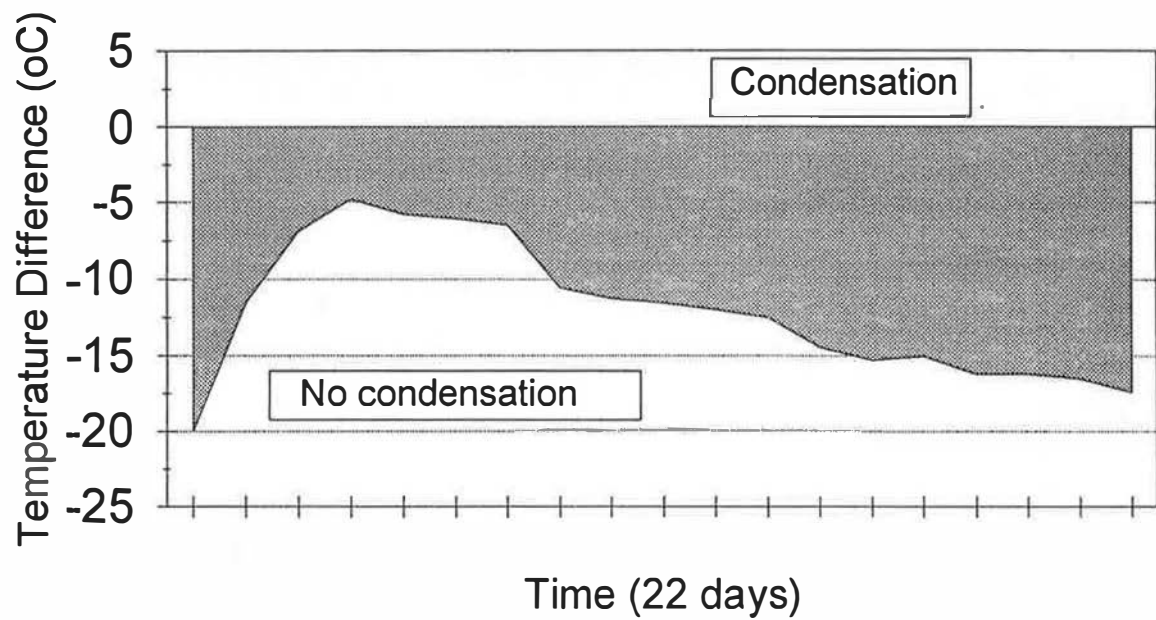
**Figure A2-Curtain Wall Rabbit Cavity**  
Dewpoint Temperature Analysis

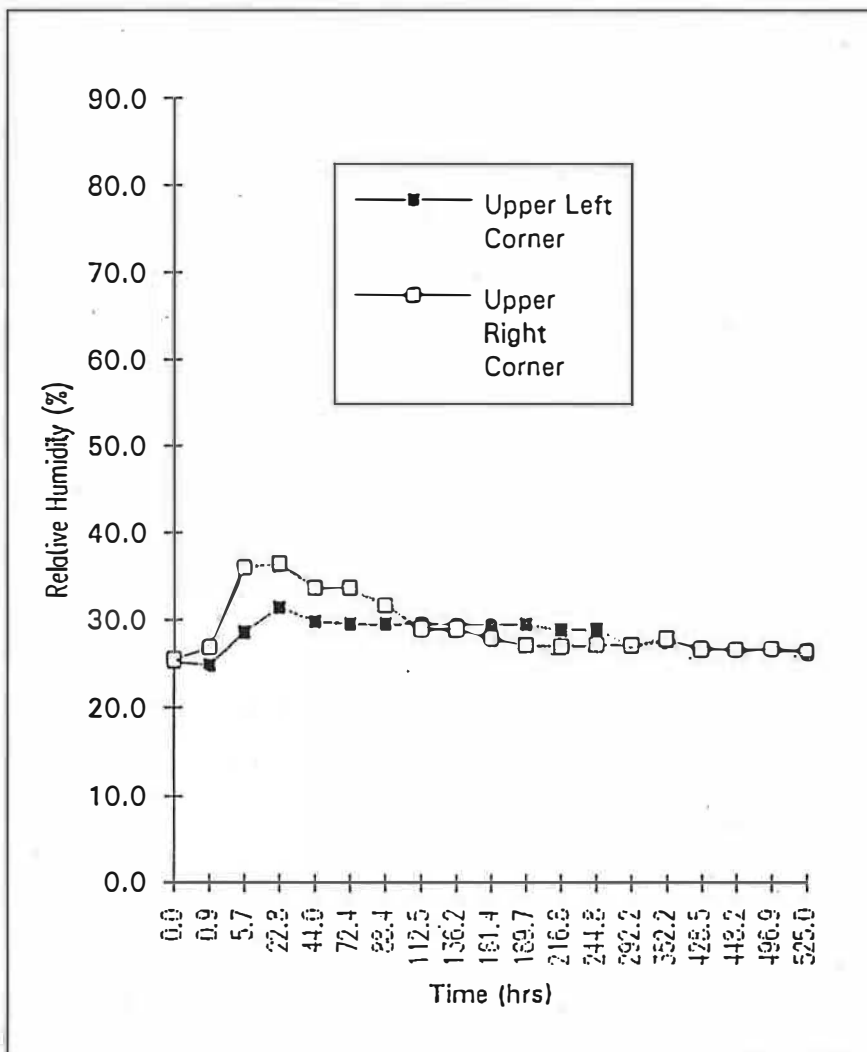
## GRAPH RH-4 GLAZING CAVITY RELATIVE HUMIDITY DECAY

Summary of Test Conditions	
Direction of Air Flow through Connected Source	N/A
Vision Unit Perimeter Seal	1
External Snap Caps	Off
Pressure Plate Openings	
Area	.000452 m <sup>2</sup>
Status	Open

1. Pressure plates installed over bead of silicone sealant
2. Outer face of pressure plates sealed to outer side wall of mullion

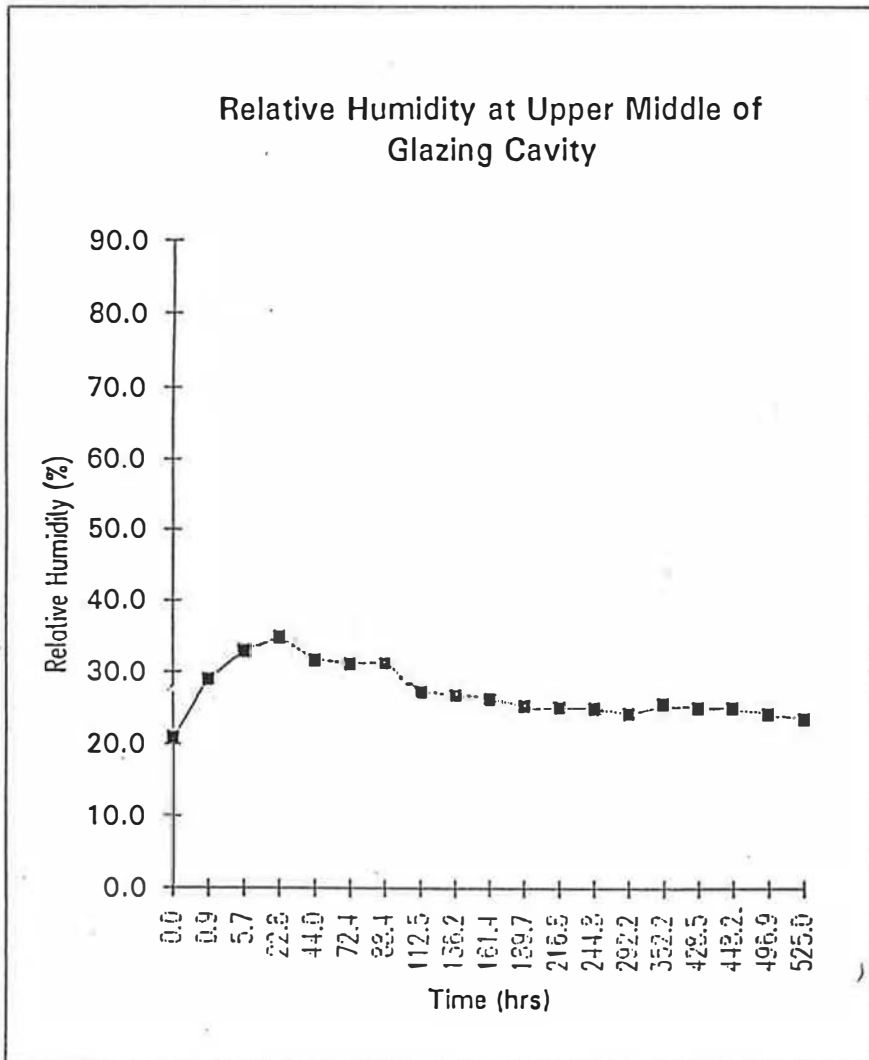
## GRAPH RH-5 GLAZING CAVITY RELATIVE HUMIDITY DECAY

Summary of Test Conditions	
Direction of Air Flow through Connected Source	N/A
Vision Unit Perimeter Seal	1
External Snap Caps	Off
Pressure Plate Openings	
Area	.000452 m <sup>2</sup>
Status	Open

1. Pressure plates installed over bead of silicone sealant
2. Outer face of pressure plates sealed to outer side wall of mullion

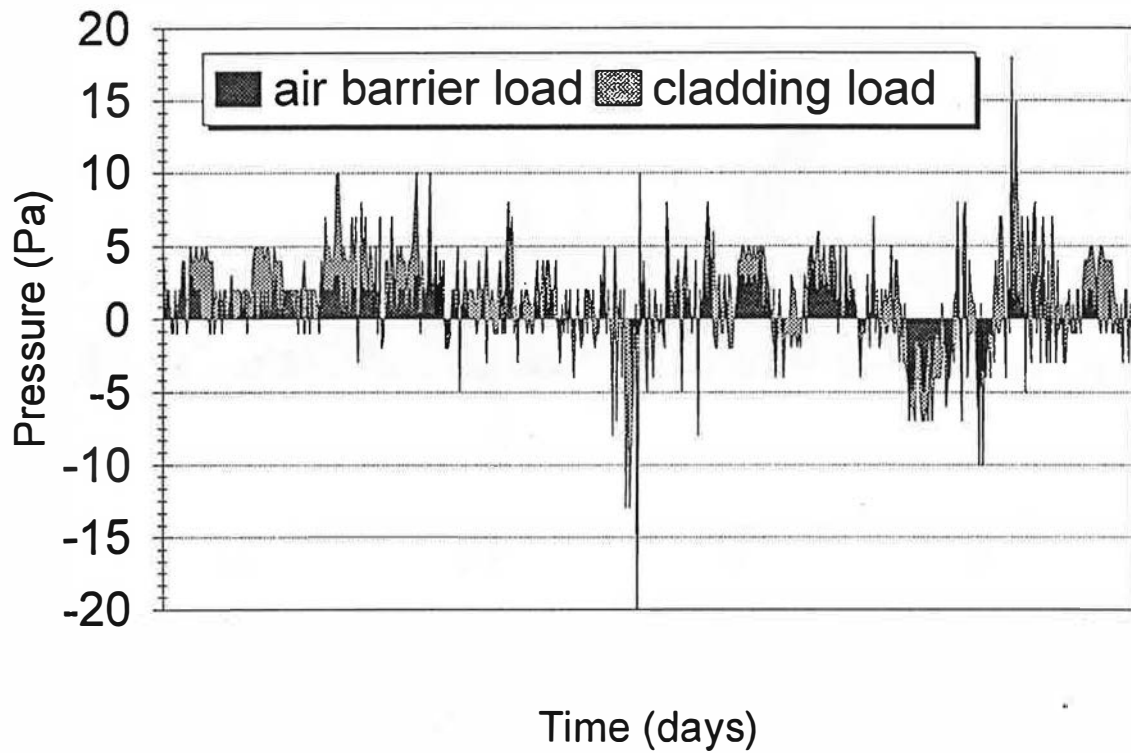
**Figure A3-Curtain Wall Spandrel Panel**  
Long Term Monitoring Oct 25-Nov 8, 1994

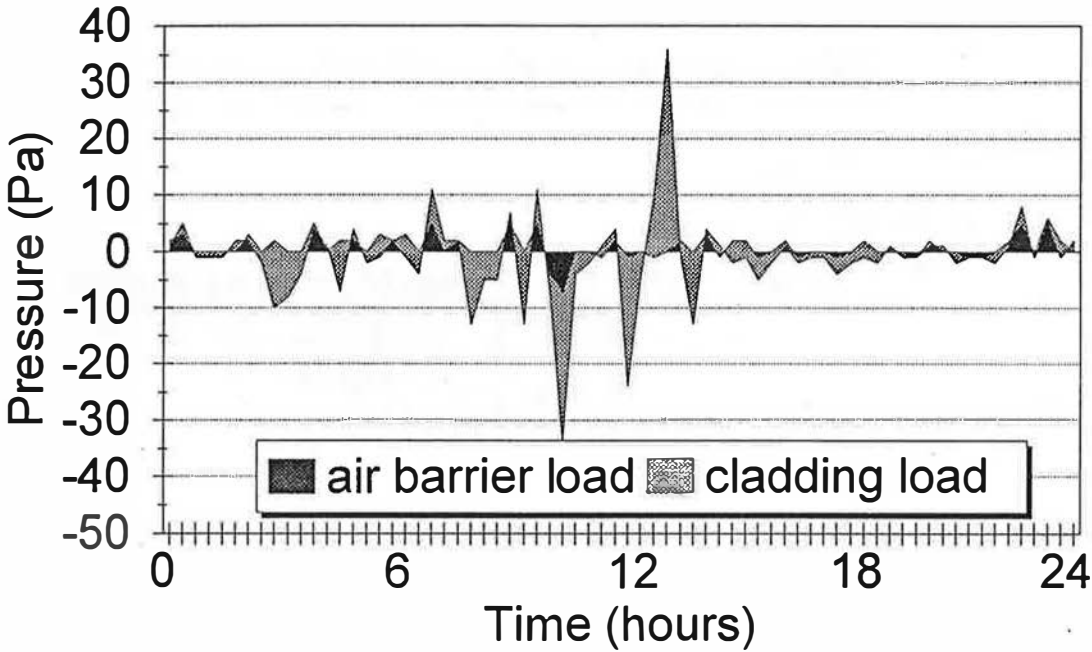
**Figure A5-Curtain Wall Spandrel Panel**  
Long Term Monitoring Nov. 1, 1994

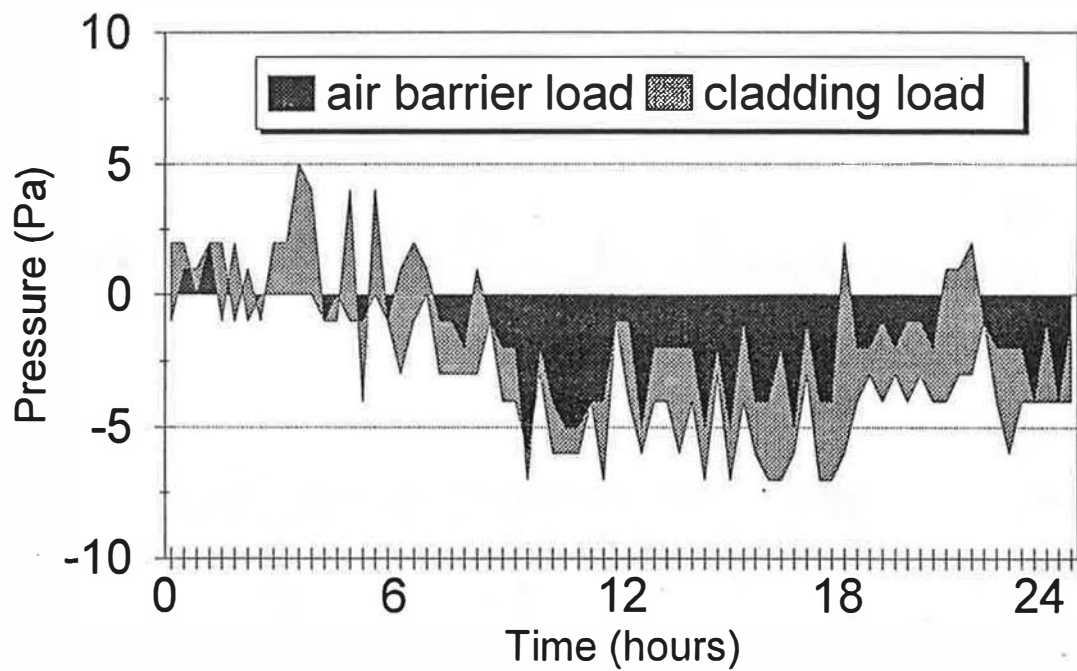
**Figure A6-Curtain Wall Spandrel Panel**  
Long Term Monitoring Nov. 5, 1994

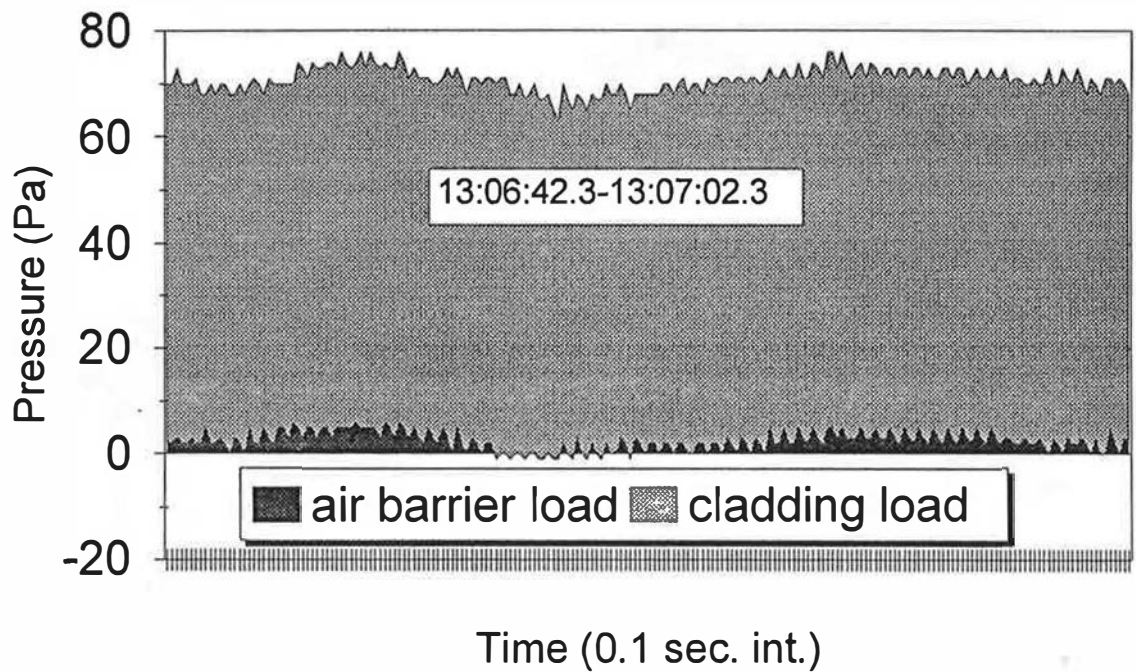
**Figure A8-Curtain Wall Spandrel Panel**  
Short Term Monitoring Nov. 1, 1994

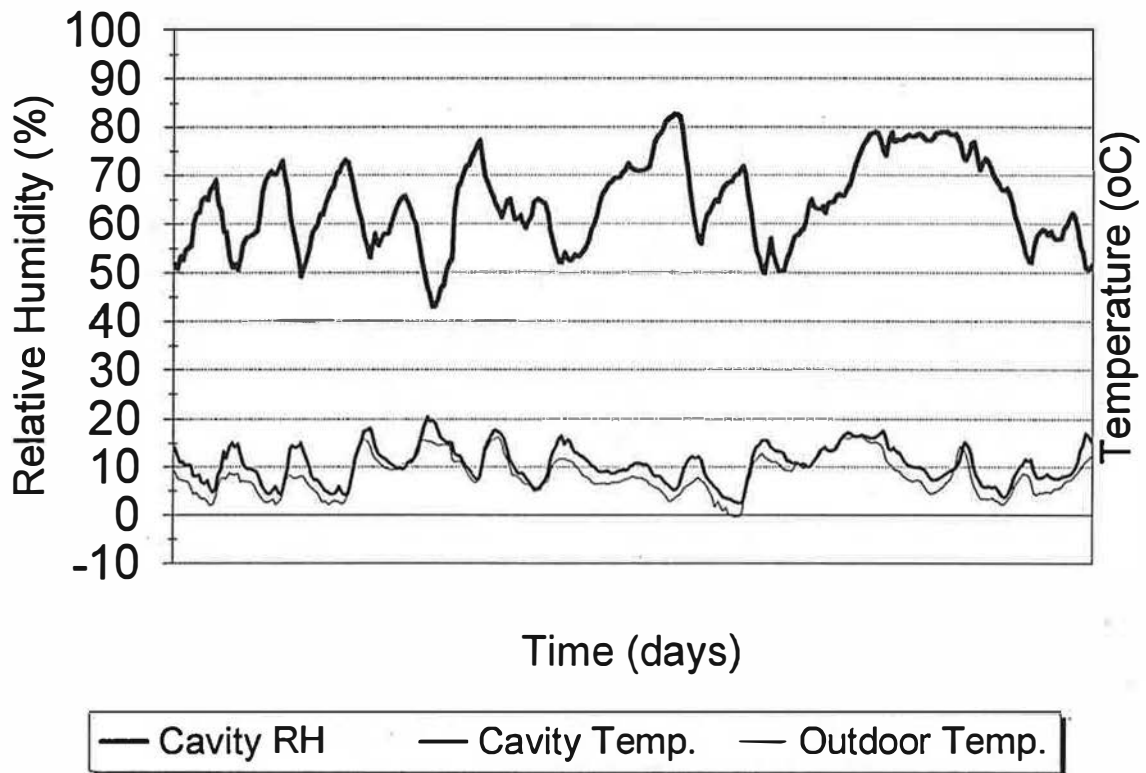
# Figure A11-Curtain Wall Spandrel Panel

Long Term Monitoring Oct 25-Nov 8, 1994

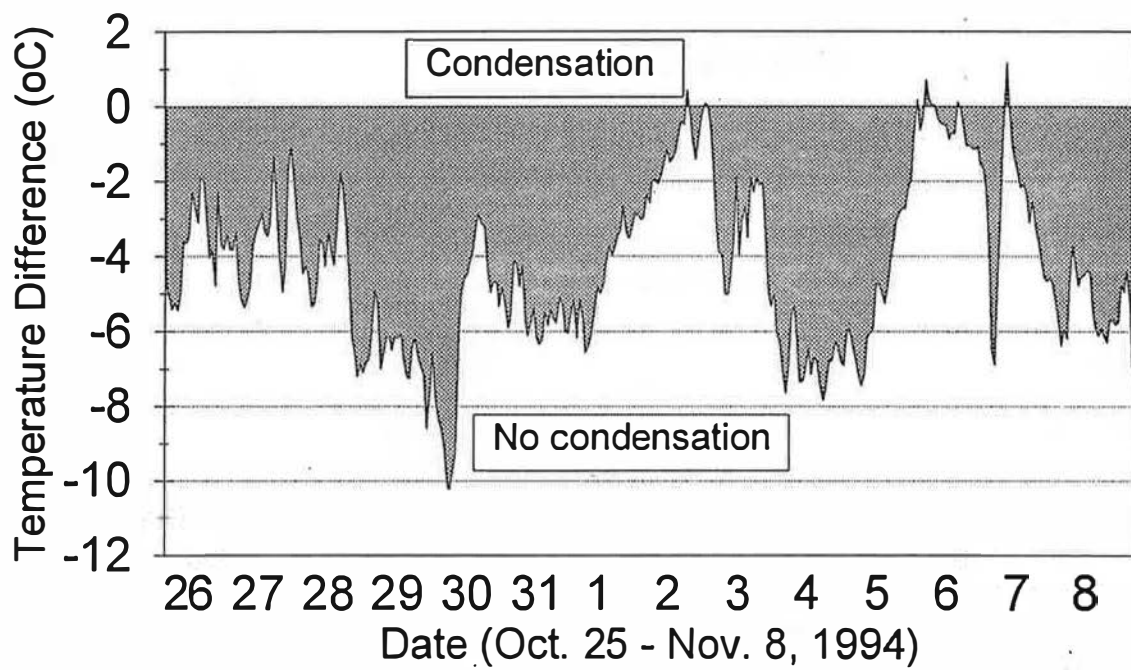
**Figure A13-Curtain Wall Spandrel Panel**  
Dewpoint Temperature Analysis

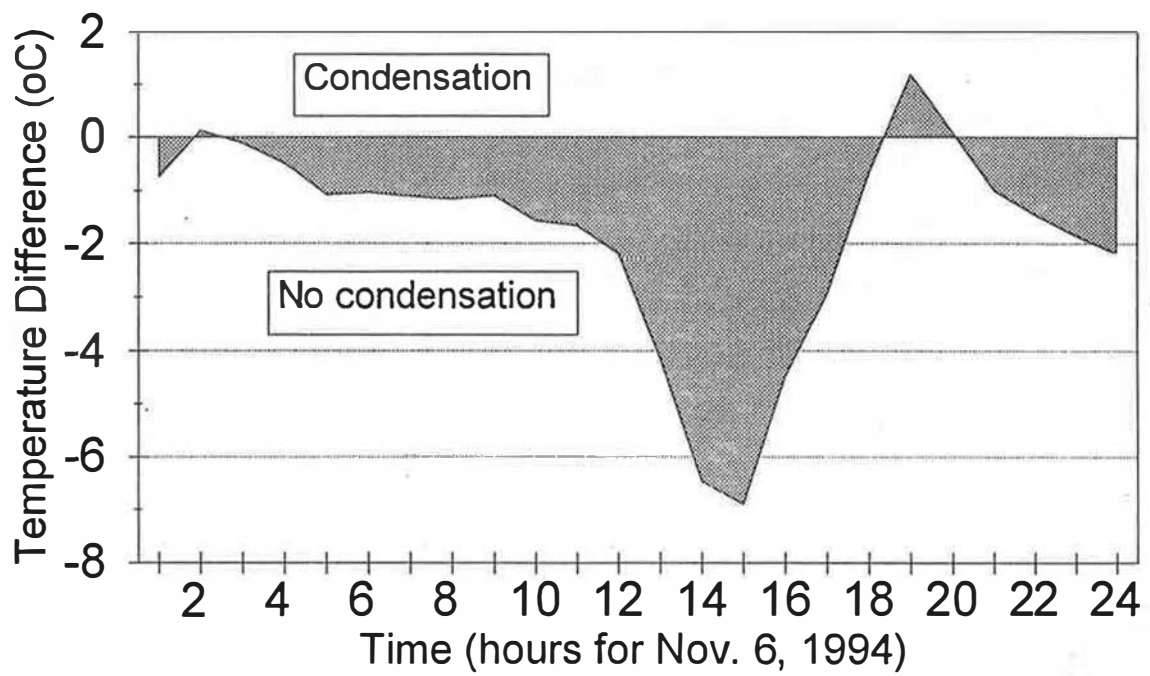
**Figure A14-Curtain Wall Spandrel Panel**  
Dewpoint Temperature Analysis

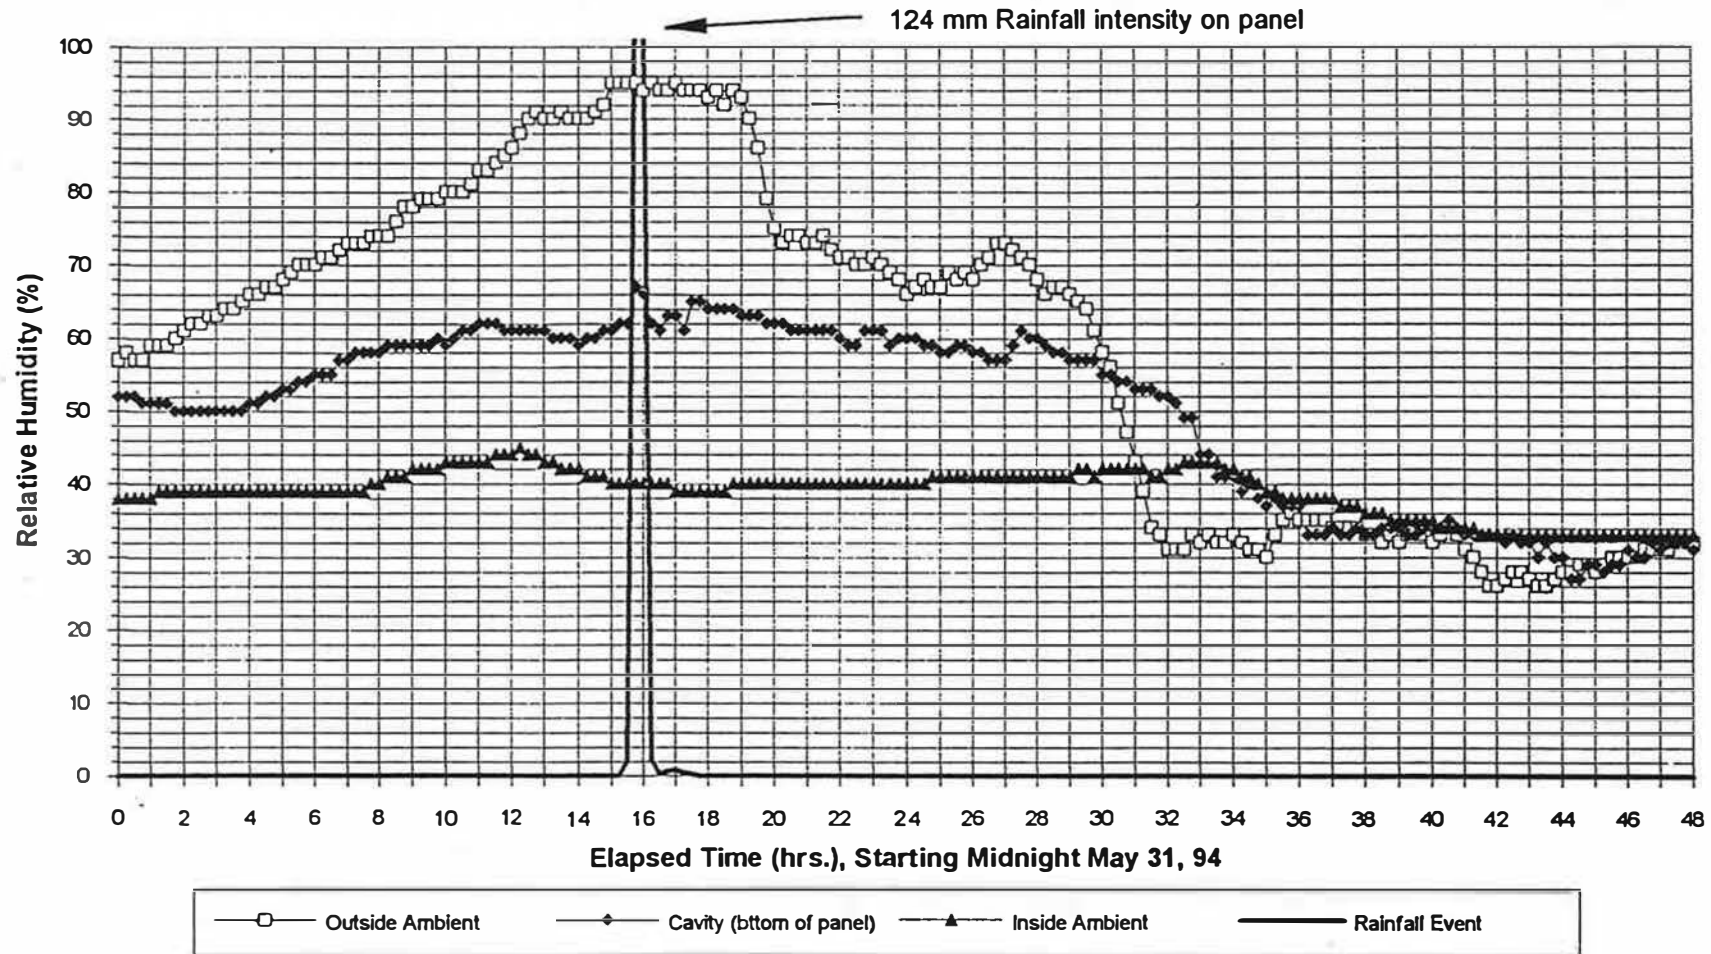
Figure B2

Figure (1): Relative Humidity Inside and Outside Wall Cavity  
Canada Life Building, 12th Floor, West Elevation  
Centre Panel #101

The results show clearly that the cavity moisture did not reach saturation. There was however, a rise in humidity before the rainfall and a gradual drop in humidity after the rain. This pattern of change is believed to be related to the absorption and evaporation of moisture from the limestone face and its effect on the cavity conditions. To be certain however, this effect should be examined in the laboratory.

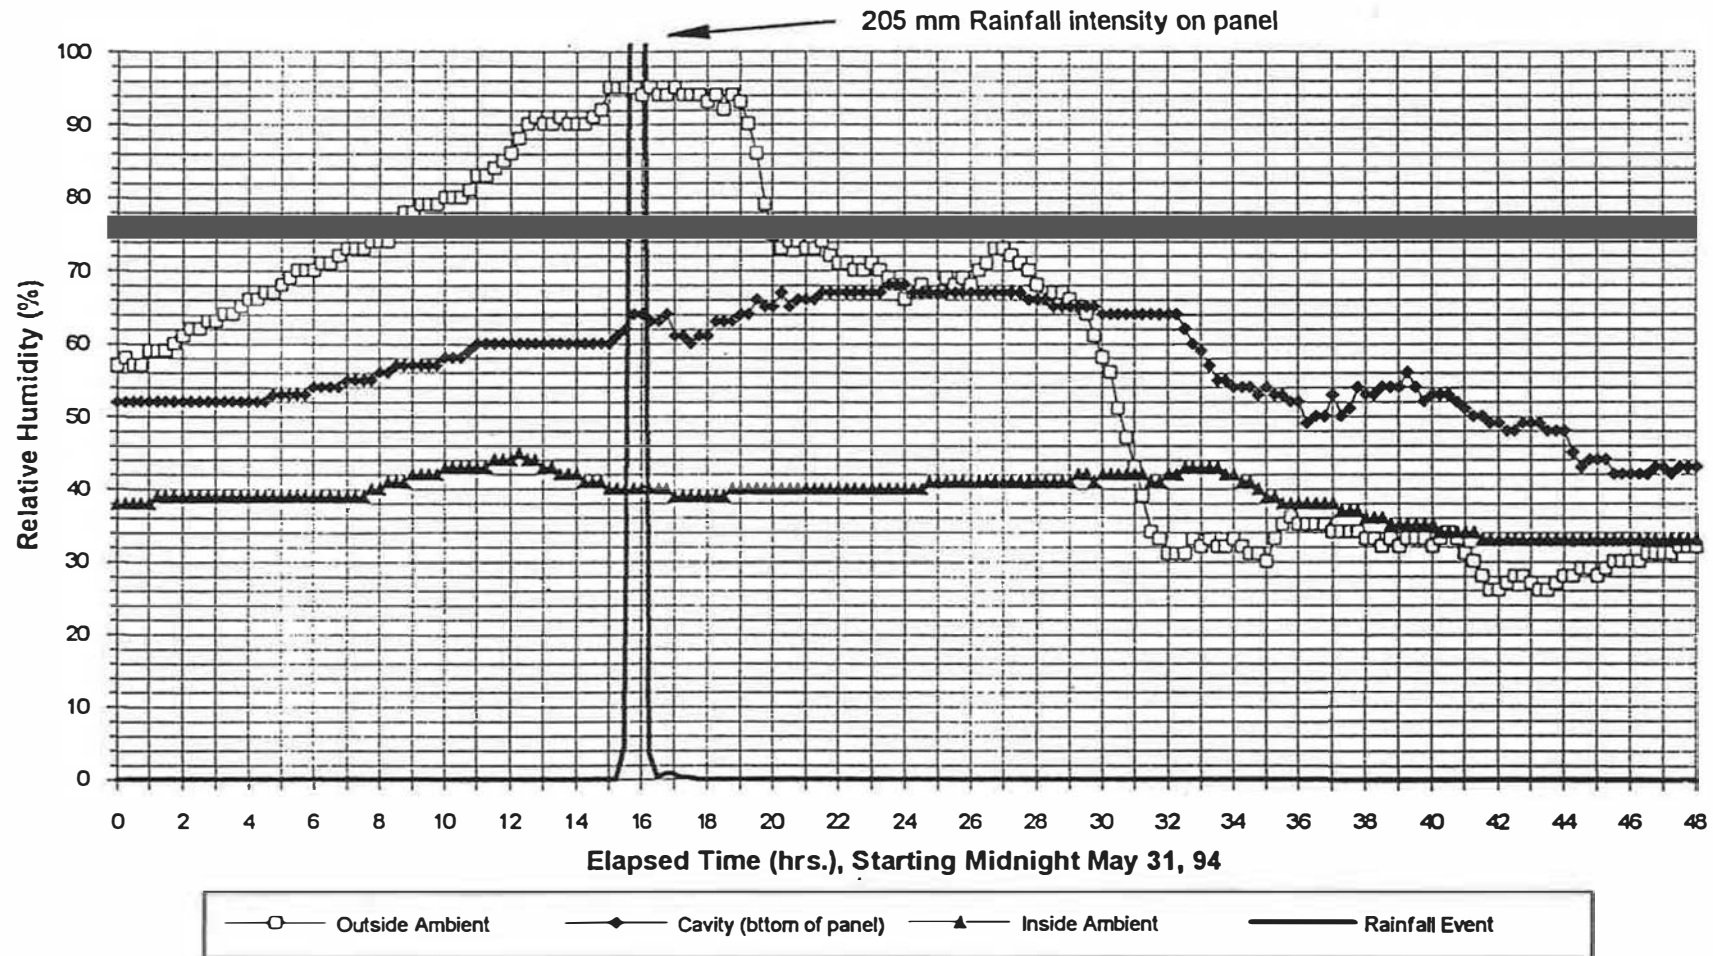
Figure B3

Figure (2): Relative Humidity Inside and Outside Wall Cavity  
Canada Life Building, 12th Floor, West Elevation  
Panel #99

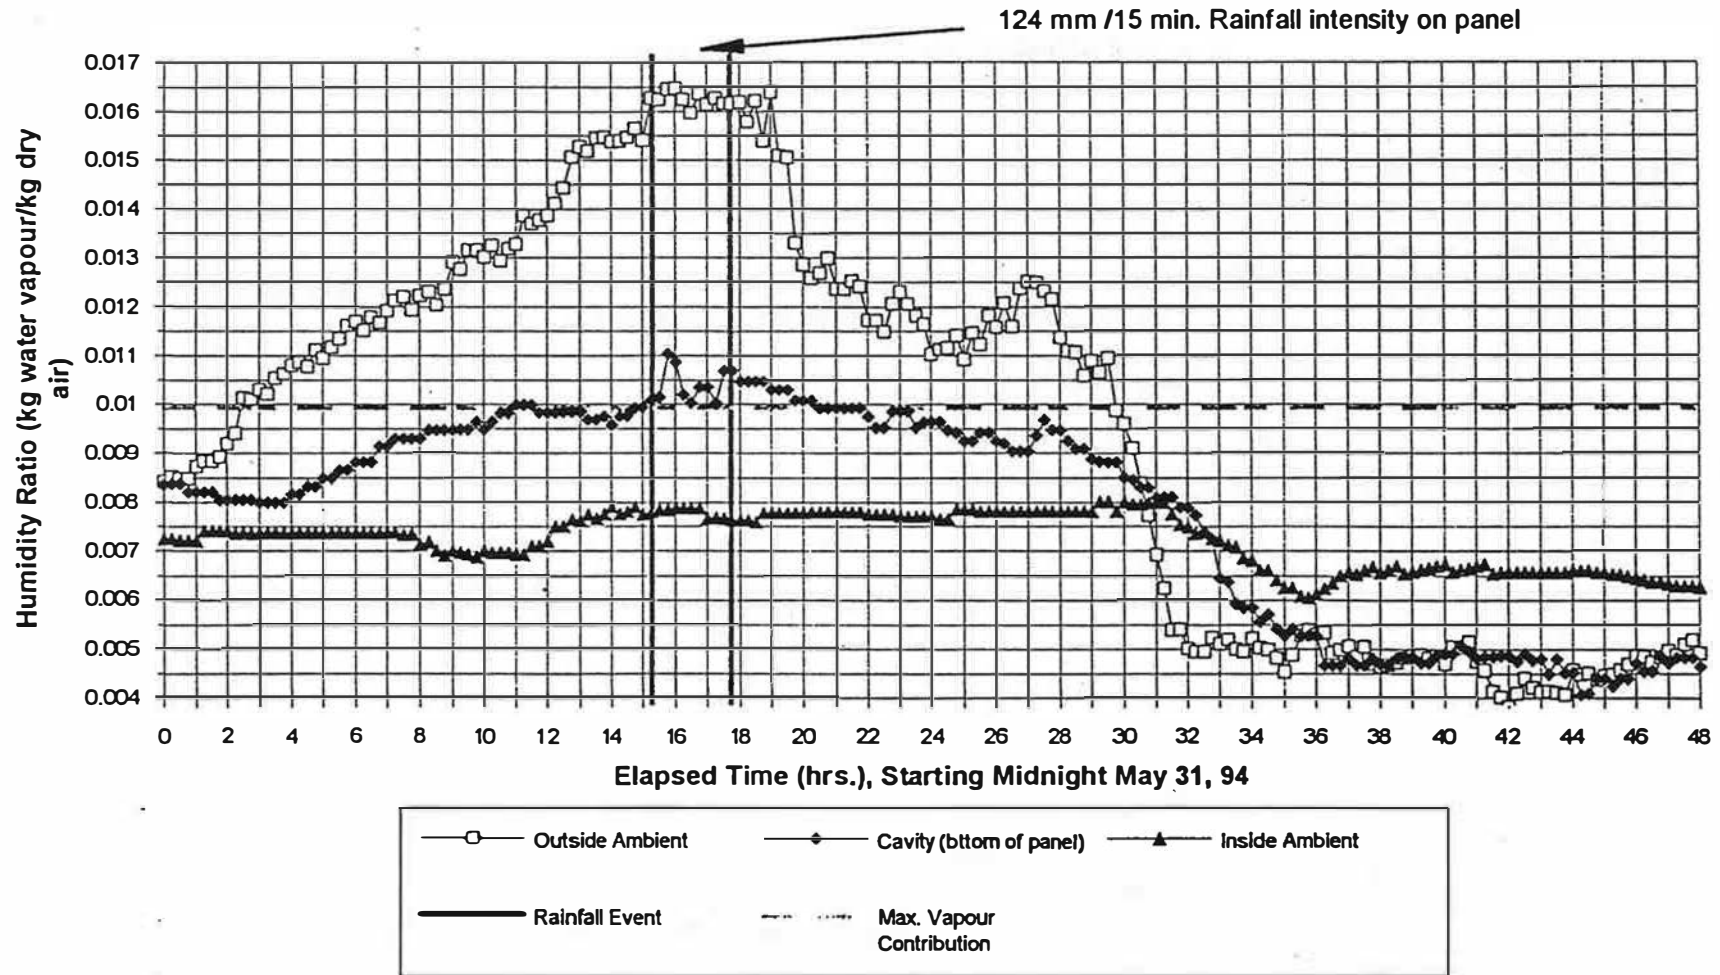
Figure B4

Figure (3): Air Humidity Ratio Inside and Outside Wall Cavity  
Canada Life Building, 12th Floor, West Elevation  
Centre Panel #101

Based on the collected data of relative humidity, temperature and barometric pressure, the Humidity Ratio (HR) curves for each wall cavity and for both the exterior and interior ambient environments were plotted prior to, during and following rainfall (see Appendix C).

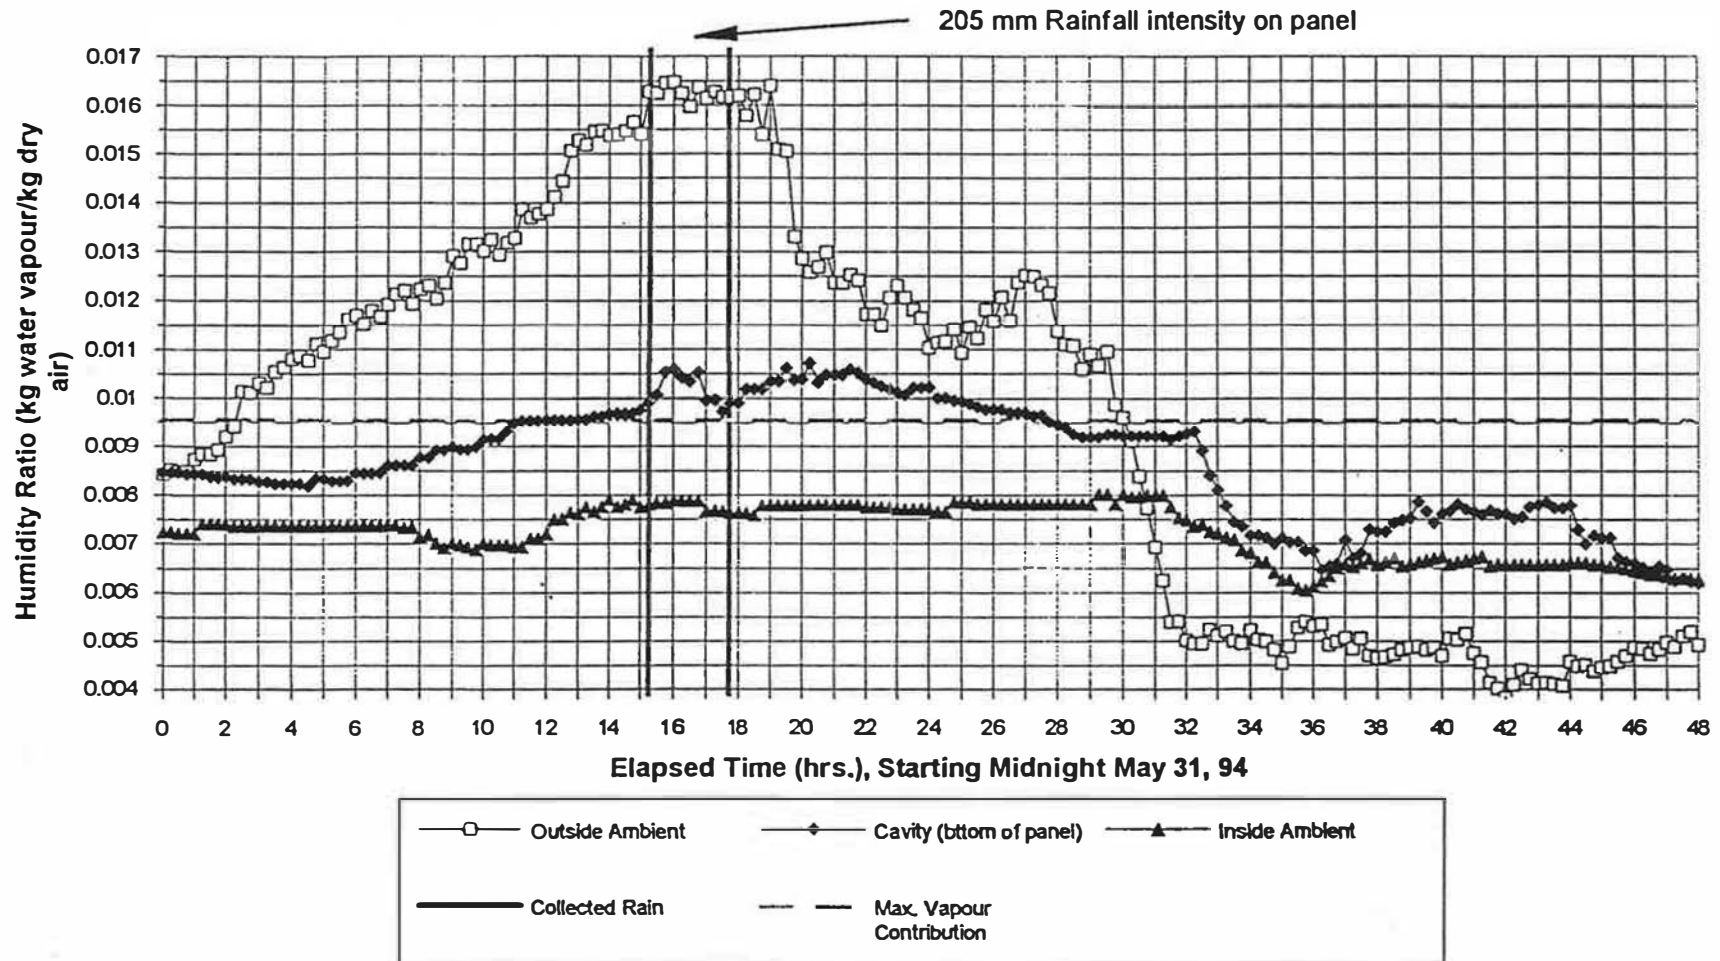
Figure B5

Figure (4): Air Humidity Ratio Inside and Outside Wall Cavity  
 Canada Life Building, 12th Floor, West Elevation  
 Panel #99
