**PERFORMANCE OF BRICK VENEER
STEEL STUD WALL SYSTEMS
SUBJECT TO TEMPERATURE,
AIR PRESSURE AND
VAPOUR PRESSURE
DIFFERENTIALS**

**PART 3 OF THE McMASTER UNIVERSITY LABORATORY TEST
PROGRAM ON BRICK VENEER/STEEL STUD WALL SYSTEMS**

**PROJECT IMPLEMENTATION DIVISION
CANADA MORTGAGE AND HOUSING CORPORATION**

May 1990

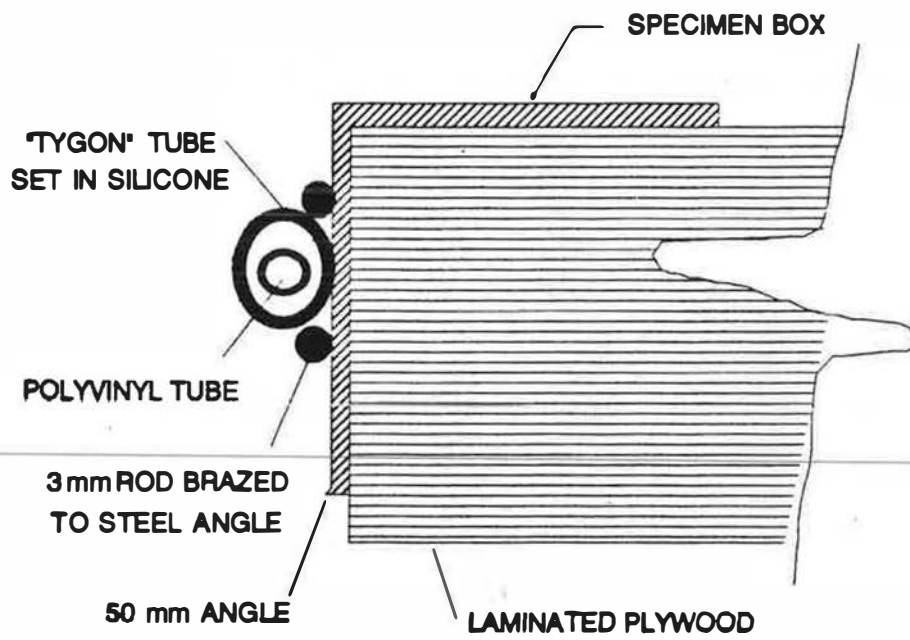
FIGURE 2.7 PRIMARY SEAL - ESTA 1

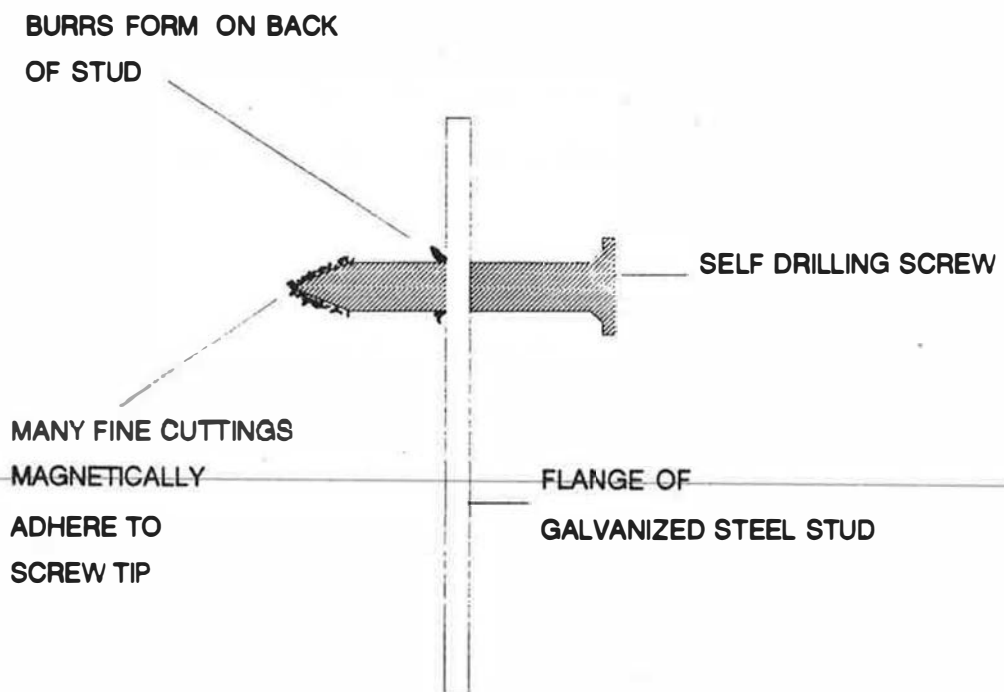
FIGURE 3.3 CONDITION OF SCREW AND STUD AFTER SELF DRILLING OPERATION

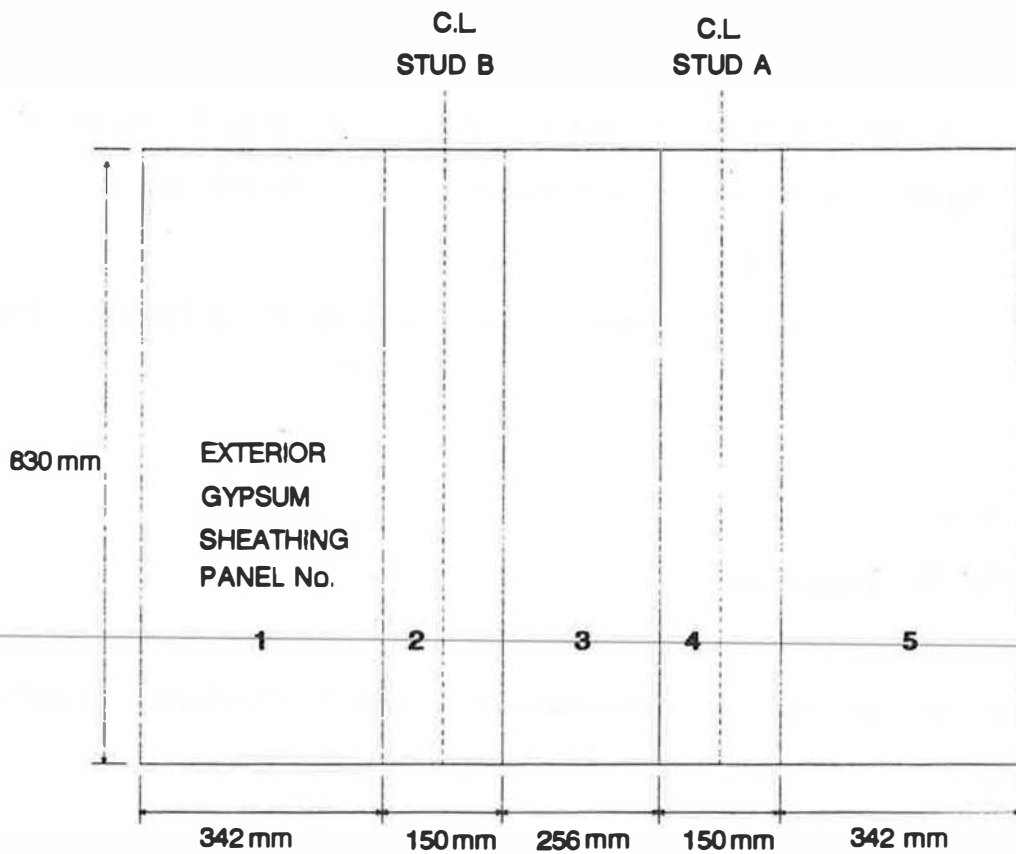
FIGURE 3.4 EXTERIOR VIEW OF GYPSUM SHEATHING PANELS IN WALL SPECIMEN 1B

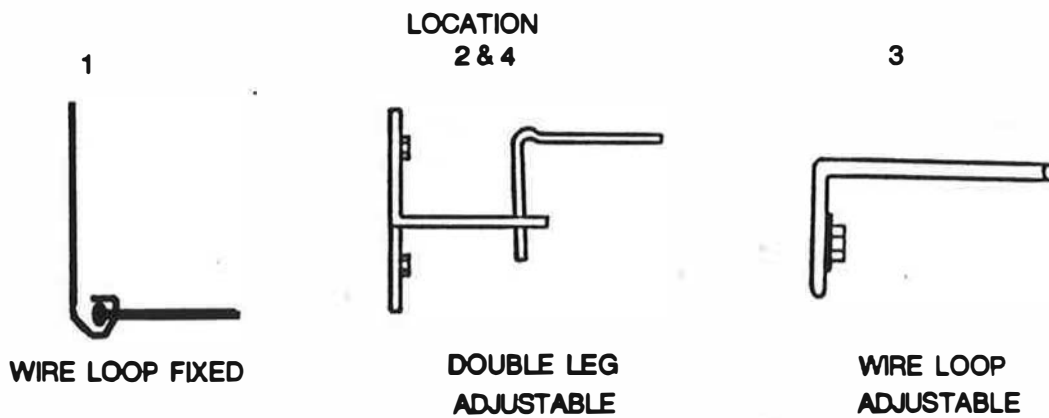
(a) EXTERIOR VIEW OF WALL SPECIMEN 1A SHOWING LOCATION OF BRICK TIES

(b) TYPES OF BRICK TIES USED

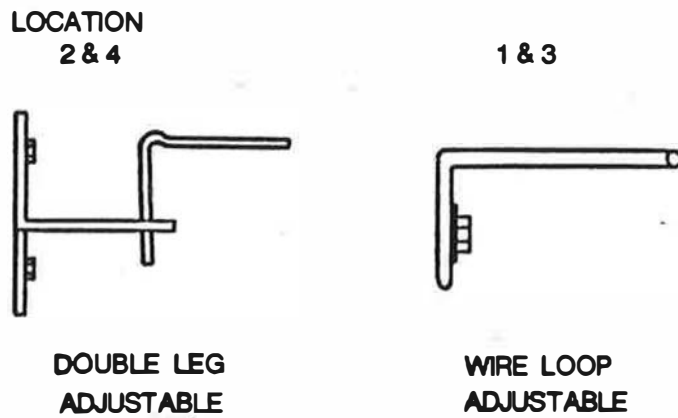
(a) EXTERIOR VIEW SHOWING LOCATION OF BRICK TIES AND BUTT JOINT IN SHEATHING

(b) TYPES OF BRICK TIES USED

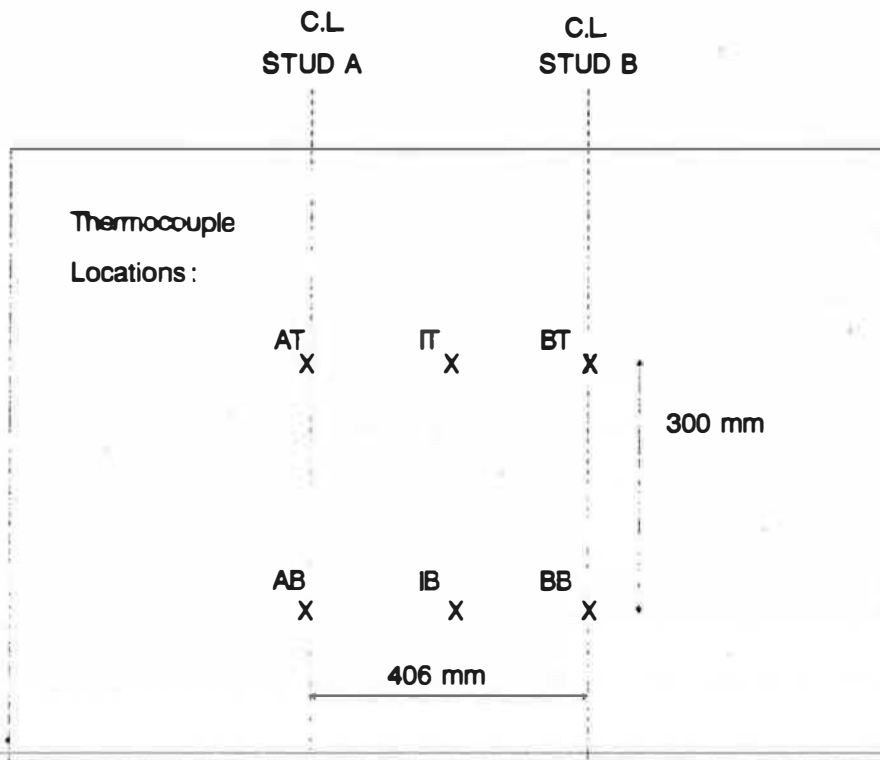
FIGURE 3.13 INTERIOR VIEW SHOWING THERMOCOUPLE LOCATIONS FOR SPECIMENS 1A AND 2A

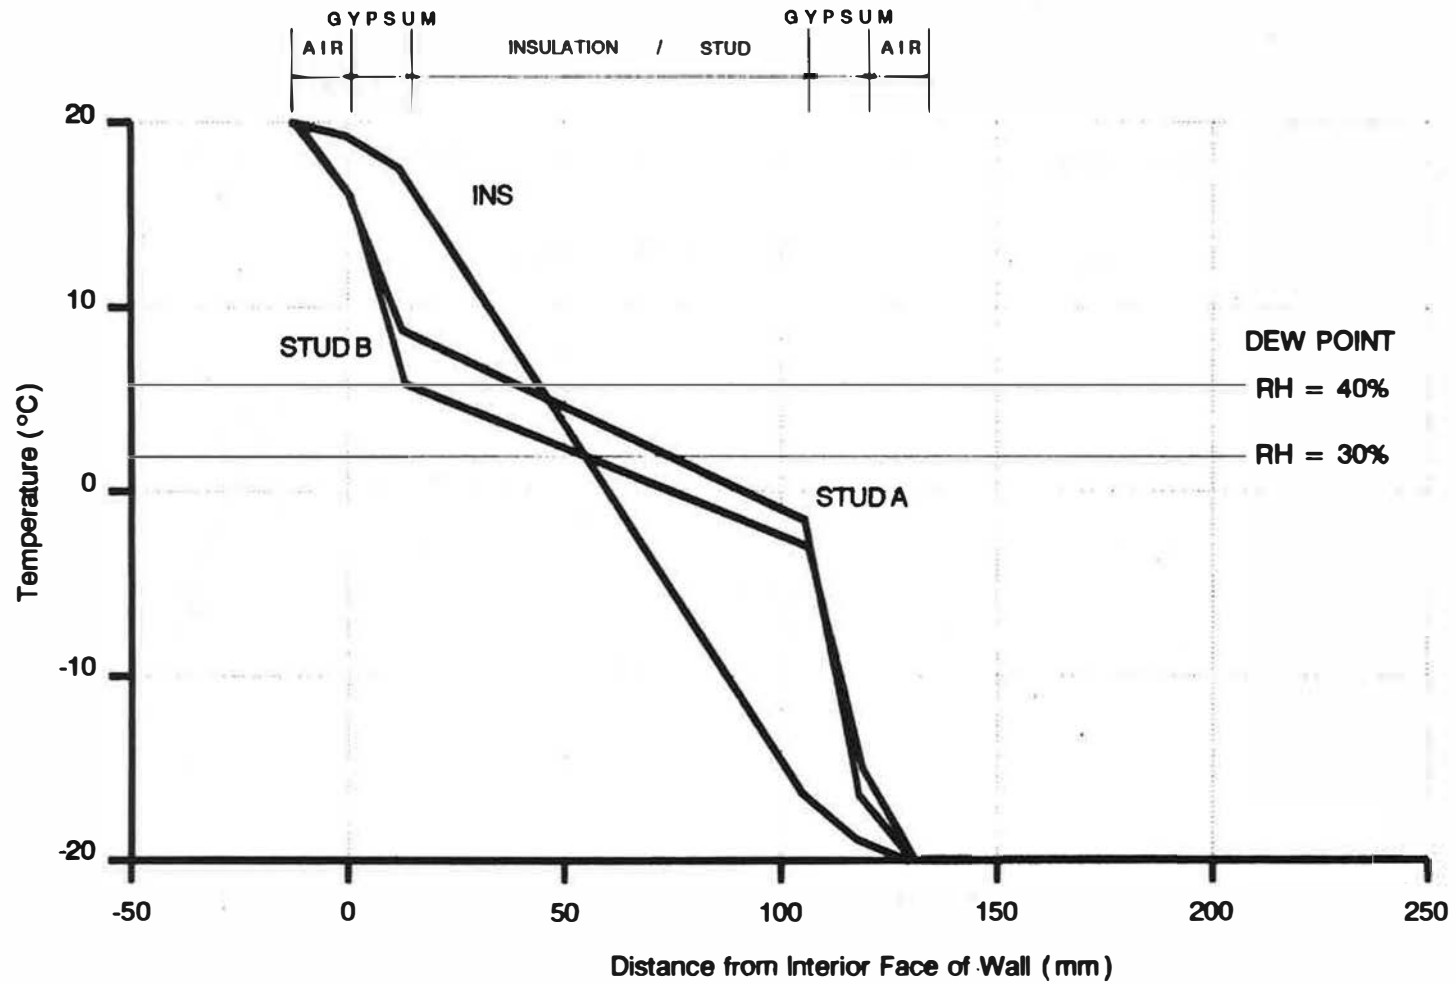
FIGURE 3.18 THROUGH-THE-WALL THERMAL PROFILES AT STUD A, STUD B AND INS FOR SPECIMEN 1B

The thermal behaviour of Wall Specimen 1B was obtained over a period of 11 days. The data obtained was divided into 8 sequential groups representing 8 days. From each group, 10 sets of steady state temperature profiles were chosen and are listed in Appendix B, Table B2, for each of the thermal profiles monitored. Three of the profiles, Stud A, INS and Stud B, were in the standard configuration at each material interface at mid wall height (Figure 3.17(a)). The fourth profile, AIB was in the plane of the wall at the interior face of the exterior gypsum board sheathing (Figure 3.17(b)). The three through-the-wall profiles were measured with six thermocouples while the in plane profile was measured with nine thermocouples, three of which were common with the three perpendicular profiles. Average α_x values for the entire set of data is presented in Table 3.6. Figure 3.18 and 3.19 represent the calculated temperature profiles for each of the four profiles as obtained from the overall average α_x values.

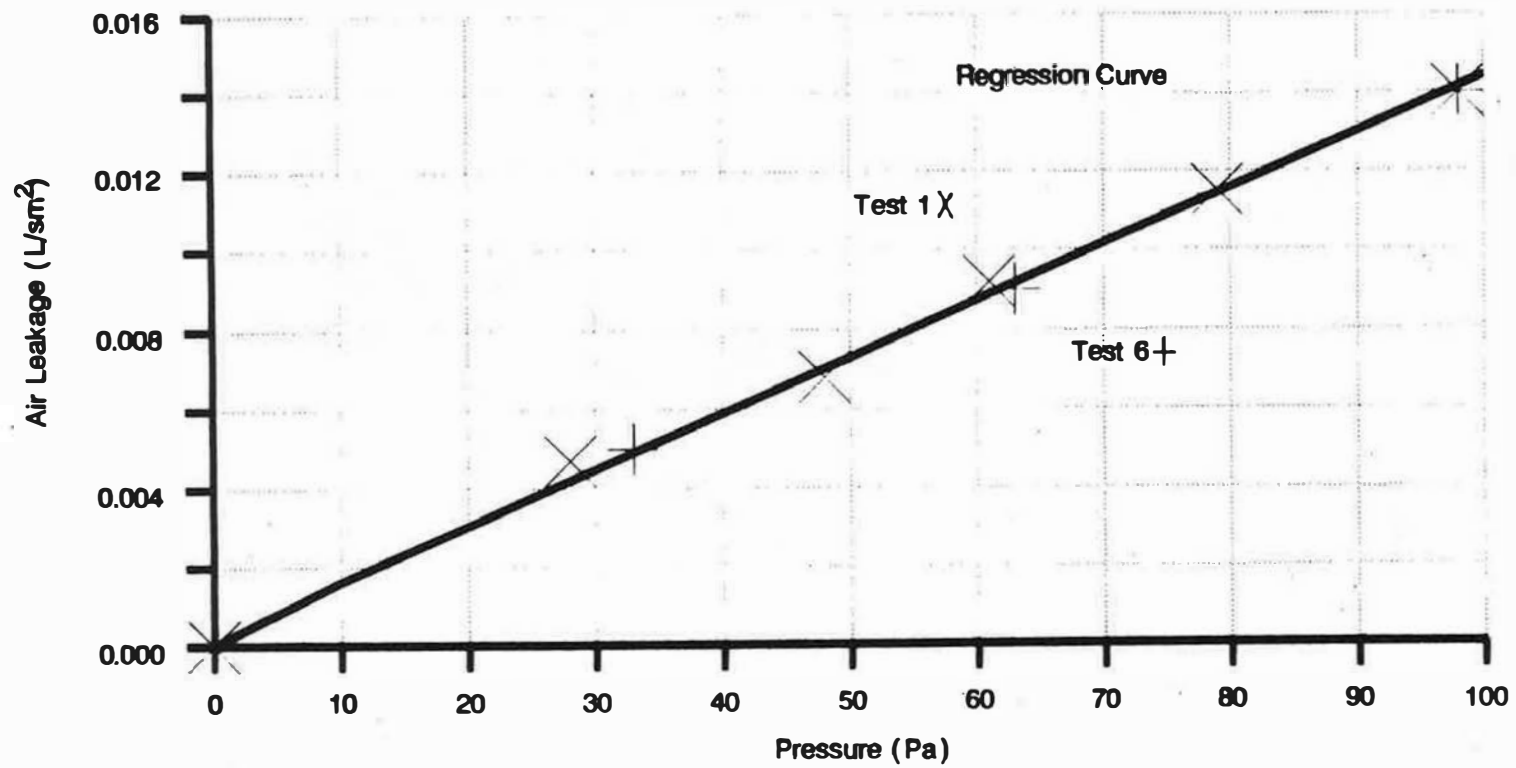
Note : Test 1 and 6 - gross flow ; all other tests net flow (i.e. apparatus leakage removed)

FIGURE 3.28(a) SPECIMEN 2B AIR LEAKAGE CHARACTERISTICS - TESTS 1 AND 6

In Figure 3.28(a), the results from Tests 1 and 6 are plotted. Test 1 was intended as a calibration test and as such an extra sheet of polyethylene was taped over the unpainted dry-wall interior to prevent flow through the wall. Test 6 represents the results after the drywall
