**BRE Client Report**                      **CR 272/98**

**Detailed Monitoring of the Canning  
Crescent Centre, London**

## Work Package 2: Performance of naturally ventilated buildings

### Detailed Monitoring Report Canning Crescent Centre (GB2) Vina Kukadia, James Pike, Martin White Building Research Establishment, UK *Indoor Environment Division*

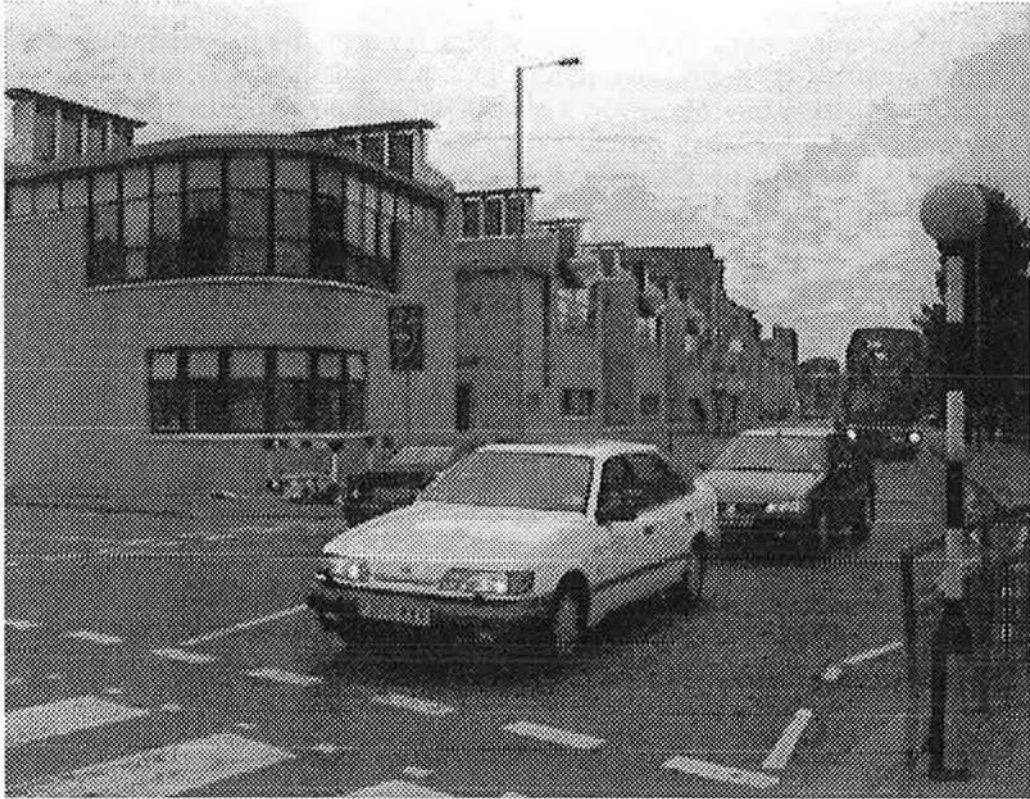
Figure 1(a). View of the Canning Crescent Centre from the Busy High Street.

The Canning Crescent Centre (Figures 1(a) and 1(b)), is a purpose built L-shaped community day care centre completed in 1994 at a cost of £1.3 million. Located on a busy high street in Wood Green, an urban area of London, it is built on two storeys and has a gross floor area of 1350 m<sup>2</sup>. The building is a high thermal mass construction comprising a steel frame with exposed brick walls and a concrete ground floor ceiling. It contains cellular office spaces all branching off from a central corridor. The occupancy within the offices is in general variable and of an intermittent nature.

The south west side of the building, on which the therapy and interview rooms are located, (Figure 2) faces the busy high street (Figure 1a) and pedestrian area where air pollution and noise levels are perceived to be high. The north east side of the building backs onto an enclosed garden courtyard, which also serves as the Centre's car park (Figure 1b).

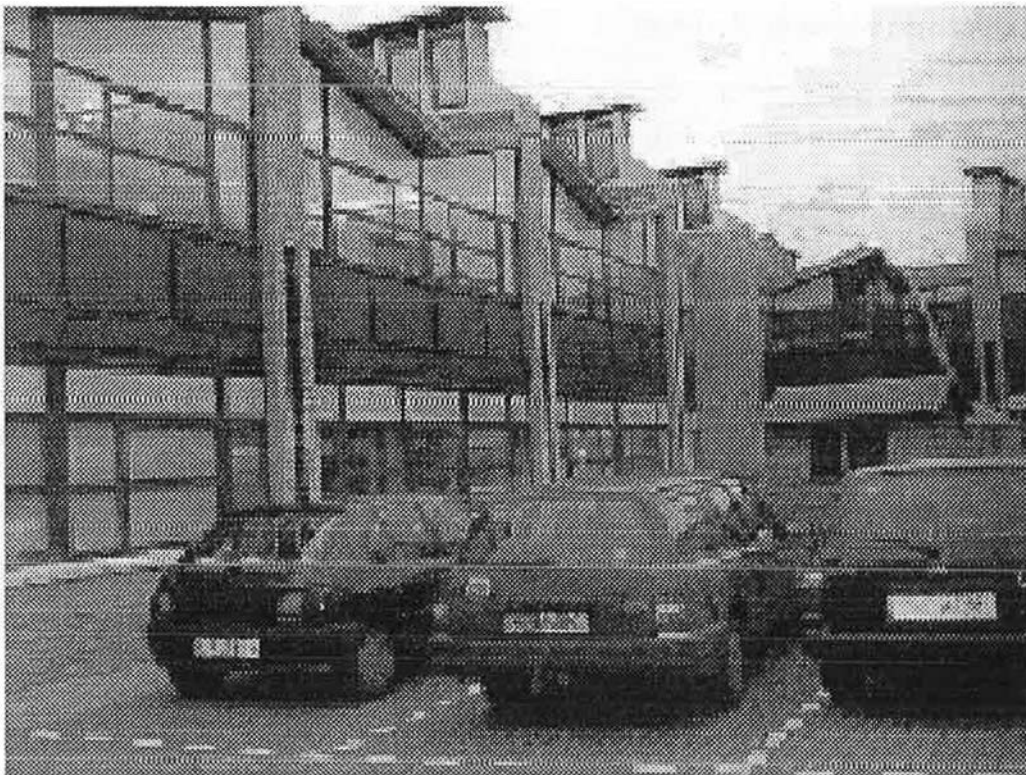
Figure 1(b). View of the Canning Crescent Centre from the Courtyard Side.

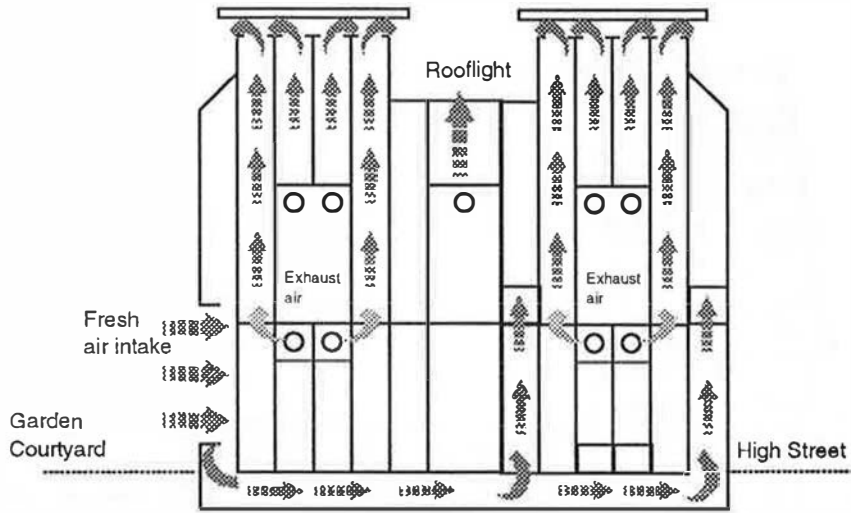
Taking the above into consideration, a natural ventilation strategy (Figure 3) was developed using diaphragm cross walls to provide a series of individual chimneys which allow air to be drawn through the building assisted by wind and/or buoyancy forces according to the prevailing weather conditions.

Figure 3. Natural Ventilation Strategy

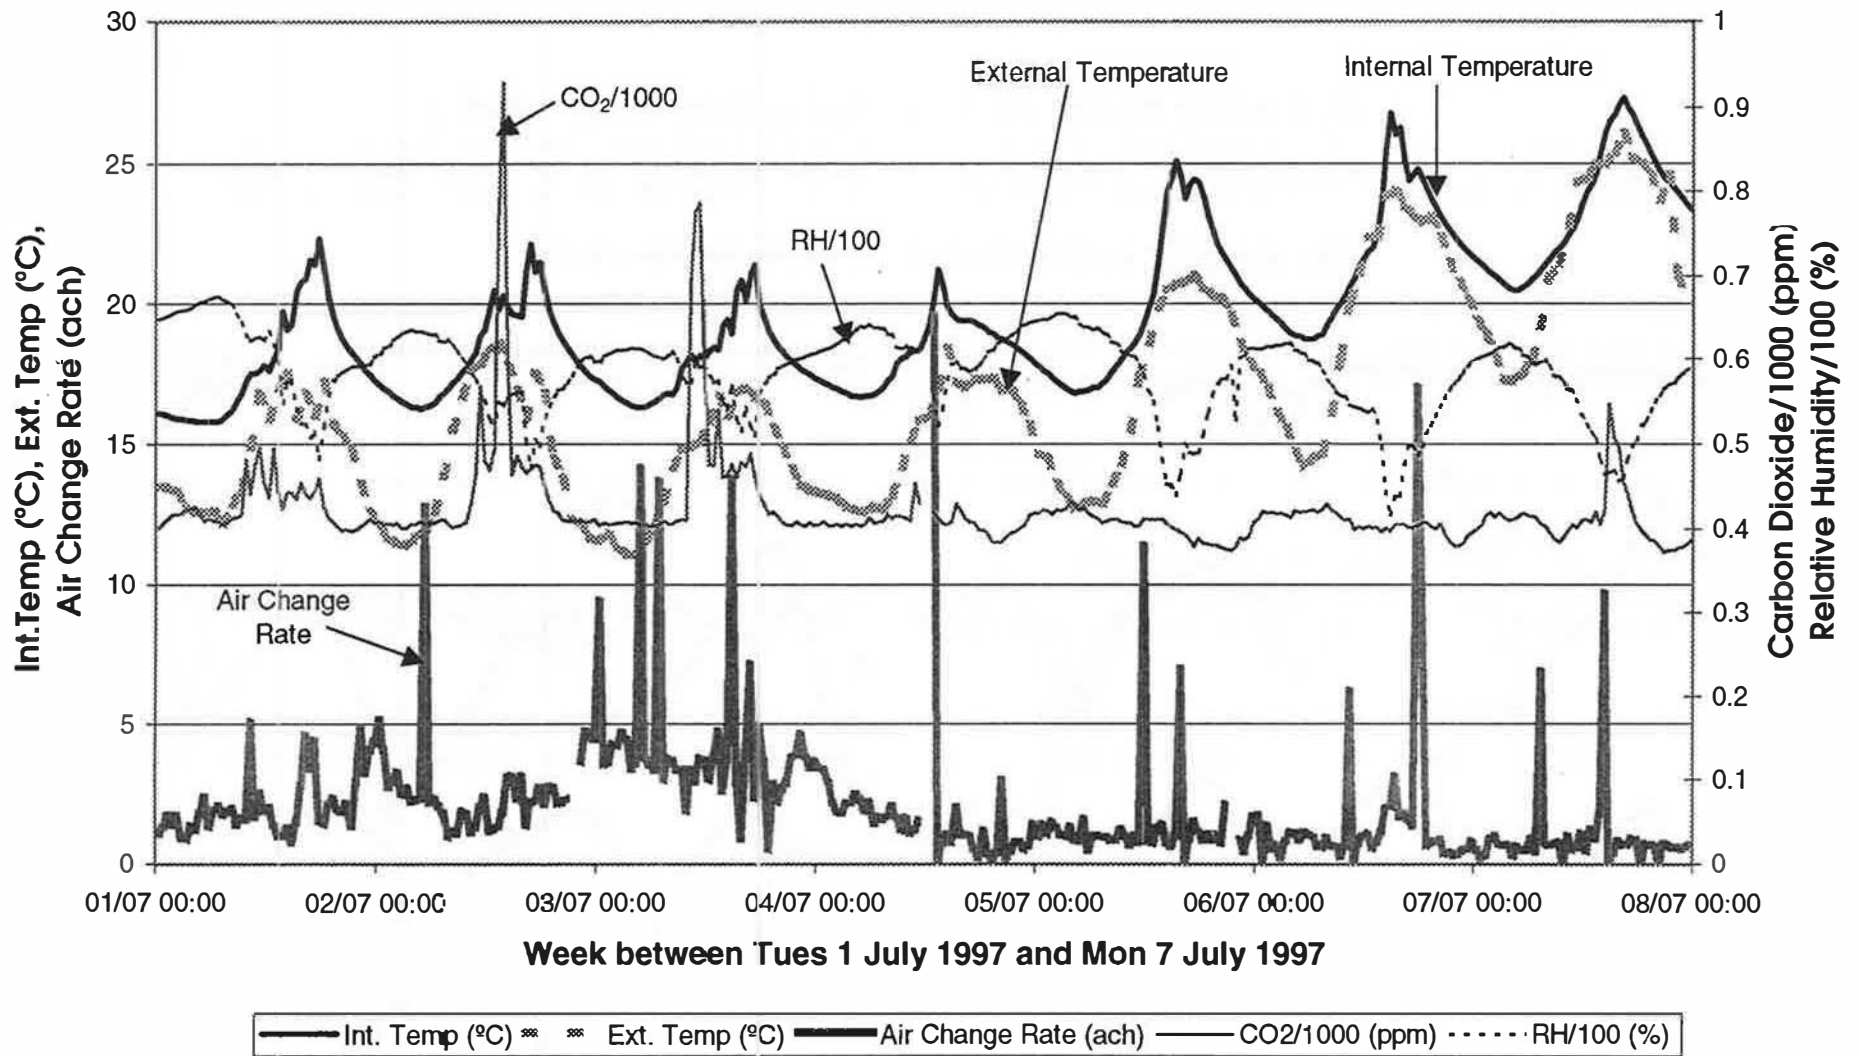
From Figure 10 it can be seen that the summer air change rates varied on average around 2-3 air changes per hour. This is lower than design values (see section 6.3) and that necessary to achieve sufficient levels of cooling. Investigations revealed that control of the central

damper was uncertain since it was not clearly marked as 'open' or 'closed' but as '0' (for open) to 100% (for fully closed). Access to the main damper control room was restricted and it was not known what the real settings were. The suspicion remained that the damper had not been opened after the winter period. This decreased the opportunity for the building to be cooled effectively during the night as intended and, in turn, resulted in heat retention and relatively high temperatures. The short periods (1 hour) of high air change rates shown in Figure 10 indicate the times when the dampers in the office were opened manually by operating the override switch to reduce the high temperatures in the offices. Simultaneous study of the air change rate and temperature at these points shows that as the air change rate increased, the temperature began to decrease.

Figure 10. Summer Monitoring Results for the Canning Crescent Centre

- Should a damper be retained, the settings should be clearly marked 'open' and 'closed' or 'summer' and 'winter' to avoid confusion and so that the correct setting can be applied.

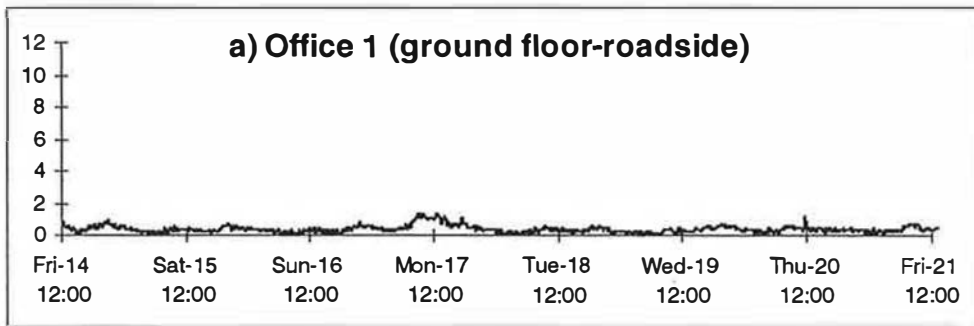
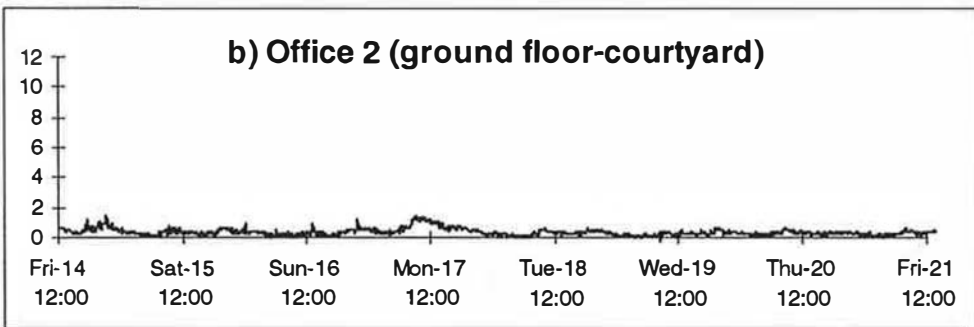
Figures 11(a-e) show the internal and external (measured at one point on the roadside) concentrations of CO within the four offices monitored. As expected, all the offices show very similar contaminant levels because of the common air intake from the courtyard side. Low external CO levels measured over the weekend period indicate little vehicular activity in comparison with the working week. During certain periods of the working week, relatively high CO concentration peaks occurred externally reaching levels of about 12 ppm. Comparison of the contaminant levels measured inside the offices with external measurements taken at a single point on the roadside indicate that these high contaminant peaks were reduced considerably and did not occur inside any of the offices monitored. Even

office 3, outside which the external measurements were carried out, does not show these peaks, indicating little pollutant infiltration through the fabric of the building.

Figure 11(a-e). Carbon monoxide concentrations (ppm) vs Time of day (14-21 March 1997)
