CO-OPERATIVE RETAIL SERVICES HQ PROBE

Co-operative Retail Services wanted its new headquarters building to be both energy efficient and humane. Have these green ambitions been realised, and did the chilled beams and displacement ventilation systems provide the promised improvements in occupant comfort?

17: Co-operative Retail Services hq

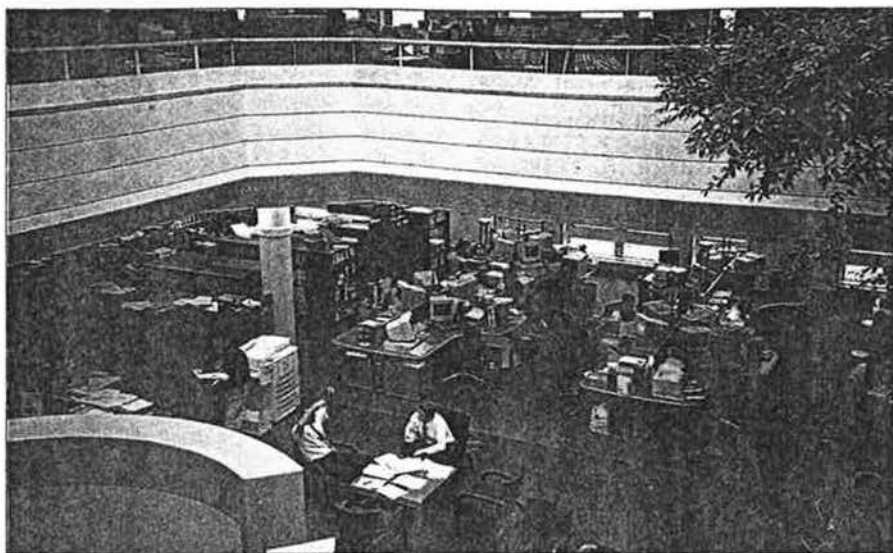
The ground floor offices at Co-operative Retail Services, viewed from an atrium. Due to the unreliable lighting control system, the metal halide uplighters tend to be on outside of normal office hours, contributing to an 'uplift' of 3-4°C to the supply air temperature in the first floor plenum.

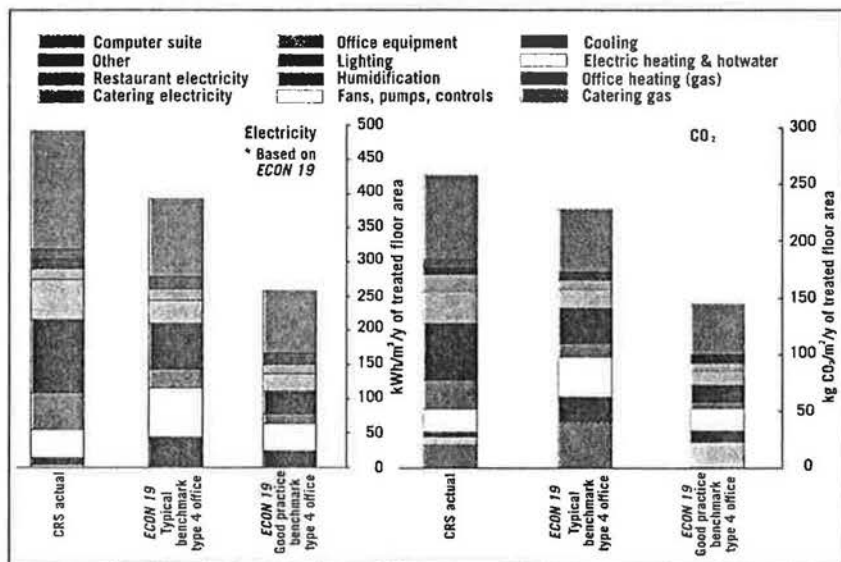
FIGURE 1: End-use energy breakdown at the Co-operative Retail Services headquarters building. The conversion factors are: gas – 0.2 kg CO₂/kWh and electricity – 0.52 kg CO₂/kWh.

At 100 kWh/m²/y, main office lighting is considerably higher than typical (60 kWh/m²/y) and over three times that of good practice. This reflects the relatively inefficient installation (22 W/m²) combined with the unmanageable controls which cause much of the lighting to stay on during the night.

The computer suite consumption (157 kWh/m²/y) is made up from a load of 60 kWh/m²/y for the actual equipment, including the losses from the interruptible power supply and 11 kWh/m²/y for the lighting, which mostly seems to be on 24 h/day. The remaining 86 kWh/m²/y (120% of the equipment load) is for the air conditioning.

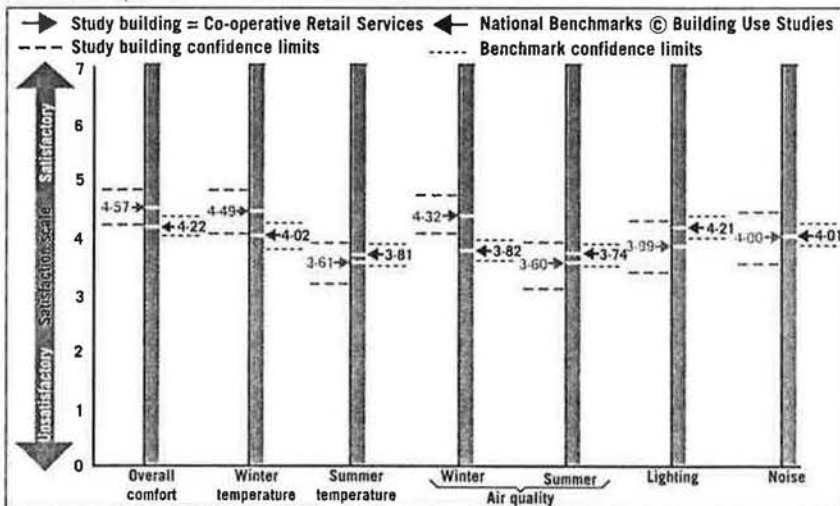
FIGURE 2: Overall satisfaction with comfort conditions at the Co-operative Retail Services headquarters.

On overall performance, the CRS performs slightly better than average in the BUS dataset. As figure 2 shows, the most notable findings are good ratings for overall comfort (despite lower results for summertime conditions), high scores for design and needs (top 10% of BUS dataset), a surprisingly low score for health and a high forgiveness or tolerance of faults by occupants.

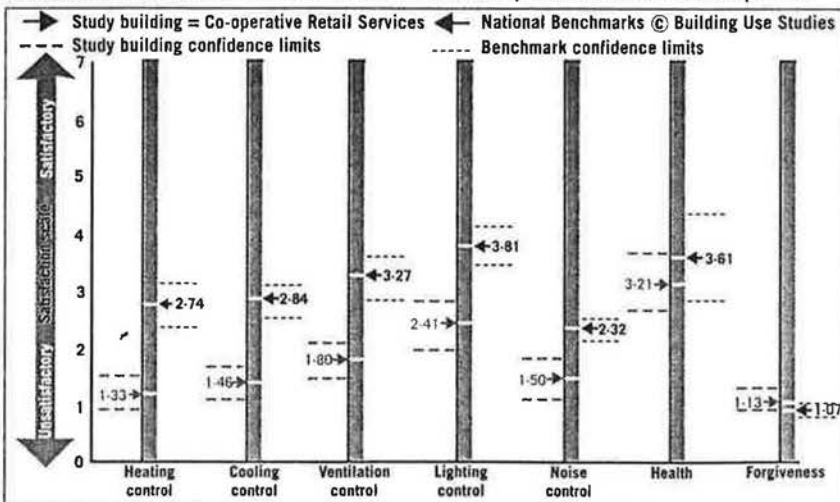
FIGURE 3: Occupant satisfaction with the building's health, management and control strategies.

The perceived low level of control over all environmental parameters is not surprising for a large, fully-air conditioned building such as this (figure 3). In similar PROBE buildings, the effect has been successfully countered by higher scores for quickness of response to complaints. At CRS, the responsiveness scores are quite low, a reflection of the limited options open to the facilities staff to adjust conditions locally. Several staff comments referred to dissatisfaction with the lighting controls, and a general wish to have more local control.

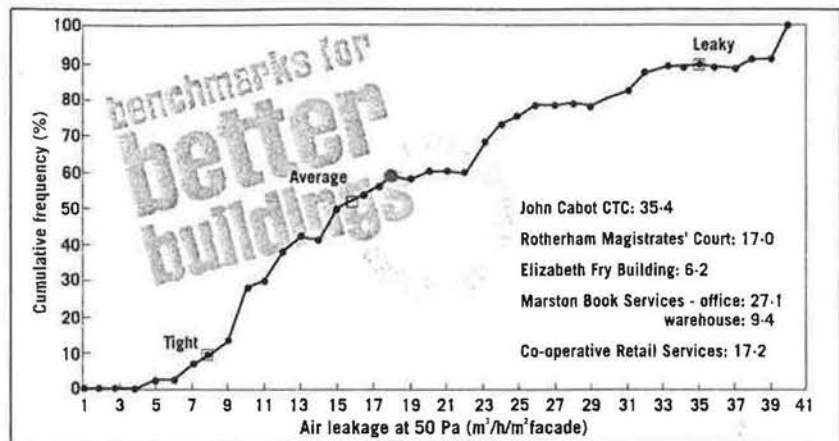
FIGURE 4: The air leakage data for the CRS headquarters building, plotted on the BRE/BSRIA database.

Overall, the Q-value (Q50/S) for the offices and main entrance was 17.2 m³/h/m², based on an envelope area of 9046 m² (excluding the restaurant area which was screened off). This places the CRS hq building's infiltration rate at over three times the best practice value of 5 m³/h/m², and close to the leaky category of 20 m³/h/m².

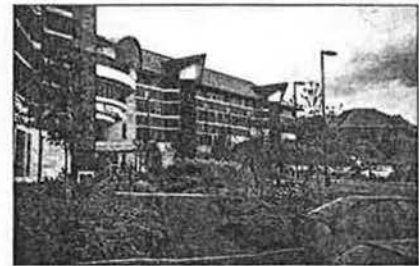
Air was seen to leak through the outer frame, especially along the top of the wood frame where it joins the wall. The building was found to leak badly along the bottom of some window frames in the stairwell. Air also leaked through the bottom of doors, which lacked draught-proofing. On

some openable windows, mastic was found along the bottom of the openable element, but not along the other three sides.

It is thought that damage caused by a fire during construction – plus inadequate sealing of one section of envelope – has contributed to air leakage. Heating and draught problems have been confirmed by infrared thermography. The contractors have been called back to carry out remedial work.
