CH-99-11-5

Test and Evaluation of the Attic Temperature Reduction Potential of Plastic Roof Shakes

John K. Holton, AIA, P.E.
Member ASHRAE

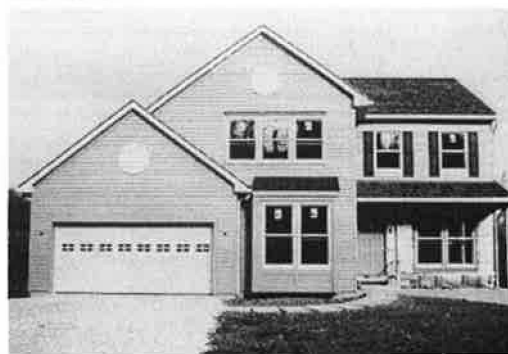
Figure 1 Test houses.

In order to comparatively evaluate new home construction technology, two visually identical test houses have been constructed in Pittsburgh, Pennsylvania (Figure 1). Lab House A is a standard 2400 ft² (220 m²) two-story house taken from a current builder line. Lab House B is identical in design and appearance, but all major components of the house have been revised for improved performance. Every component of the shell, HVAC, plumbing, electrical, finishes, and cabinetry has been modified. The topic of this paper is the modification done to the roof of Lab House B and the thermal performance that resulted from these changes.

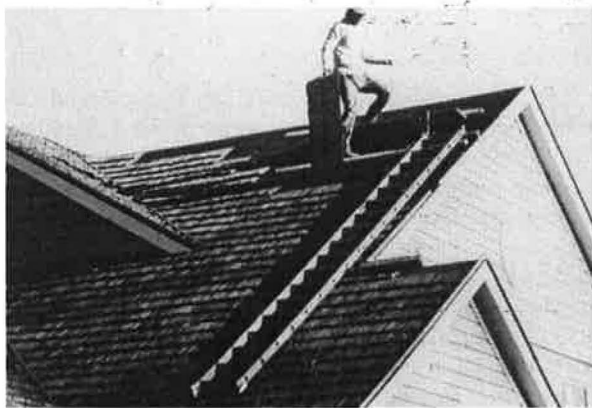
Figure 3 Plastic shake roofing (w/skylights).

The chronology of this investigation is listed in Table 2. Thermocouples (type T, standard limit of error $\pm 1^\circ\text{C}$) were placed tight against the undersurface of the plastic shake (Figure 3) and tight against the undersurface of the oriented strand board (OSB) roof deck, and the attic temperature sensor was suspended at the geometric midpoint of the attic (Figure 4).

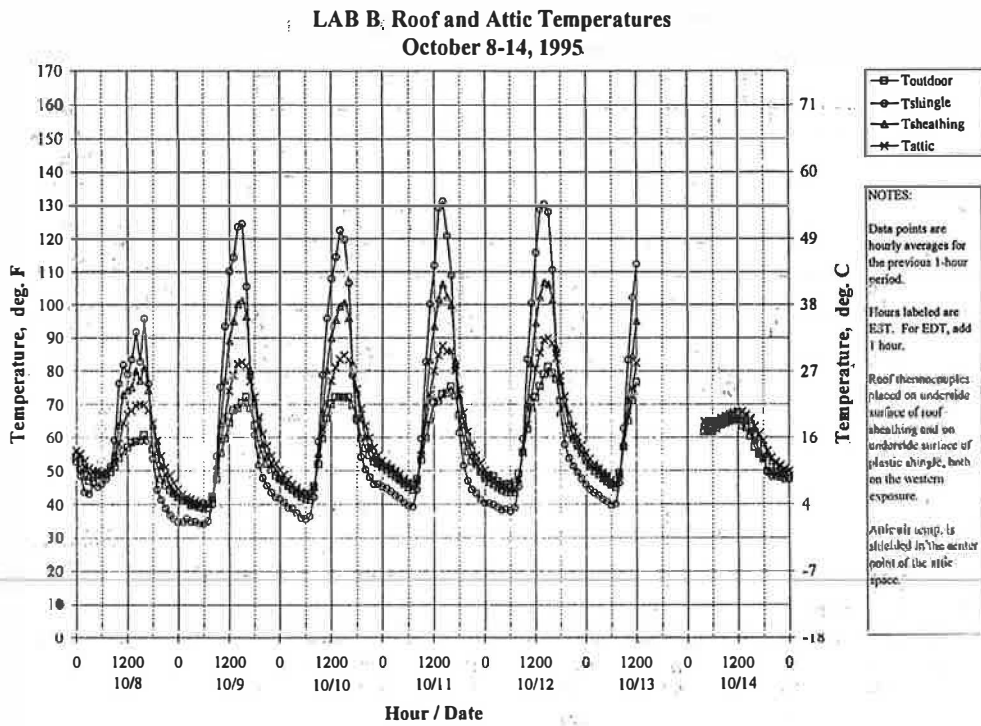
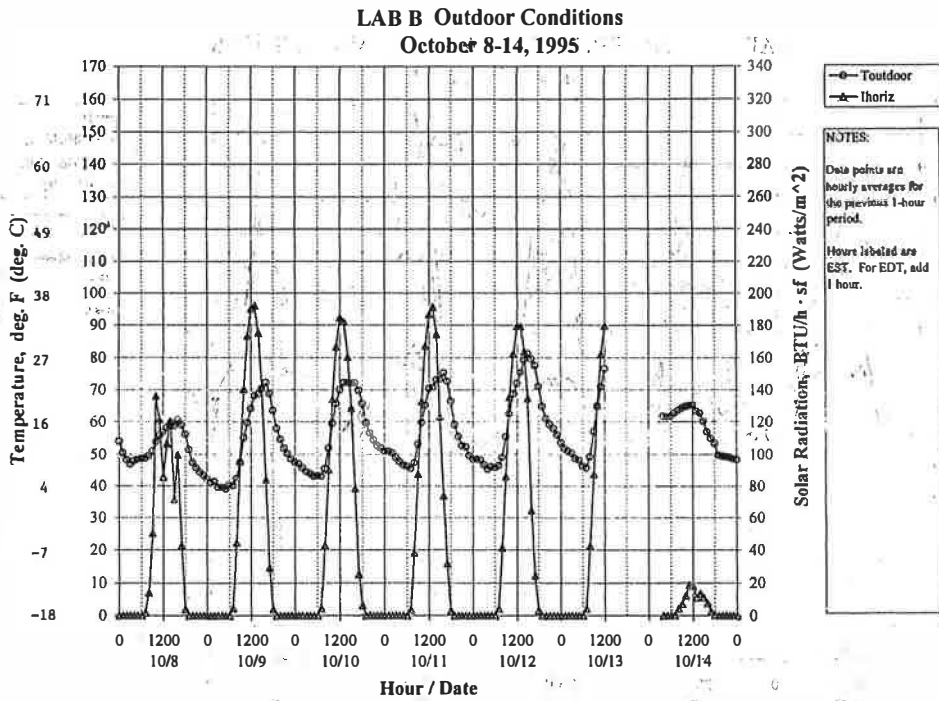
Figure 5 Examination period 2, October 12, 1995.

After installing the temperature sensors to the plastic shakes and roof deck on October 6, 1995, the warmest day in the fall of 1995 was October 12, examination period 2 (Figures 5 and 6). Here, with a peak outdoor temperature of 81°F (27°C), an attic air temperature of 90°F (32°C) was reached. The attic is peaking 9°F (5°C) above outdoor ambient temperatures. The plastic shake temperature is 130°F (55°C), which is 40°F (22°C) above the attic temperature. This 40°F (22°C) temperature difference is composed of 24°F (13°C) between the shake and the deck and 16°F (9°C) between the deck and the attic.

- **Period 2**—This period provides the breakdown of the attic to plastic shake temperature range in relation to outdoor temperature with temperatures for the shake, the roof deck, and the attic. It shows that 60% of the temperature gradient is between shake and deck and 40% between deck and attic. This was determined with an outdoor temperature of 81°F (27°C).

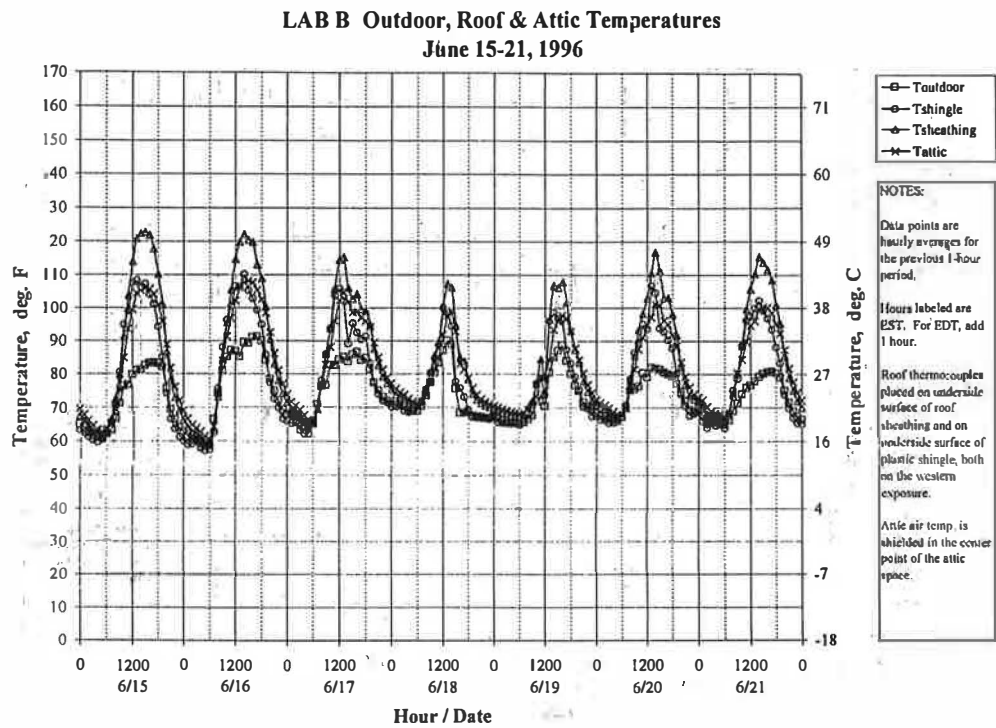
Figure 7 Examination period 3, June 16, 1996.

On June 16, 1996, a high outdoor temperature of 92°F (33°C) was recorded in examination period 3 (Figure 7). On such days in Pittsburgh, solar radiation is always at relatively high levels. Due to the problem with the sensor on the plastic shake, the reading of 110°F (43°C) is unrealistically low, only deck and attic temperatures can be evaluated. On this hot summer day, the attic air temperature of 108°F (42°C) was 16°F (9°C) above outdoor ambient air temperature. The portion between the deck and the attic was 14°F (8°C), almost the same as the previous (October 12, 1995) examination period.

- **Period 3**—The plastic shake roof is subject to peak summer conditions with outdoor temperature of 92°F (33°C). The outdoor and attic temperatures are very similar to what is seen for House B in examination period 1. Comparing period 3 to period 2, the gradient from attic to roof deck is nearly identical, suggesting that the big gradient is again from deck to shake.

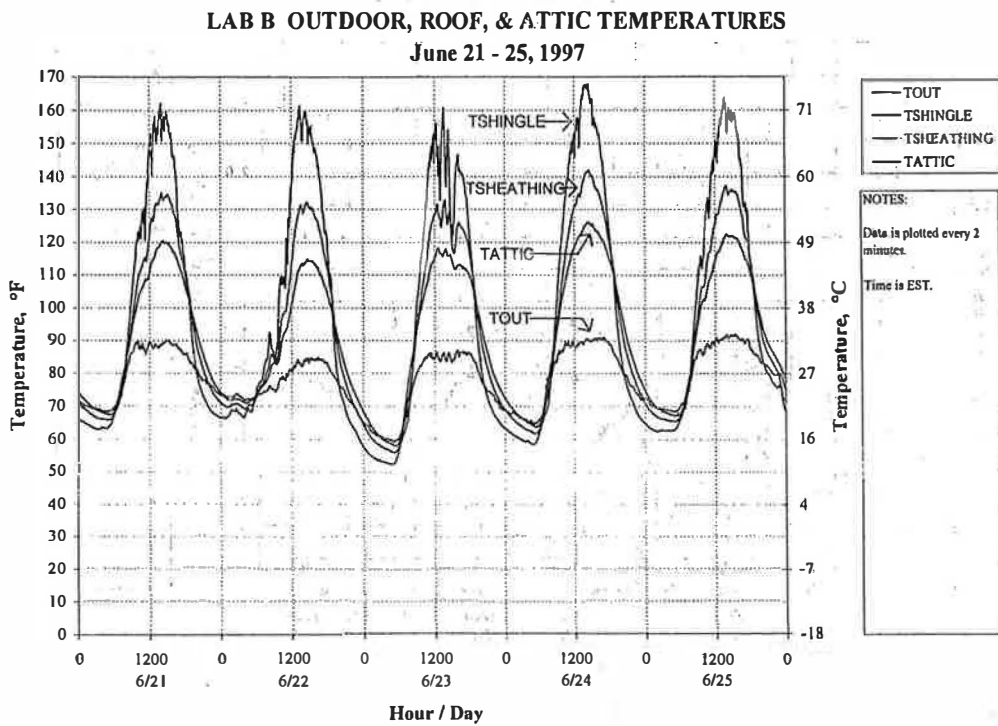
Figure 8 Examination period 4, June 24, 1997.

Shortly after the June 16, 1996, examination period 3, the plastic shakes were removed and Lab House B was re-roofed with asphalt composition shingles. High temperatures were not recorded on this roof until the summer of 1997. The final examination period 4 is June 24, 1997 (Figure 8). On this hot

summer day that reached 91°F (33°C), the attic rose to 126°F (52°C), 35°F (19°C) above outdoor ambient. The 42°F (23°C) temperature difference between shingle and attic is composed of 26°F (14°C) between shingle and deck and 16°F (9°C) between the deck and the attic. These relative temperature differences are virtually the same as for the plastic shakes. It appears that the shingle surface becomes considerably hotter than the plastic shake, and the attic temperature is similarly elevated.

- **Period 4**—On the same house (House B), under the same summer conditions (91°F-92°F [32°C-33°C]), the

composition shingles now result in an attic temperature 18°F (10°C) higher than the plastic shakes in period 3, indicating that the plastic shakes are likely responsible for the observed beneficial lower attic temperatures of period 3.
