# HOW GREEN IS IT?

## Evaluation of a sustainable building

**Ekoporten, a block of flats converted into an experimental sustainable building, is now 2½ years old. The building is one of the most visited and debated projects carried out in Sweden in recent years. With the support of the Swedish Council for Building Research, researchers from the Faculty of Architecture, Royal Institute of Technology, Stockholm (KTH) have followed up and documented the experiment.**

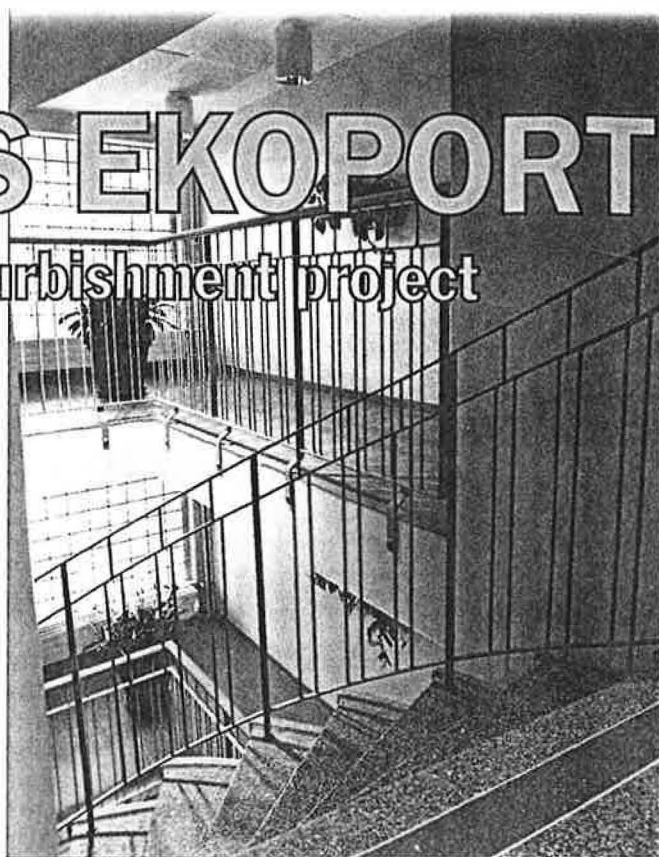
The old stairway was opened up to the facade. FOTO: NINO MONASTRA

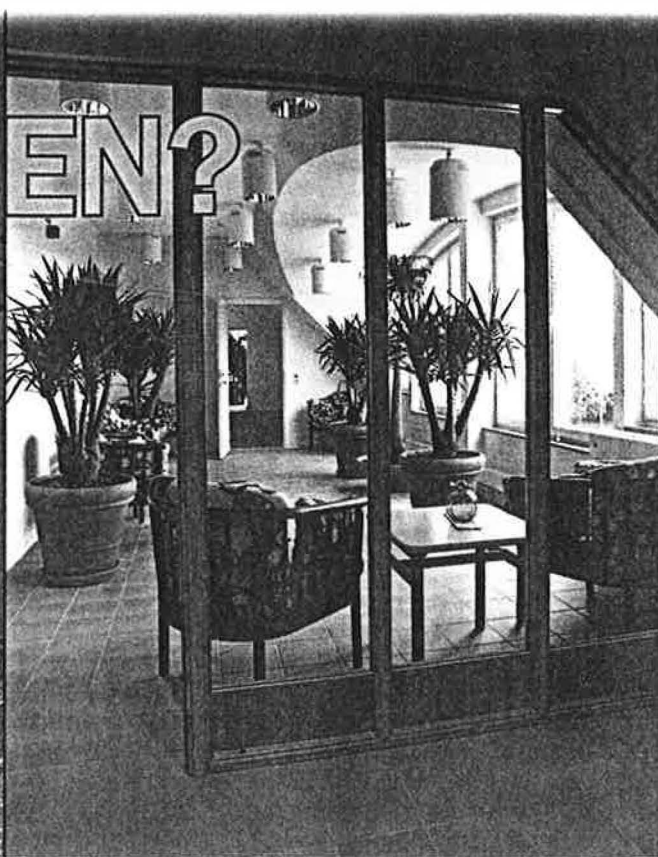
In the attic storey there are large communal areas, very much appreciated by the occupants. FOTO: NINO MONASTRA

The high consumption of building services electricity can be partly explained by the large communal spaces in the attic storey which were also very often used in the first year for study visits. Energy was in addition used to provide additional heat for the compost room when it became very wet, and to run the roof fans which were operated continually. This type of energy use will decrease after all systems have been adjusted.
