THE USE OF THERMOGRAPHY IN THE THERMAL PERFORMANCE TESTING OF BUILDINGS

by J M Hart

PD91/86

J Hart, Building Research Establishment

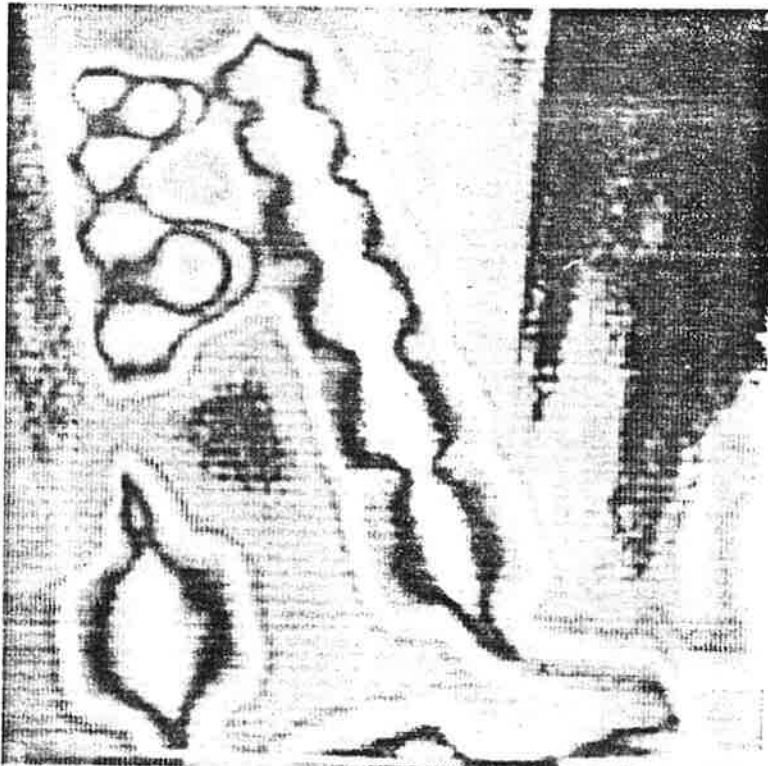
Figure 15b The additional feature of heat spreader plates can be seen under the first floor chipboard.

system in situ. The thermogram in Figure 15a shows the distribution of underfloor heating pipes, an application useful for position location, identifying blockages and leaks and for assessing overall temperature distribution. In this example of a ground floor heating installation, the plastic pipes are situated beneath a 50 mm concrete floor screed. Initially, however, the surface temperature distribution was so even that a step change in the circulated water temperature was necessary to highlight the pipes. Figure 15b shows the first floor pipes of the same installation located beneath 25 mm of chipboard, where not only are the pipes very clearly defined but so also are the metal heat spreader plates located at intervals over the pipes.

Figure 15b The additional feature of heat spreader plates can be seen under the first floor chipboard.

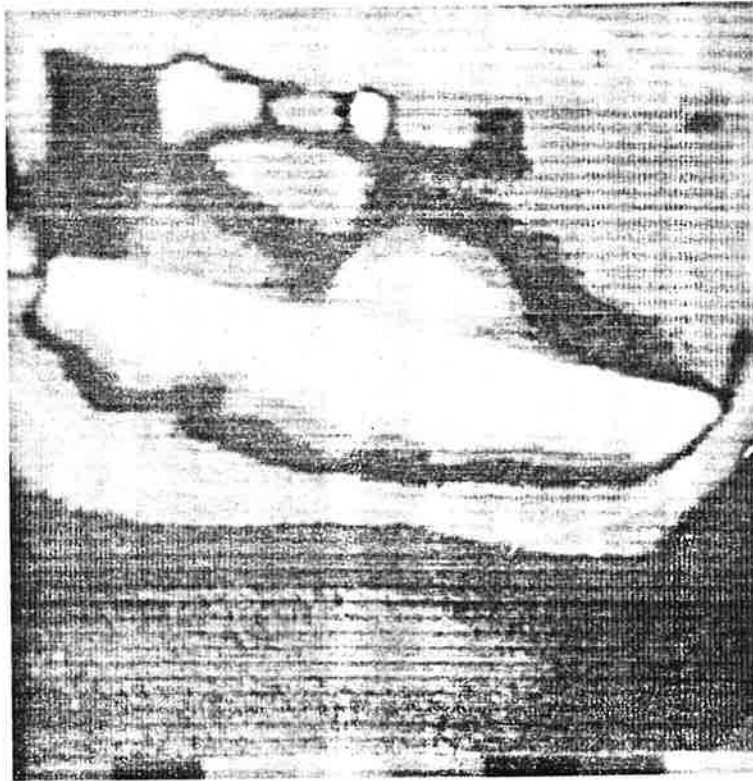
Figure 16a The low level heat distribution from this fan assisted heater is seen as it spreads over the floor surface.

Figure 16a shows the heat distribution from a convector/blower heater. Although the IR camera cannot 'see' warm air, the distribution of heat from this low level fan assisted warm air system can be clearly seen as it warms the floor area in front of the heater. The thermogram Figure 16b, however, shows a similar heater with an uneven temperature distribution, clearly indicating a blockage in the air duct at the centre.

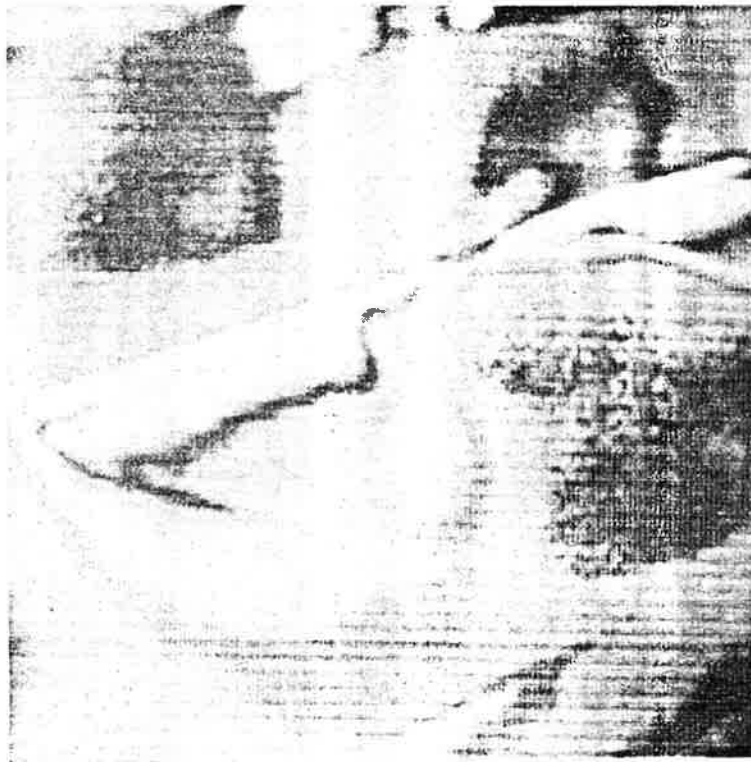
Figure 16b An identical heater to Figure 16a but clearly showing an air blockage at the centre of the slotted output.
