Residential Combustion Venting Failure - A Systems Approach

Project 5

Remedial Measures for Gas-fired Appliances

FINAL TECHNICAL REPORT

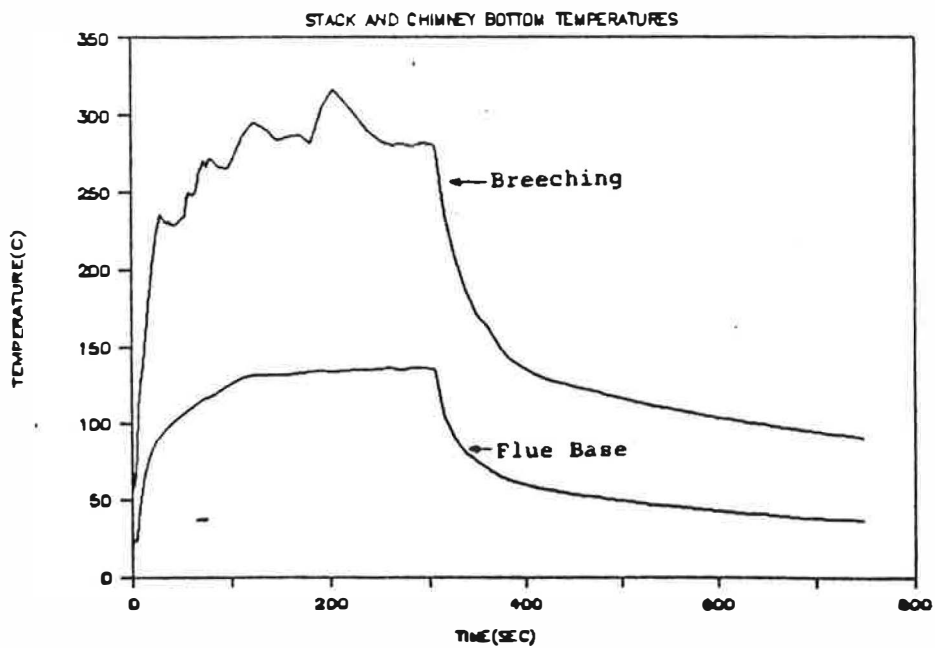
FIGURE 5: Heat-up/cool-down test: furnace as found

Figure 5 is a plot of the flue gas temperature at the furnace breeching and at the chimney base versus time for the heat-up/cool-down test of the house/furnace/flue system as found. This plot is similar to many others we have seen with the exception of an apparently erratic temperature response as the system approached steady state. The exact nature of this behaviour is not quite clear and we are unable to speculate as to the exact cause at this time. Despite this minor anomaly, the plot still satisfactorily describes the house/furnace/flue system as found and provides a suitable baseline upon which to compare steady state performance of the other remedial measures.

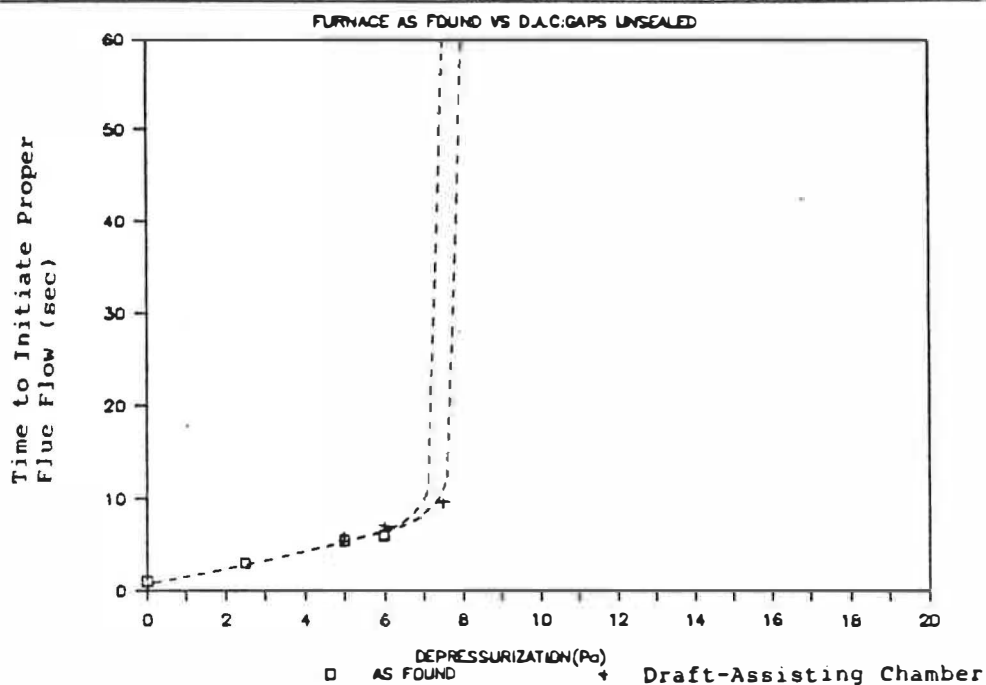
FIGURE 6A: Depressurization vs. time to initiate proper flue flow - furnace as found vs furnace with draft-assisting chamber: gaps unsealed

It was found that the "time to initiate upward draft" was about the same with or without the "draft-assisting chamber". This is shown in Figure 6A.

On examining Figure 6A, it is apparent that, with the casing/dilution box gaps unsealed, the incorporation of this particular prototype "draft-assisting chamber" has not significantly improved the time required to initiate upward draft compared to results for the furnace as found. At best, it has increased the house depressurization limit by about 0.5 Pa, an insignificant amount given the accuracy of the measuring device (± 0.5 Pa).

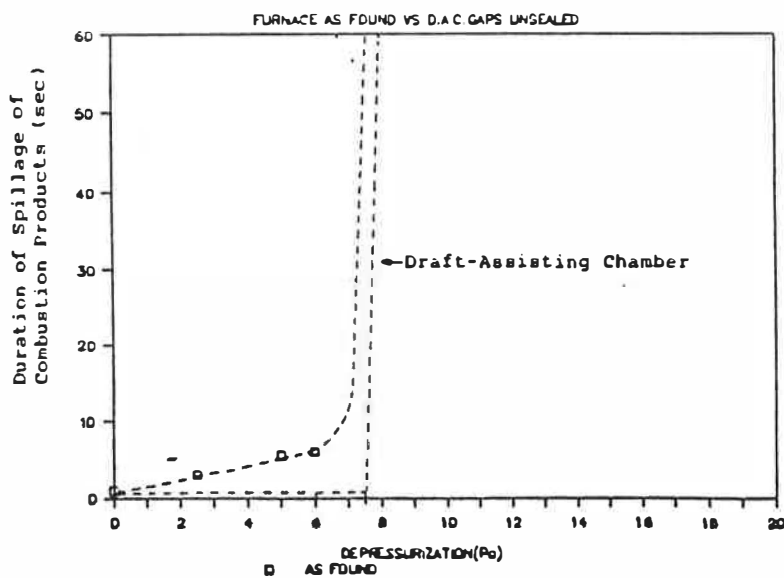
FIGURE 6B: Depressurization vs. spillage of combustion products at system opening - furnace as found vs. furnace with draft-assisting chamber: gaps unsealed

of spillage line in Figure 6B. The vertical separation between this line and the curve for the furnace as found represents the benefit of the chamber in containing the spilled combustion products.

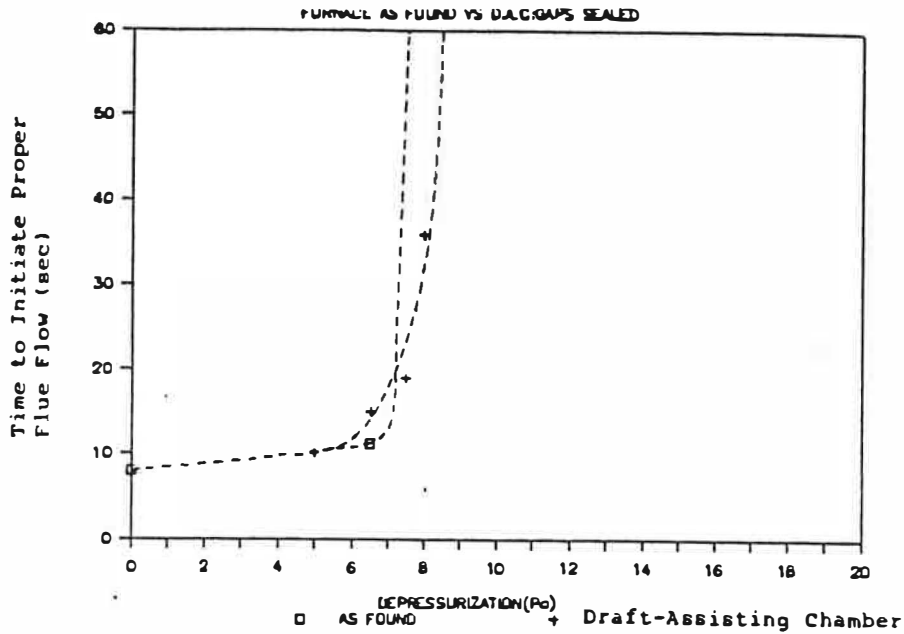
FIGURE 7A: Depressurization vs. time to initiate proper flue flow - furnace as found vs. furnace with draft-assisting chamber: gaps sealed

Figures 7A and 7B are plots similar to Figures 6A and 6B but for the second phase of testing the casing/dilution box gaps were sealed. Note that a new plot for the furnace "as found" is shown. The data for this plot was collected on the same night and just preceding the second evaluation of the draft-assisting chamber.

For a given level of depressurization, much longer times to initiate upward draft were recorded for both the furnace as found and with the draft-assisting chamber installed, compared to the first series of tests (Figures 6A and 6B). This is probably due to the different ambient conditions which prevailed. Although this may make it difficult to compare the first series of tests with the second series of tests, the comparisons of the performance of system to that of the furnace as found is valid.

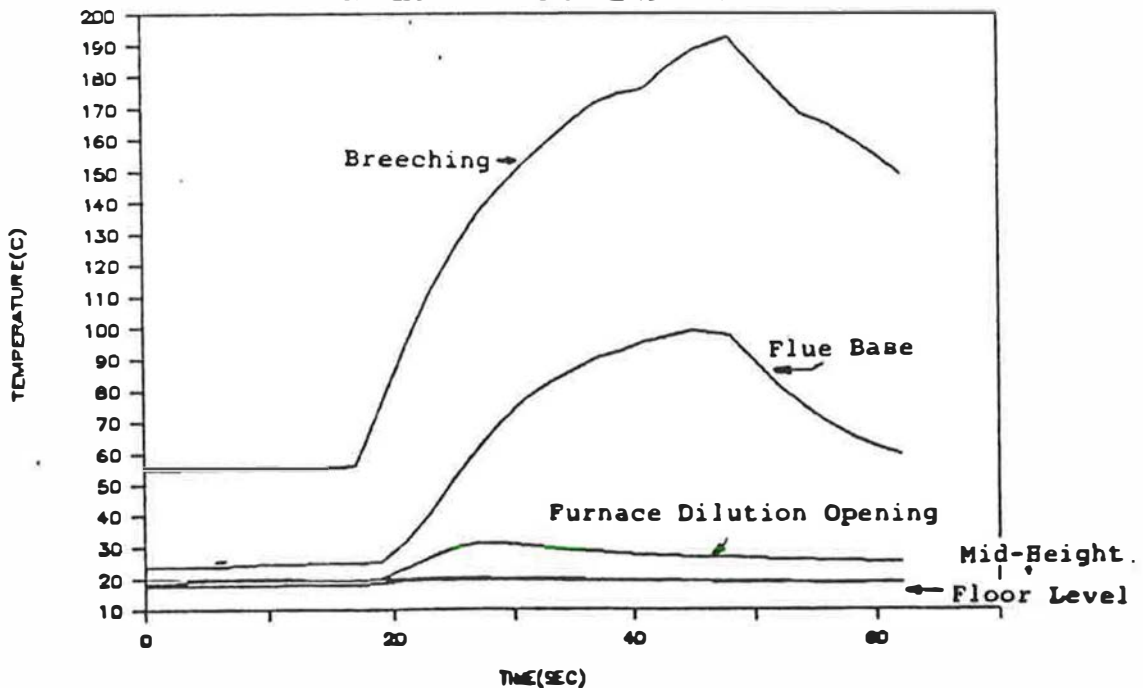
FIGURE 8B: Temperature profiles along draft-assisting chamber: gaps sealed - $\Delta P = 5$ Pa

An interesting condition was observed at a depressurization level of 8 Pa. The technician observing flow at the bottom opening of the "draft-assisting chamber" reported the flow fluctuating from outward to inward. Simultaneously, another observer noted that the sides of the chamber were alternating from hot-to-the-touch to cold-to-the-touch. This see-saw condition lasted 36 seconds before full upward draft was finally established. During this time no spillage of combustion products was detected at the chamber opening. The temperature profiles for this example are shown in Figure 8A. For comparison the temperature profiles for a similar test where the flow reversal occurred after only 10 seconds is shown in Figure 8B.

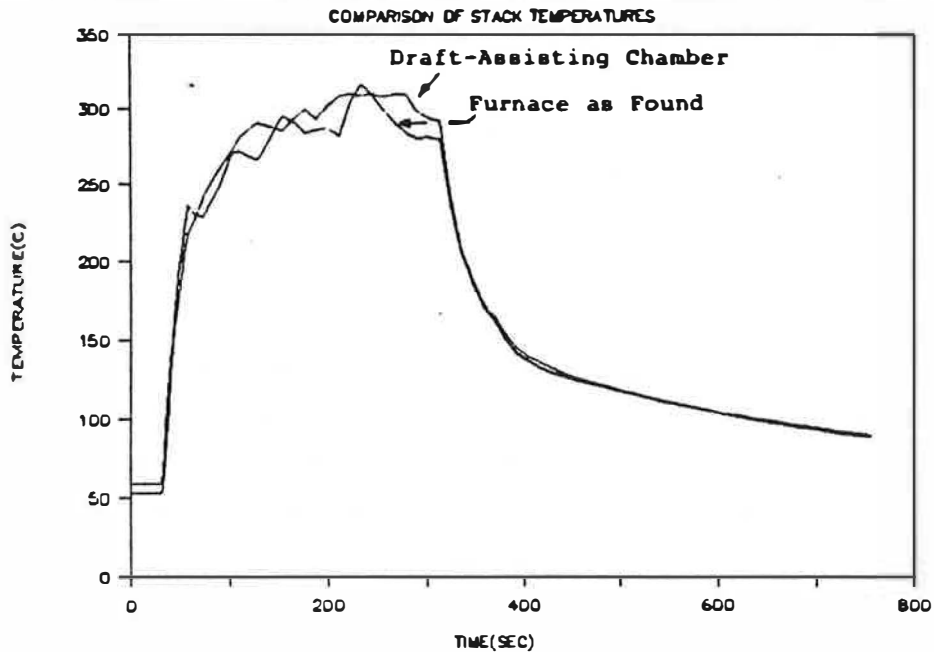
FIGURE 9A: Heat-up/cool-down test: stack temperatures - furnace with draft-assisting chamber (D.A.C.) vs. furnace as found

Figures 9A and 9B superimpose the heat-up/cool-down test results with the draft-assisting chamber installed (no house depressurization) on those for the system as found. It is clear that the prototype did not show a detectable effect on operation of the furnace/flue system during normal operating conditions (i.e. no house depressurization).
