THERMOSTAT LOCATION FOR A NATURALLY VENTILATED SWINE BARN

Y. Choinière, O. Ménard and F. Blais
Alfred College of Agriculture and Food Technology
Ontario Ministry of Agriculture and Food
Alfred, Canada K0B 1A0

Written for presentation at the 1987
International Winter Meeting of the
AMERICAN SOCIETY OF AGRICULTURAL ENGINEERS

SUMMARY: The recommended location of thermostats in an Automatically Controlled Natural Ventilation barn was determined based on the ability to establish comfort zones for the animals and to minimize the effect of wind direction and exterior temperature.

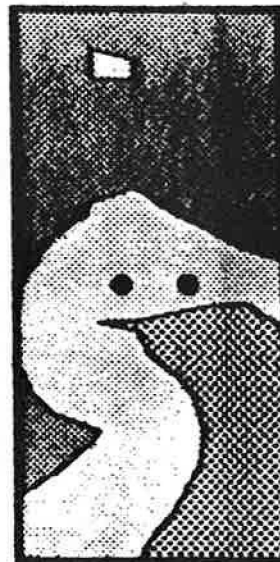
OCTOBER 8-9, 1987
 10 Hours - Night
 Wind:
 West 299', STD 18.7'
 3.2m/s, STD 1.12m/s
 Outside Temperature:
 1.4°C, STD 2.59°C

OCTOBER 14, 1987
 7.5 Hours - Morning
 Wind:
 South 213', STD 7.5'
 2.8m/s, STD 0.56m/s
 Outside Temperature:
 -0.9°C, STD 0.70°C

Figure 3: Plan View of temperature fluctuations and air flow patterns for a Naturally Ventilated Barn with thermostats 0.9 m above floor level

Fig. 3 shows temperature profiles and fluctuations along the building for cold weather conditions.

Ogilvie and Boyd (1985) reported that the wind effect dominates over the stack effect for wind speed over 2.0 m/s and a 10°C inside-outside temperature difference. Fig. 3 demonstrates that the wind direction was a significant factor influencing the temperature profiles along a naturally ventilated building.

Wind from the south west created a high negative pressure zone on the ventilation doors in the south east part of the barn. The ridge outlet was also influenced by wind direction. The south end of the ridge (high negative pressure) was the main outlet. Hellickson et al. (1983) reported that winds perpendicular to the building length exerted a fairly uniform pressure along the windward side of the building. Figs. 4 and 5 show temperature profiles of a cross section at the midlength of the barn. For wind perpendicular to the building length, these profiles would remain uniform along the building but for winds parallel to the building length, the profiles varied along the building.

For exterior temperatures of about 0°C, and westerly winds, the location of the thermostat along the building was not critical based on the similarity of the temperature profiles. With southerly winds, the central location of the thermostats was satisfactory even though the temperature fluctuations at the north end were greater compared to those obtained with west winds (Fig. 3). No data are presently available for the combination of colder temperatures and south winds (a rare combination at this site). The use of a multi-temperature sensor system as proposed by Owen (1984) would not solve the problem of the longitudinal temperature gradient due to the wind direction effect, but might help to reduce the temperature fluctuations at the north end.

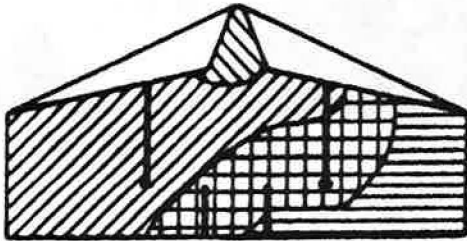
NOVEMBER 4, 1987
 10 Hours - Daytime
 Wind:
 West 257°, STD 4.7°
 8.2m/s, STD 1.43m/s
 Outside Temperature:
 17.1°C, STD 0.71°C

NOVEMBER 3, 1987
 10 Hours - Afternoon
 Wind:
 West 252°, STD 12.1°
 3.6m/s, STD 0.87m/s
 Outside Temperature:
 12.1°C, STD 0.28°C

OCTOBER 8-9, 1987
 10 Hours - Night-time
 Wind:
 West 299°, STD 18.7°
 3.2m/s, STD 1.12m/s
 Outside Temperature:
 1.4°C, STD 2.59°C

Figure 4: Temperature zones, temperature fluctuations and airflow patterns for a Naturally Ventilated Barn with a West Wind and thermostat 0.9 m above floor level.

Results (Figs. 4 to 7) show that the wind direction (west versus south) had limited influence on the temperature profiles across the midlength of the barn. For both wind directions and the three outside temperatures studied, the thermostat controller was able to provide a comfort zone over the sleeping area. But generally higher temperature fluctuations occurred with south winds

as compared to with west winds. During cold weather, temperature fluctuations over the sleeping area in the order of 2.6°C occurred with south winds compared to 1.4°C with west winds.

Comparison of Figs. 4 to 7 show that both thermostat elevations, 0.9 and 1.5m, maintain the temperature over the sleeping area above the L.C.T. But, for intermediate and especially cold conditions, temperature fluctuations were generally greater when the thermostat was at the 1.5m height.
