PROJECT TO CONTINUOUSLY MONITOR THE
PERFORMANCE OF THE LAMINAR AIR FLOW
SUPER WINDOW-HUMIDITY CONTROLLED
AIR INLET - BASEBOARD HEATER
VENTILATION AND HEATING
SYSTEM

REPORT FOR
CANADA MORTGAGE AND HOUSING CORPORATION

G. K. YUILL AND ASSOCIATES LTD.

NOVEMBER 28, 1989

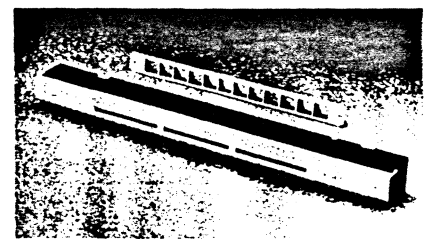
Humidity Controlled Through-Window Sash Inlet

For installation in window sashes. Designed to be used with ALDES ventilation systems. Controlling element is a humidity sensitive device. Free opening varies from 0.78 sq. in. to 4.65 sq. in. and is determined by the relative humidity of the room in which the inlet is installed. Interior fixture deflects thin ribbon of fresh air towards ceiling. Adjustable to two relative humidity operating ranges:

Consists of beige or brown face plate with controlling element and white exterior weather grille.
