# A PROCEDURE FOR DETERMINING AIRTIGHTNESS CHARACTERISTICS OF ATTIC SPACES CMHC C.R. File 6730-7

Sheltair Scientific Ltd.

Octobre, 1989

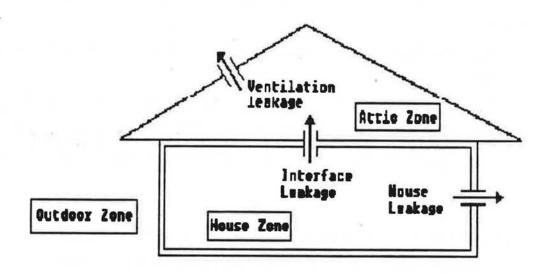
# FIGURE 1 DIVISION OF ZONES AND LEAKAGE AREAS

These air flows are illustrated in Figure 1. The most complicated air flow paths are from the indoor zone into the exterior wall cavities, (which is part of the outdoor zone), and then into the attic zone, through the top plate of the wall. In this way, air flow from outdoors into the attic can actually carry humidity from indoors.

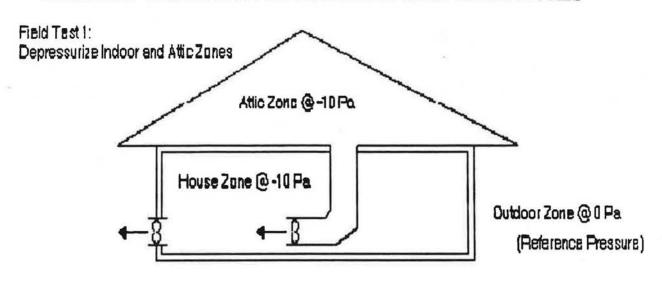
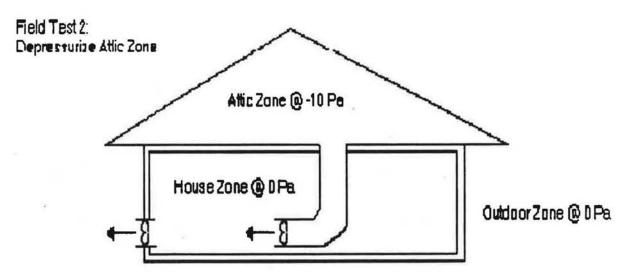
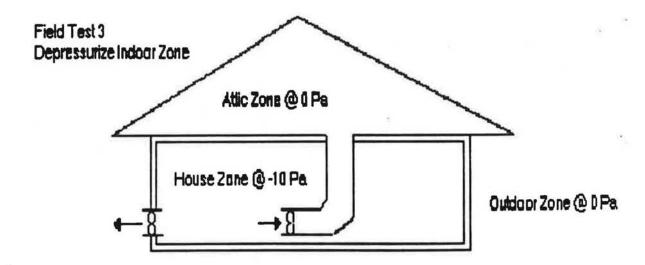
# FIGURE 2: SCHEMATIC OF THE FIELD TEST PROCEDURES

Refer to Figure 2 for a schematic of the test procedures. All leakage areas were measured at 10 Pa of pressure differential relative to outdoors. This was considered the lowest possible pressure for measuring leakage without excessive interference from winds, and is consistent with existing CGSB standards. The value of testing at the lowest possible pressure is the greater potential for obtaining results on leaky attic spaces. Existing blower door equipment can only blow 2,000 to 3,000 L/s. It is estimated that at 10 Pa, 90% or more of attics can be evaluated. Those attics that are not measurable can simply be termed excessively leaky, or can be measured with the installed ventilation sealed, or can be measured at a lower pressure differential.

The first test was designed to directly measure Ventilation Leakage and House leakage. The indoor zone and the attic zone were both depressurized to 10 Pa relative to outdoors. In an attempt to avoid a requirement for using long ducts between the attic and outdoors, the fans are used in tandem. While one fan blows air from the attic into the house, the other blows a combination of attic

and the house air to the outdoors. By monitoring pressures, there is no need for hard ducting air from one fan to the other. The attic blower is measuring Ventilation Leakage and the house blower is measuring both the House Leakage and the Ventilation Leakage. If the parameter of Ventilation Leakage is all that is of interest, the house blower would not need to be calibrated.

The second test was designed to measure the combination of Ventilation Leakage and Interface Leakage. The attic zone is depressurized to 10 Pa and the envelope zone is maintained at 0 Pa, relative to outdoors. The attic blower is measuring Ventilation Leakage and Interface Leakage, and the house blower is measuring only Ventilation Leakage. Air flow through the Interface Leakage is returning to the attic in a continuous loop. The difference in flow between the two blowers is therefore equal to the Interface Leakage.

The third test was designed to measure House Leakage and Interface Leakage. The Indoor Zone is depressurized to 10 Pa and the Attic Zone is maintained at 0 Pa, relative to outdoors. The attic blower is reversed and is measuring the flow into the attic zone to maintain a 0 pressure. The house blower is measuring the House Leakage plus the Interface Leakage. The attic blower is measuring only

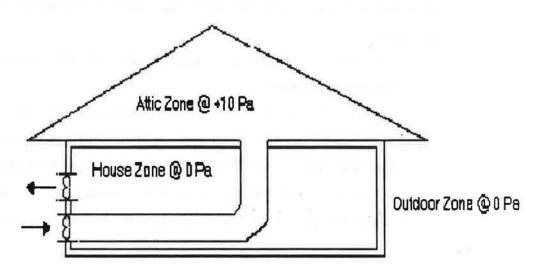
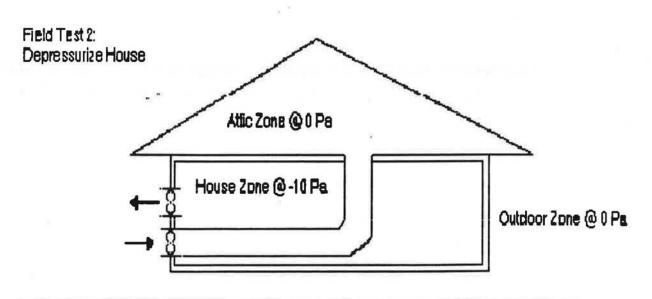
# FIGURE 3 REVISED FIELD TEST PROCEDURE

Only two tests were used to calculate the leakage areas. The tests are described below. Please refer to Figure 3 for an equipment set up schematic.

The attic zone is pressurized to +10 Pa, relative to outdoors and the house zone is maintained at zero. The attic blower is mounted in an exterior door and blows air from outdoor into the attic through a long flex duct. The attic blower is measuring both the Ventilation Leakage and the Interface Leakage. The house blower is blowing air out of the house and is measuring only the Interface Leakage (i.e. the air that is flowing from the attic into the house). The difference between the blowers is the Ventilation Leakage.

The indoor zone is depressurized to -10 Pa, relative to outdoors, and the attic zone is maintained at zero. The house blower is blowing air out of the house and is measuring the House and Interface Leakage. The attic blower is blowing air from outside through the duct to the attic, and is measuring only the Interface Leakage (i.e. the air that is flowing from the attic to the house). The difference between the blowers is the House Leakage.

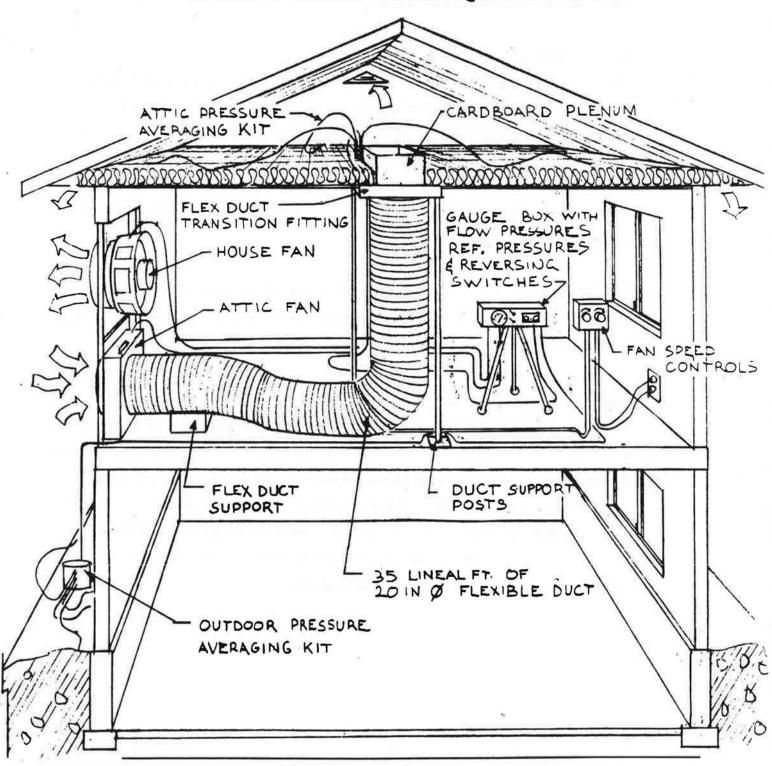
FIGURE 4 RECOMMENDED EQUIPMENT SET-UP

The attic zone is pressurized to +10 Pa, relative to outdoors and the house zone is maintained at zero. The attic blower is mounted in an exterior door and blows air from outdoor into the attic through a long flex duct. The attic blower is measuring both the Ventilation Leakage and the Interface Leakage. The house blower is blowing air out of the house and is measuring only the Interface Leakage (i.e. the air that is flowing from the attic into the house). The difference between the blowers is the Ventilation Leakage.

The indoor zone is depressurized to -10 Pa, relative to outdoors, and the attic zone is maintained at zero. The house blower is blowing air out of the house and is measuring the House and Interface Leakage. The attic blower is blowing air from outside through the duct to the attic, and is measuring only the Interface Leakage (i.e. the air that is flowing from the attic to the house). The difference between the blowers is the House Leakage. Interface Leakage is measured directly in both tests, and provides a convenient cross-check for operator errors.

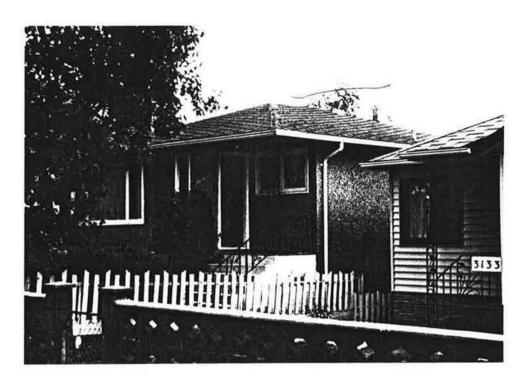
House No.1 - Front View Showing Hip Roof

The attic is enclosed by a hip roof which eliminates gable ends. It is likely that a hip roof would leak less than roofs with gables. The summer heat tends to bond asphalt shingles together, reducing the leakage area of roofs. Gable ends, on the other hand, are expected to be leakier than a typical wall section because they lack insulation and an interior finish. The soffits of the house were fabricated from plywood. Years of repainting the house will have tightly sealed the joints of the plywood and facia board. Both factors would increase the tightness levels of the attic. In general terms, we would expect soffits constructed from perforated aluminum, or wooden slats to have higher leakage areas. The Unintentional Ventilation leakage was the lowest of the three research houses.

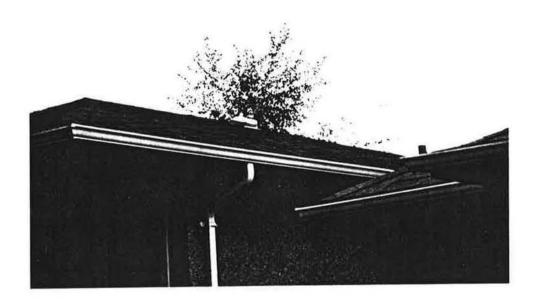
House No.1 - Existing Roof Vent

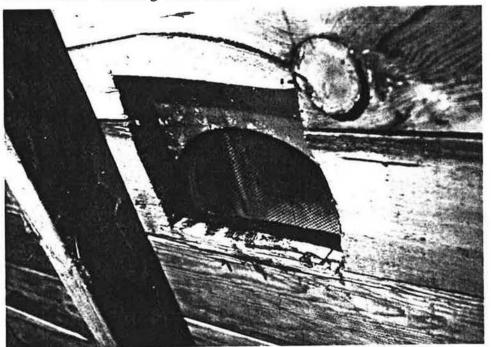
House No.1 - Existing Roof Vent From Inside Attic

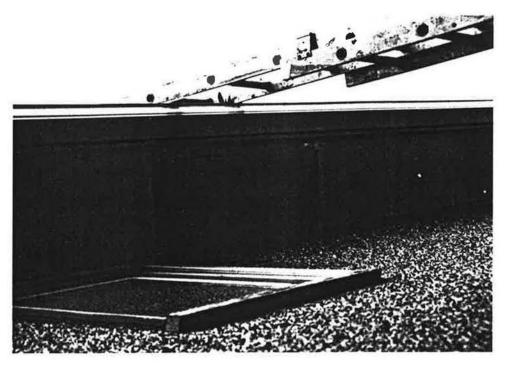
House No.1 - Soffit Vent Blocked For Test

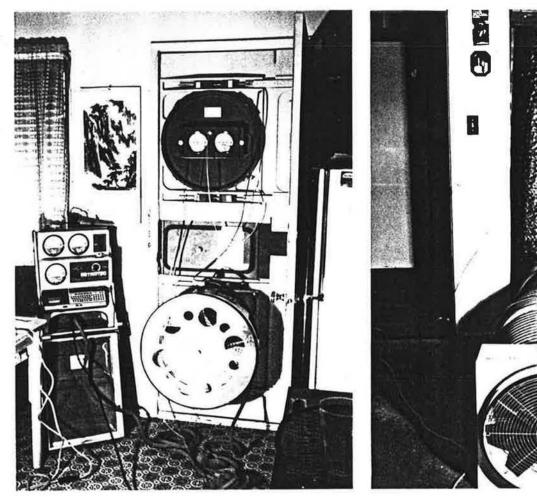
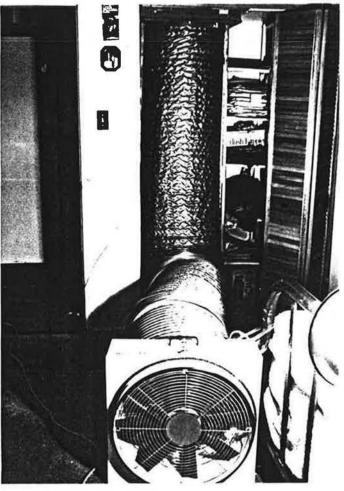
House No.1 - Equipment Set-up

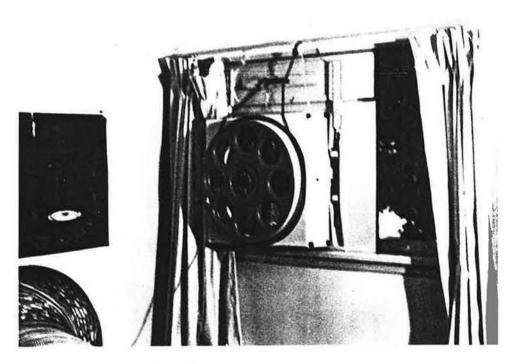
House No.1 - Window Fan Option

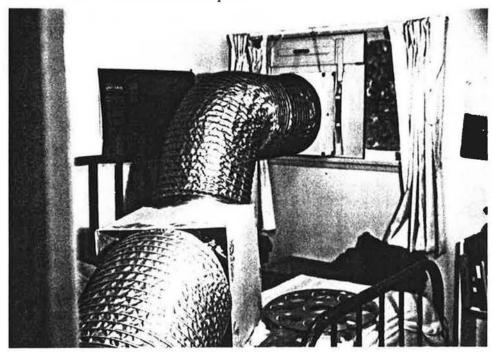
House No.1 - Single Blower With Mixing Box

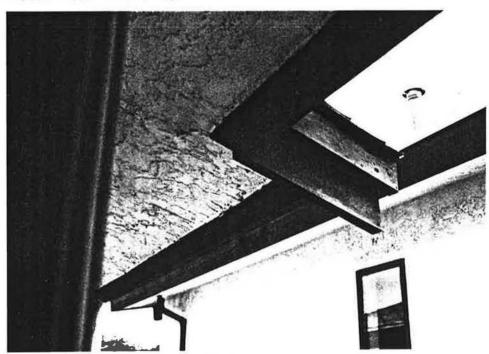
House No.2 - Continuous Soffit Vent

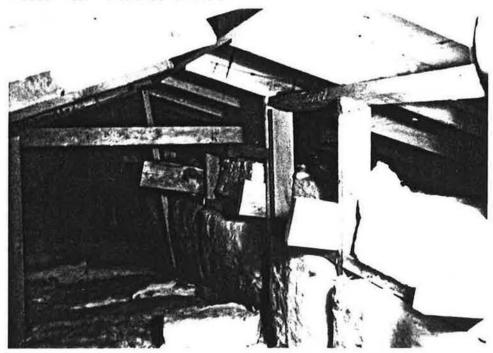
House No.2 - Join Between Attic and Cathedral Ceiling

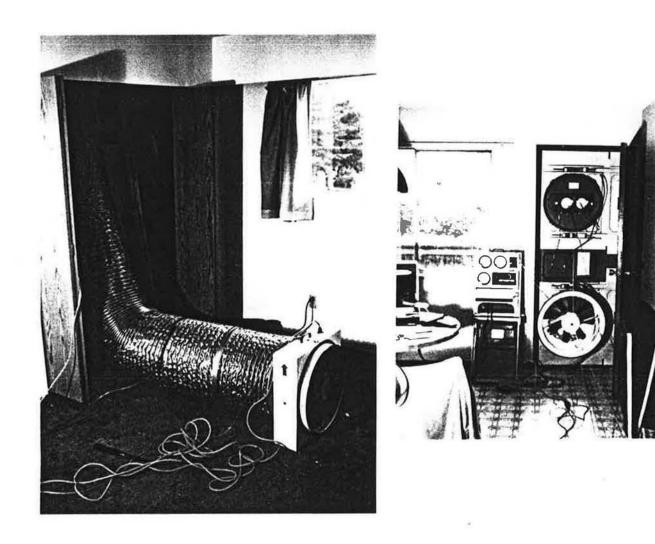
House No.2 - Equipment Set-up

The set up of equipment in House No.2 was relatively easy, because of the lack of furniture in the house. The extremely high air flow from the attic flow element caused the bedroom door to close during one of the tests. This was the highest flow recorded in any of the three research houses. The blower was unstable on its own at these high flows, and needed to be supported. Between tests the householder left a window open and operated both a bathroom fan and a range hood fan. The field crew were lucky to notice these disruptions prior to further testing.

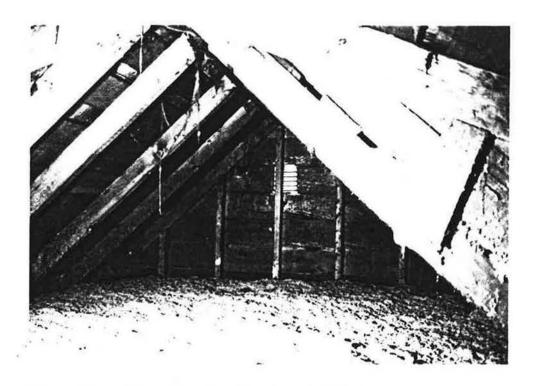
House No.3 - Front Interior of Attic with Cellulous

There did not appear to be a major restriction between knee wall attic spaces and the ridge peak attic. Insulation material was loose blown cellulose, only partially filling the rafter spaces between peak attic and knee wall attics. Pressures differences of 1 to 2 Pa were recorded between the different attic spaces, suggesting that there was only minor restrictions to air flow between the connected attic spaces.

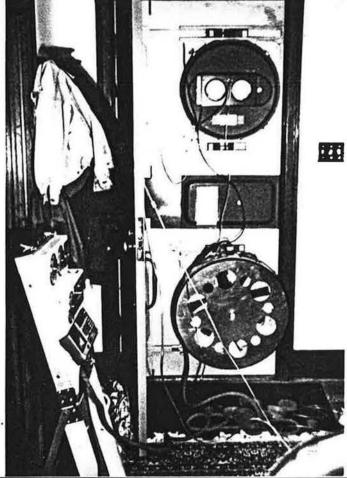
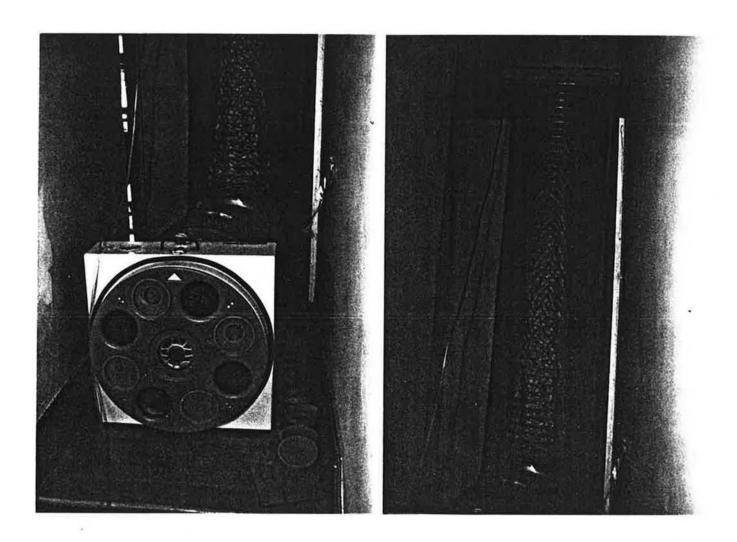
House No.3 - Attic Blower
