# Monitoring Looe school

Looe school is a direct-gain solar building which has undergone a year's rigorous monitoring. The results of the study reveal some surprises as to the efficiency of natural ventilation combined with passive solar techniques.

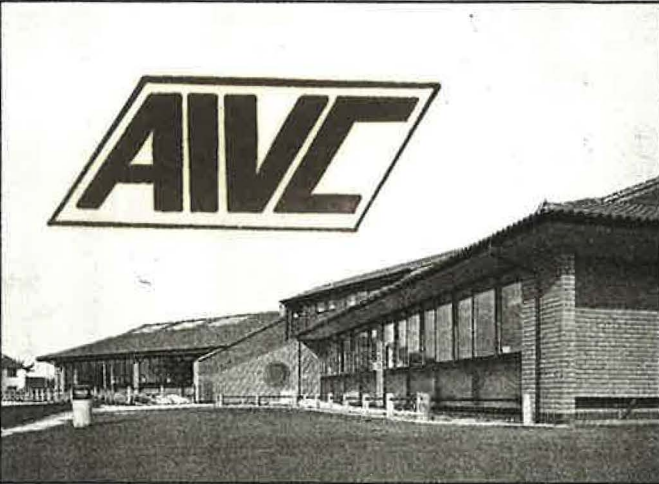
Above: The south facade of Looe junior and infants school. The trombe wall is shown here below the glazing, and makes up 40% of the facade.

To the outside observer, the south facades present a 100% glazed facade. However, internally, 40% of the facade is made up of what is essentially a short trombe wall. This cavity is intended to intercept direct solar energy, then store and release it to the classroom as warmed air. Air openings are provided at the top and bottom of the cavity to promote the natural convection of heat.

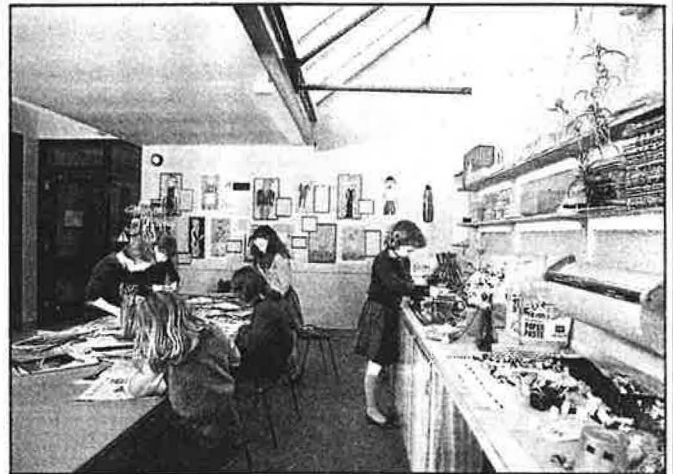
Above: Three south facing lightwells have been set into each classroom wing. The light is channelled down a well to the rear part of classroom and to the toilets.

reduced the incidence of daylight into the building. Although the designer anticipated this and placed a lightwell in the infant classrooms, in practice this had little measurable effect on daylight levels in these rooms.
