"The airtightness of houses"

NBI Norwegian
Building Research
Institute

Working Report 31

Results of airtightness measurements
in newer Norwegian dwellings

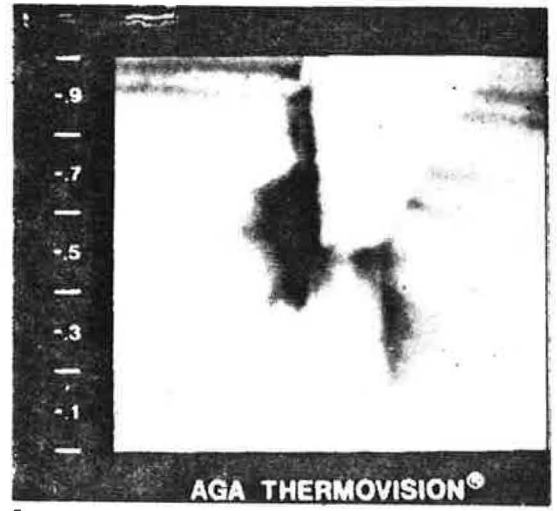
Fig. 3.4
Termogrammer - luftlekkasje
a. Lekkasje gjennom konstruksjonen
b. Lekkasje inne i konstruksjonen

A negative pressure is normally established in the dwelling with the aid of a fan. Cold outdoor air then penetrates through the leakages and cools the internal covering. This is indicated by dark "jagged" areas on the screen. If the cold air penetrates the structure but does not emerge on the inside, the dark areas have rounded contours. See Figure 3.4.

Thermograms - air leakages.

- a. Leakage through the structure.
- b. Leakage inside the structure.

Thus the results depend on the cold outdoor air cooling the visible surfaces and being registered by thermography. In cases where the air flows directly into the room without being in contact with inner surfaces, it is less simple to register such leaks with thermography.

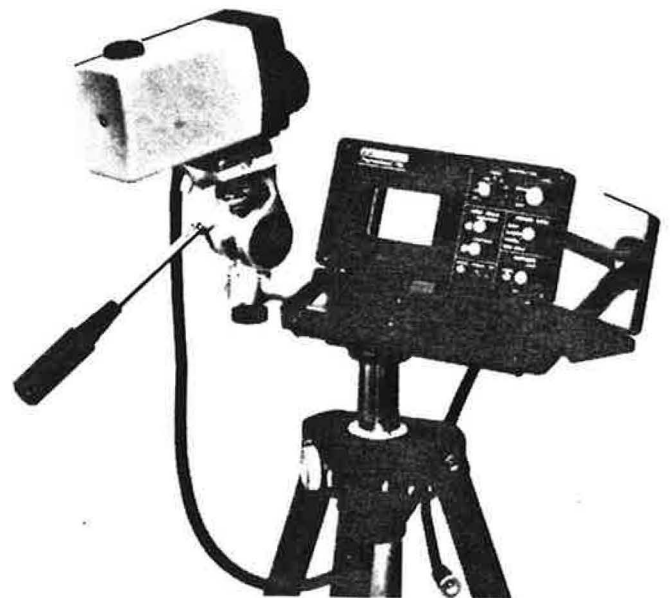
Fig. 3.5
Termograferingsutstyr

Measurements were carried out using AGA Thermovision 750 equipment. See Figure 3.5.

Thermography equipment.

Thermography equipment registers the intensity of part of the heat radiation (IR radiation) from a surface. For common surfaces, the radiation intensity is primarily determined by the surface's temperature. Temperature variations of the surface investigated appear as variations in brightness on a screen. A cold surface appears as dark areas whereas warmer surfaces appear brighter. The screen can be photographed with a polaroid camera.

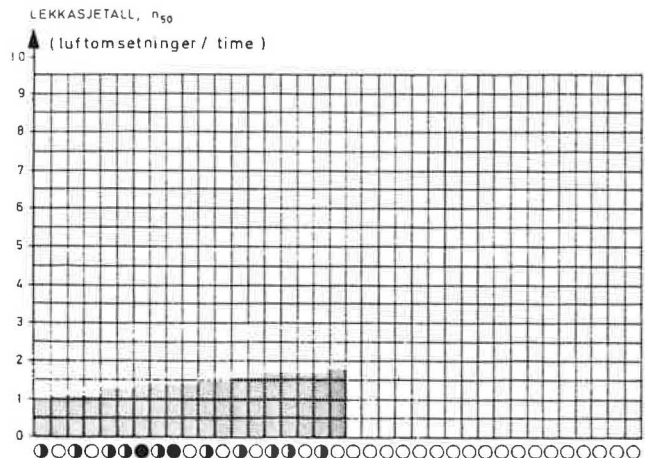
Diagram 15

TYPE BOLIG : Blokkleiligheter
 KOMMUNE : Kristiansund N
 ANTALL : 19
 MIDLERE LEKKASJETALL $n_{50} = 1,4$
 STANDARDAVVIK $s = 0,2$
