**EASE Demonstration Project  
APCHQ's Advanced House**

**Morrison Hershfield Limited**

Report No. 33121.04  
331204-0611 Repl.doc

January 4<sup>th</sup>, 1995

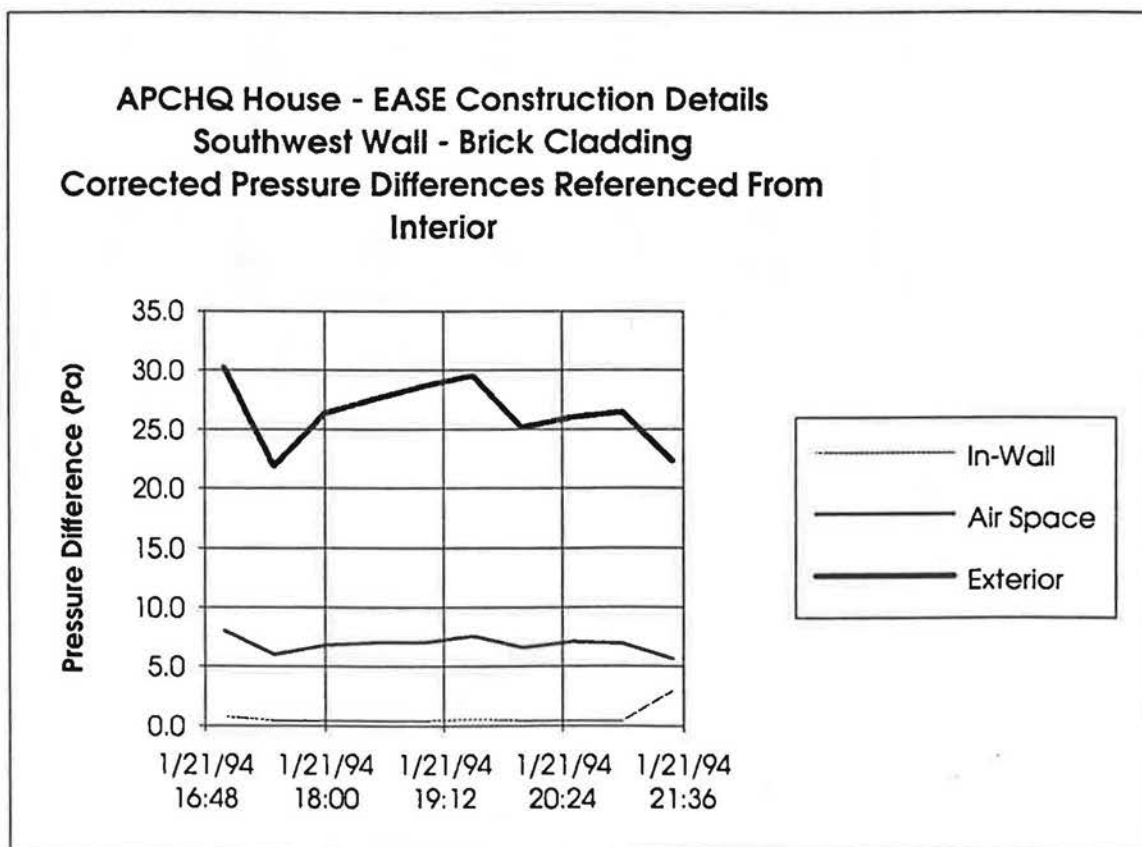
**Figure 3.2**

**APCHQ House - EASE Construction Details  
Pressure Distribution Across Wall System**

Date/Time	In-Wall Press Diff Corrected (Pa)	Air Space Press Diff Corrected (Pa)	Exterior Press Diff Corrected (Pa)	Across Interior Finish (%)	Across EASE (%)	Across Cladding (%)
1/21/94 17:00	0.7	8.0	30.2	2.5%	24.0%	73.5%
1/21/94 17:30	0.4	6.0	21.8	2.0%	25.4%	72.5%
1/21/94 18:00	0.4	6.8	26.3	1.7%	24.1%	74.2%
1/21/94 18:30	0.4	7.0	27.5	1.6%	23.8%	74.6%
1/21/94 19:00	0.4	7.0	28.6	1.6%	22.9%	75.5%
1/21/94 19:30	0.5	7.6	29.5	1.8%	23.9%	74.3%
1/21/94 20:00	0.4	6.6	25.1	1.8%	24.5%	73.7%
1/21/94 20:30	0.4	7.1	26.0	1.7%	25.6%	72.7%
1/21/94 21:00	0.4	6.9	26.4	1.7%	24.4%	73.9%
1/21/94 21:30	2.9	5.6	22.2	13.2%	12.0%	74.8%
