# Ventilation and low-income housing: a sensitive problem

M. Tomsic

*Building and Civil Engineering Institute ZRMK, Dimiceva 12, 1000 Ljubljana, Slovenia*

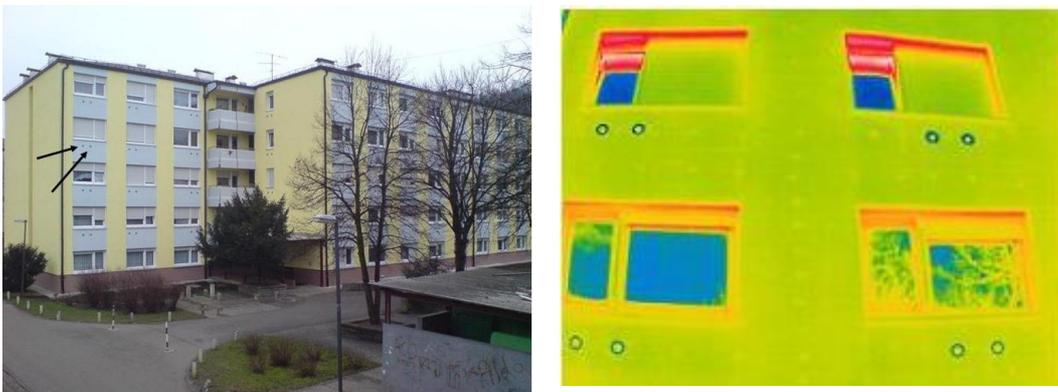
Figure 1: Left, photo after renovation, air inlets and outlets of individual mechanical ventilation units with heat recovery visible. Right, IR close-up photo, windows open, mechanical ventilation not in operation.

However, thermography did reveal some of the important possible problem sources. We saw that even on a winter night many of the windows were open due to misunderstanding of the purpose and functioning of the mechanical ventilation system with heat recovery (see Figure 1). Additionally, many of individual ventilation systems were simply switched off. Tenants explained that windows were open because it was “too hot” in the apartments. But, in the same time we heard complaints about new radiators being “too small” concerning the floor surface of rooms, so all the thermostat valves on radiators were turned to the maximum

Concerning this unchanged tenants' behaviour it was not possible to expect better results. Still, it seems that the choice of installing mechanical ventilation units to each room prevented excessive indoor air humidity, but since they were operating on a random basis, often together with open windows, there was only little effect to reduction of heat consumption. The housing fund staff realised that providing tenants with one-off information about new systems was not enough, and that these activities (information, education) would have to be continuous.

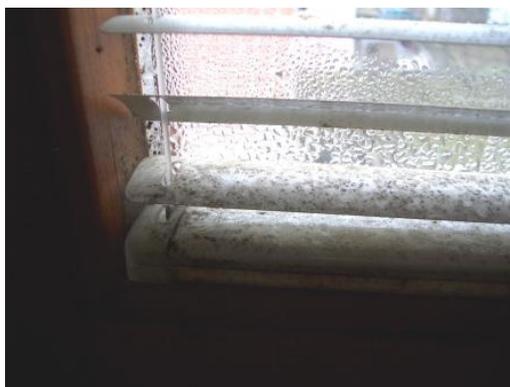
Figure 2: Condensate on glazing internal surface, and mould on internal blinds.

As a rule, mould growth was present in rooms where furniture occupied most of the room surface, including wardrobes on or very close to external walls. These rooms are thus very difficult to ventilate properly and thoroughly, especially areas behind cabinets and wardrobes. Lack of proper ventilation was demonstrated also through droplets of condensate on lower window frames and on glazing, and through mould visible even on internal blinds (see Figure 2).

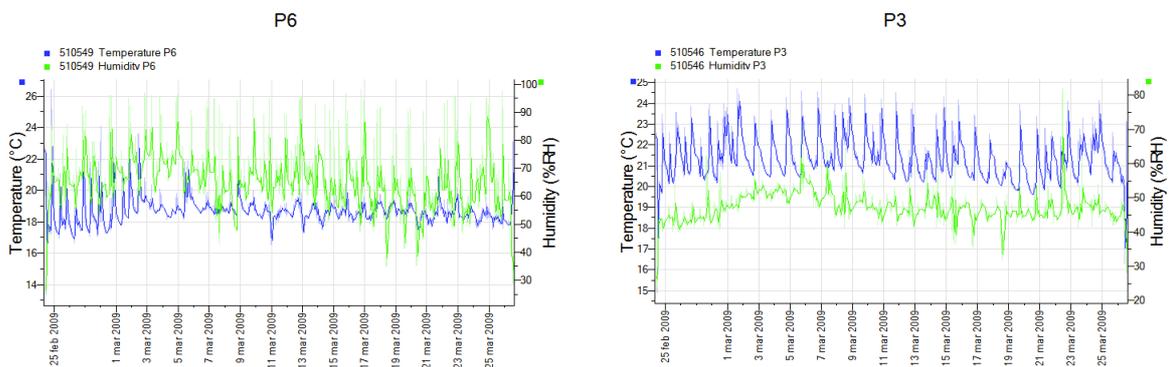
As a completely opposite situation, in other apartments there were no problems present at all. Interviews with these tenants reflected that they ventilate their apartments several times a day and in case of intermittent heating lower the thermostat settings only by a few degrees. See Figure 2 illustrating substantially different microclimate in two apartments of the building.

Figure 2: Range, fluctuations, and levels of indoor air temperature and relative humidity in two of the apartments.

This case showed that in the same building, in apartments with symmetrical or identical layout, completely different situations can occur. If there are boundary conditions present (adequate heating system, possibility of natural ventilation etc.), which allow tenants to maintain proper microclimatic conditions (air temperature and relative humidity), then tenants have to take on their share of responsibilities, and also liabilities for consequences related to patterns of use. In this case the importance of proper and regular ventilation of occupied spaces again proved to be one of the most vital elements for achieving good overall indoor comfort.

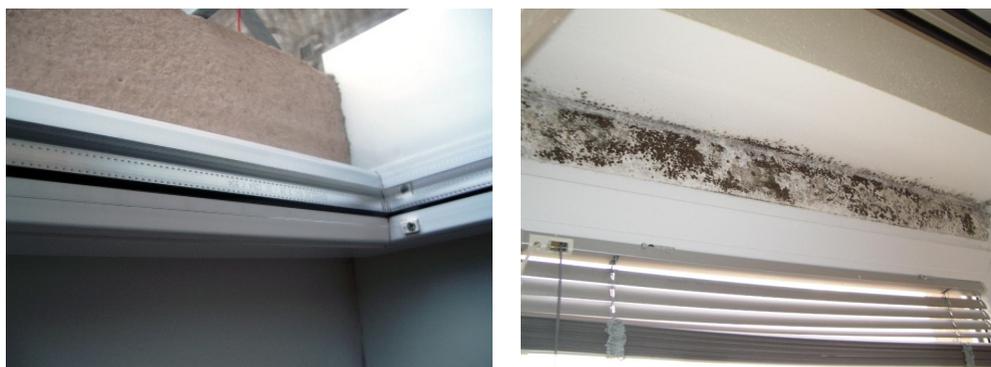
Tenants explained that indoor thermal comfort before the renovation was not too satisfying, with air draft problems occurring because of faulty windows. However, this problem actually had a positive impact as it compensated deficient natural ventilation already before renovation. New windows eliminated the aforementioned problems, but created new, even more unpleasant ones (see Figure 3).

Figure 3: Left, new energy efficient and airtight windows in an uninsulated wall. Right, consequences of constant ventilation with window in an inclined position.

Many tenants continued their previous patterns of (not) ventilating the apartments, thus supposedly saving money on heating costs. Some of the tenants claimed that they “constantly” ventilated the rooms, but this was done mainly by inclining the windows at the top, often because they could not be opened normally due to furniture layout or occupied internal window shelves. As a result surface condensation occurred, especially on window lintels, followed by mould growth. In many cases this occurred in rooms where radiators were turned off to save on heating costs, but the doors to adjacent heated spaces (especially kitchen) remained open or were not airtight at all, thus allowing warm and humid air to come in contact with cooled surfaces.

Mould was found also in some areas, which correspond to the definition of geometrical thermal bridges, but were not problematic before the renovation. Higher relative indoor air humidity after the replacement of windows brought conditions suitable enough for surface condensation and mould growth. This was especially true in apartments where bathroom and kitchen ventilators were out of function or simply not used. A well-meant measure such as replacement of windows in an uninsulated building can have unpleasant consequences if not accompanied by increased ventilation.

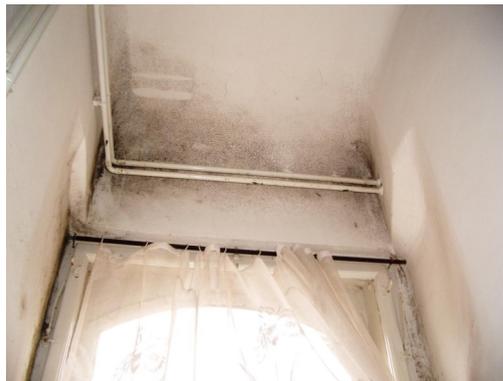
Here, the tenants heated only few rooms of the apartment. As a low-income family they wanted to reduce operational costs as much as possible. This included switching off the radiator system (district heating), and using individual gas-fired heating appliances instead. In this way indoor air temperatures rarely reached comfortable levels, and gas as a fuel added its share to air humidity. Internal surfaces remained below the surface condensation point for longer periods during colder month of the year.

Figure 4: Mould growth on the bathroom ceiling, heating turned off, poor ventilation.

Uncontrolled ventilation additionally contributed to low indoor temperatures, thus worsening the situation. One of the typical examples observed here was the ceiling area above the window in the bathroom (see Figure 4), where the combination of air temperature and humidity was particularly inappropriate. Of course, suggesting active natural ventilation of the apartment would probably reduce the indoor air humidity, but with heating and other occupancy patterns remaining unchanged it would further reduce indoor temperatures to most inconvenient levels.

In cases like this, renovation measures such as replacing the windows and making the envelope more airtight would not be a solution. It is very difficult to find a reasonable compromise in cases when low-income tenants occupy an older building, and have to pay for the operational costs.
